Beban, J.G; Stewart, C; Kim, N; Cousins, W.J; Leonard, G; Wright, K; Johnston, D.M. 2015. Challenges of installing and maintaining 200-litre emergency rainwater tanks in the Wellington region, *GNS Science Report 2015/21*. 37 p.

In July 2013, the Wellington Regional Emergency Management Office (WREMO) partnered with a provider of water tanks to make 200-litre emergency rainwater tanks available at various council locations throughout the Wellington region. These tanks can be connected to downpipes and are designed to assist households with their emergency water needs, particularly following a disaster like a large local earthquake. While the rainwater tanks are being promoted as a viable emergency water supply, very little research exists in the Wellington context which explores the effectiveness and practicality of these systems.

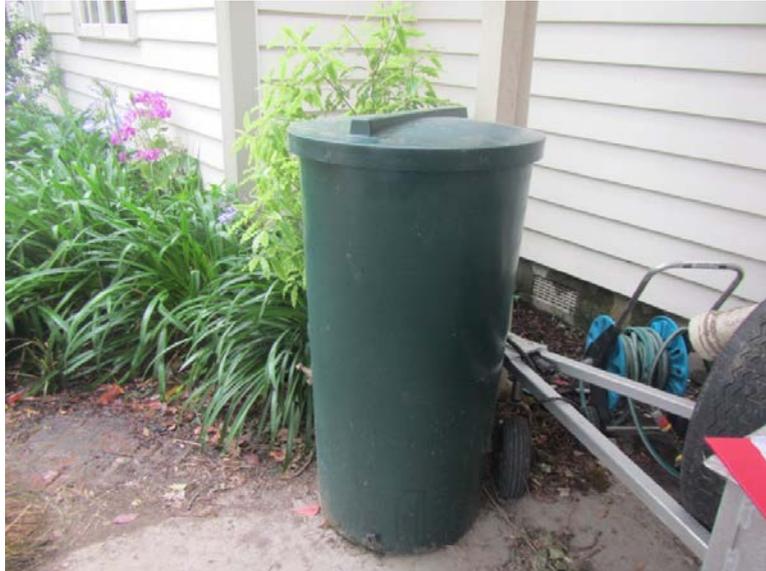
- In October and November 2014, Tank 2 had to be disconnected from the roof supply for 6 weeks due to the need to undertake emergency stormwater repairs. During this 6 week period, the rainwater tank was transported and stored under the carport and remained disconnected from the stormwater systems. The rainwater tank was reconnected to the original downpipe once the works were completed. Approximately 60 litres (30% of the tank volume) was lost during the transportation of this rainwater tank (Figure 2.3).

Figure 2.3 Tank 2 disconnected from the stormwater system.

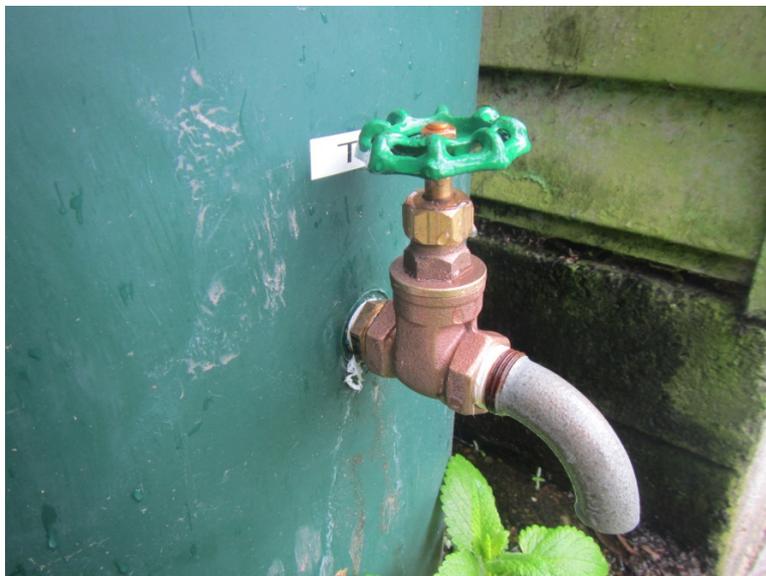
- All of the taps were replaced with new spindle taps in April 2014 due to an issue associated with spreading washers in the original taps that were supplied with the rainwater tanks. These washers adhered to the tank side of the tap valve and prevented water flowing from the tanks when they turned on. The installation of the new taps resulted in the rainwater tanks losing approximately 10 to 20 litres per tap change.

Figure 2.4 Tank 1 replacement tap.

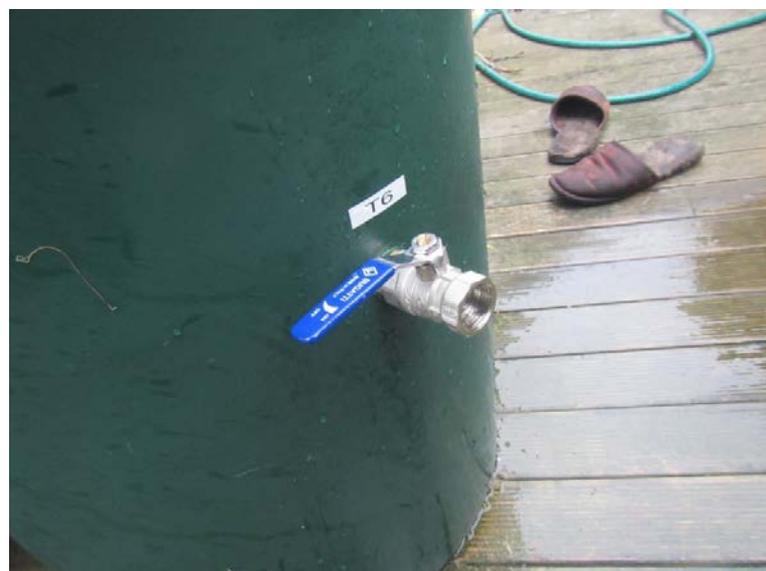
- For Tank 6, the tap was replaced by a stainless steel ball valve tap on 22 November 2014, due to continuing problems with the April replacement tap malfunctioning. Approximately 20 litres of water was lost during this exercise. For Tank 1, the tap was replaced by a gate valve in October 2014 (Figure 2.4 and Figure 2.5).

Figure 2.5 Tank 6 replacement tap.

This rainwater tank has persistent issues with a leaking tap. The owner replaced the original tap with a stainless steel ball valve tap on 22 November 2014. This appeared to fix the leaking issue.

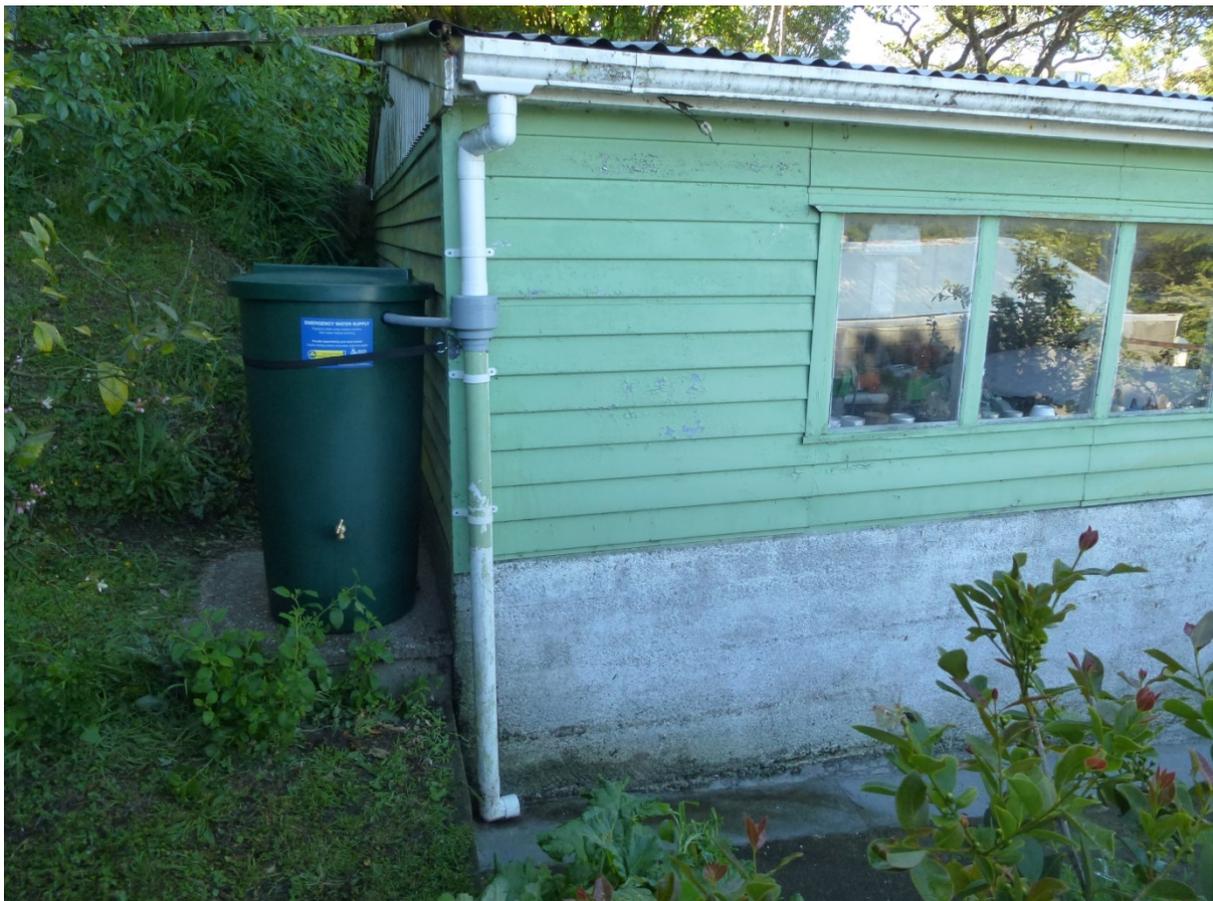
Figure A1.1 Installation at Pekanga Road, Normandale, Lower Hutt.

Installation was mostly straightforward. There were two minor problems to be dealt with, (a) the inlet spigot on the tank had to be moved to the opposite side of the tank to allow easy user access to the tap, and (b) two additional clips were needed to support the lower part of the downpipe.

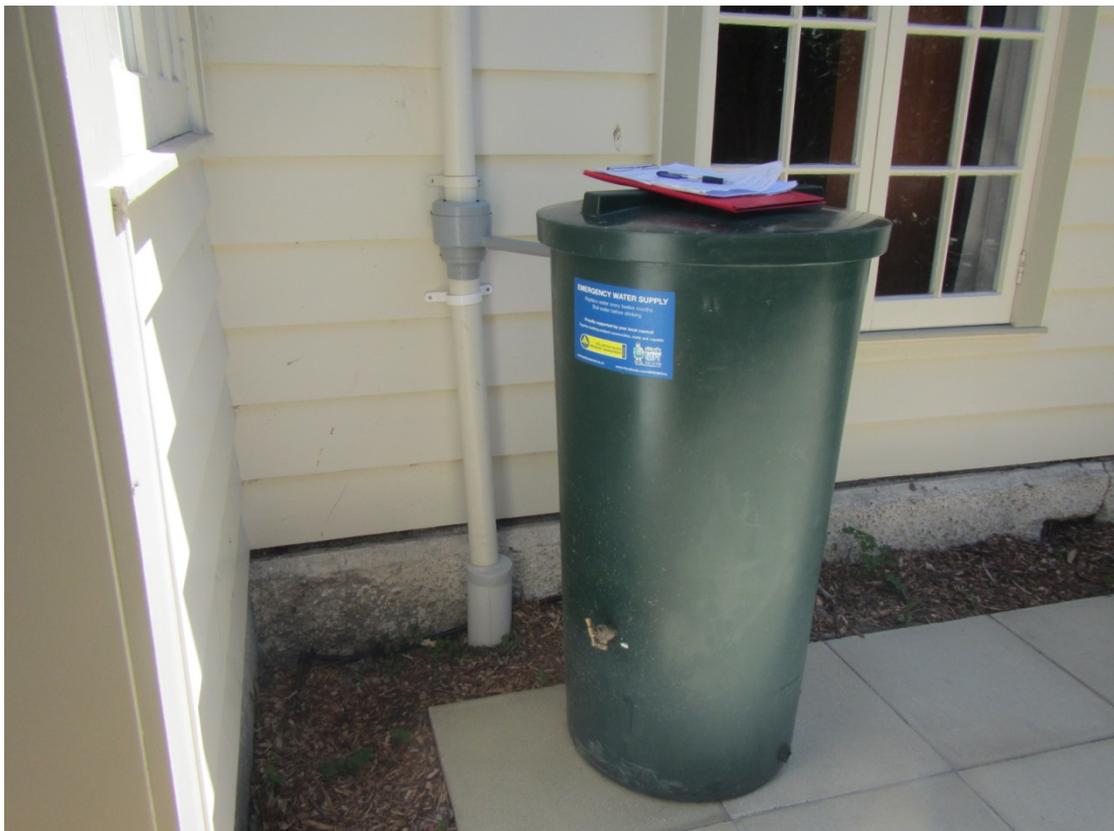
Figure A1.2 Installation at Mason Street, Moera, Lower Hutt

The owner of the property installed the tank in less than 15 minutes. The installation was relatively straightforward with the only issue being identified was the need for a clip to hold the lower portion of the downpipe. As part of the installation, the owner also glued the diverter so that it became a single unit. This modification was made to ensure that the risk of leaks from the diverter during high rainfall events was reduced.

Not long after the tank was installed, it was noted that there was a small leak around the tank. To rectify this issue, the owner removed the tap, and placed an old tap in to block the outlet. The owner then placed thread tape over the tap that was removed and reinstalled this tap. This action stopped the leak.

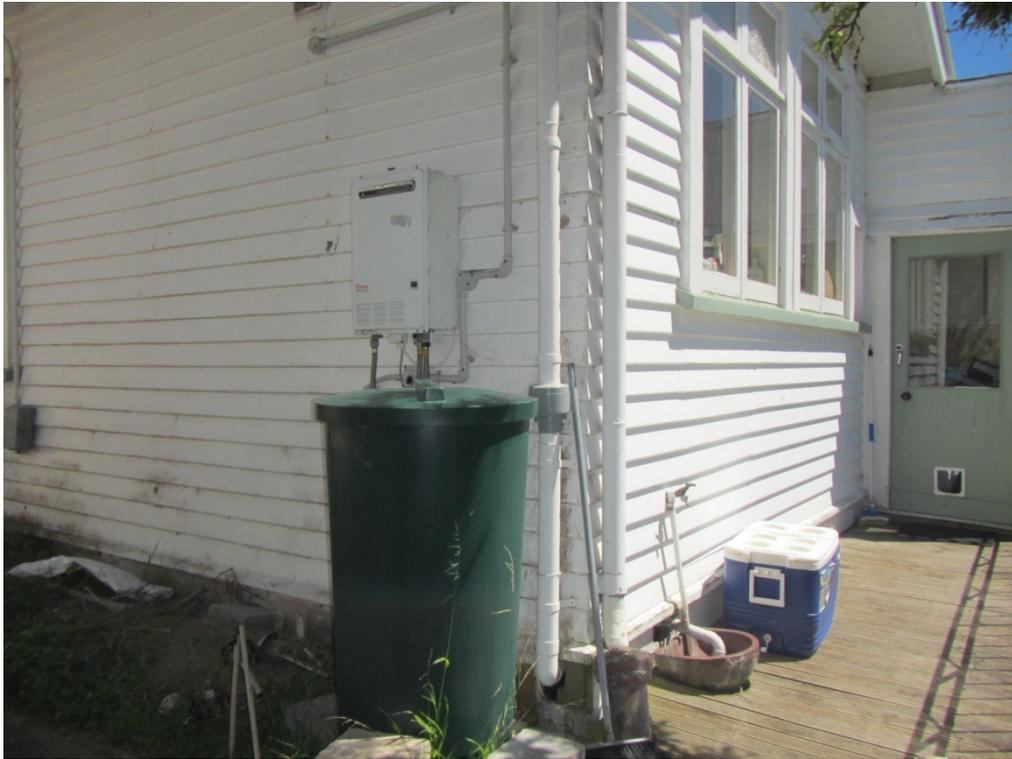
Figure A1.4 Installation at Homewood Crescent, Kaori, Wellington.

Due to the proximity of the downpipe to the dwelling façade, this rainwater tank was installed by a professional plumber. The plumber had to replace the downpipe as part of the installation to ensure there was sufficient clearance between the diverter and the dwelling's façade.

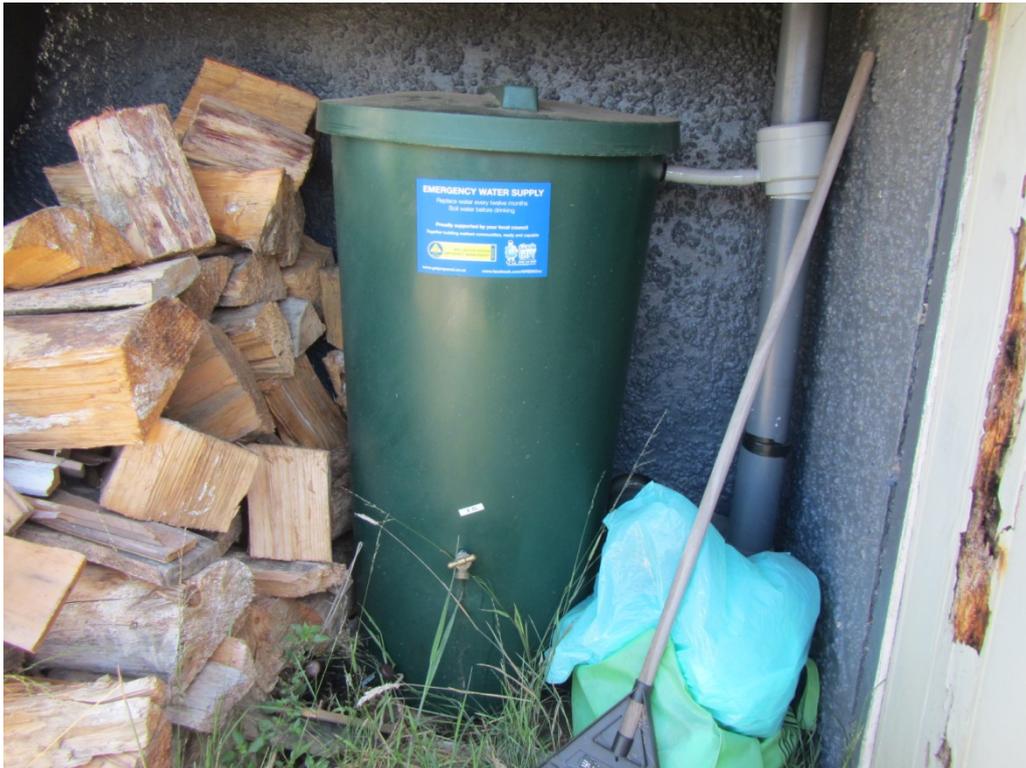
Figure A1.5 Installation at Charlotte Avenue, Brooklyn, Wellington.

The owners of the property installed the tank themselves. The installation was relatively straightforward with the only known issue identified as being if the restraining strap was installed, there would be a need to use a concrete drill to ensure that the strap was appropriately fixed.

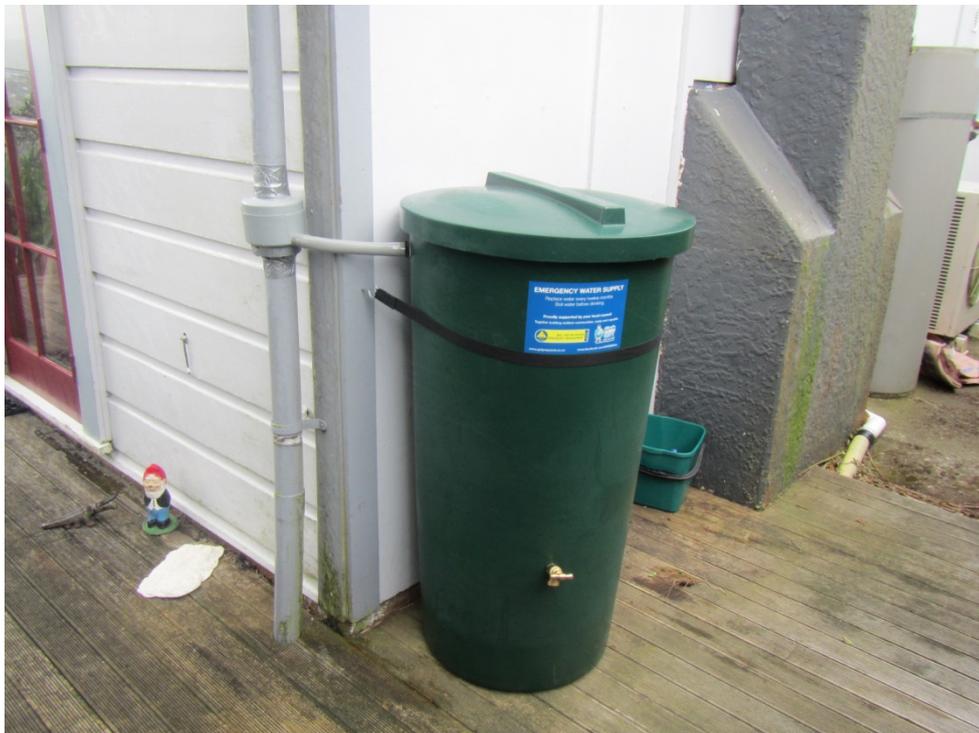
Figure A1.6 Installation at Harland Street, Brooklyn, Wellington.

The owner of this property did not install the diverter flush with the rainwater tank. This resulted in the diverter leaking in high intensity rainfall events.

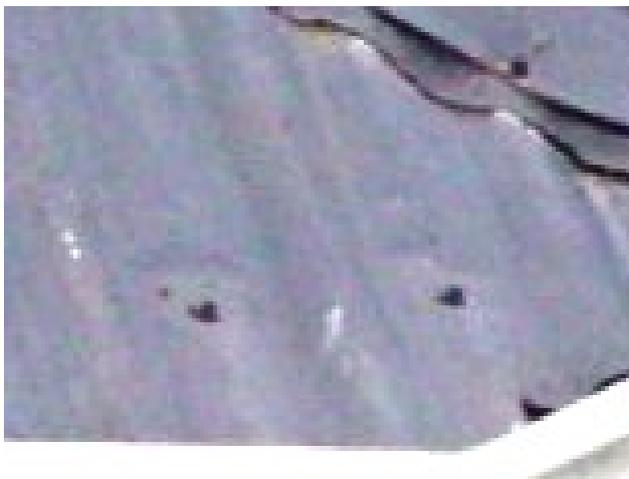
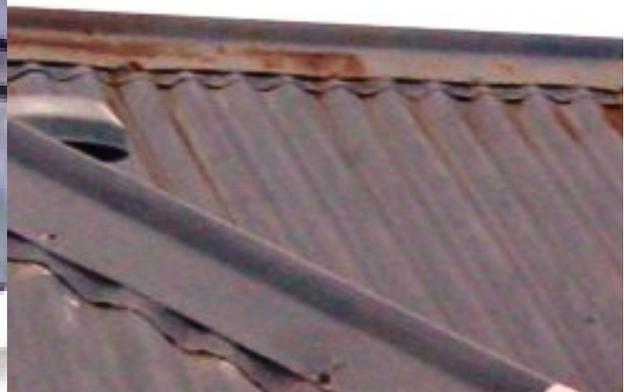
The roof structure is that of a “hip” roof with valleys. The collection area of roof cladding is made up of two distinct areas. The main area is corrugated painted galvanised iron (steel) with the other area being a newish (2-3 years old) bull-nosed galvanised steel veranda roof cladding. The condition of the roof cladding to the main area is poor and badly corroded, in need of replacement.

Older part of roof

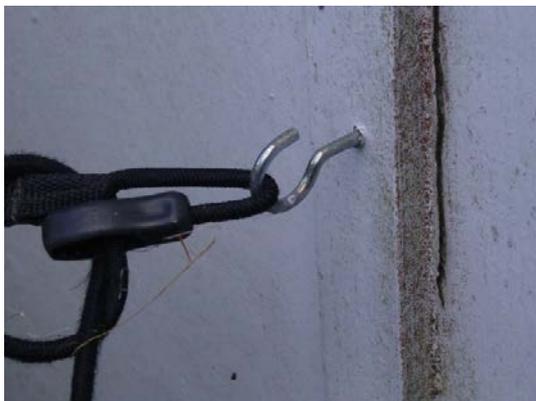
Restraining straps causing damage to the buildings they were attached to	For tank 6, the restraining strap has resulted in the batten being pulled away from the dwelling. This has resulted from the incorrect installation of the retaining strap into non-structural elements of the dwelling.	Provide clear instructions on the need for the restraining strap to be installed into structural aspects of the building.	Medium
Taps not working	The washers in the taps provided with the rainwater tanks were too soft and spread, and then adhered to the tank side of the valve, which prevented water from flowing from the tap when it was turned on.	Provide taps with washers that do not spread and adhere.	Low
The lower section of downpipe repeatedly separated from the diverter	To install the diverter the downpipe needs to be cut. Due to the design of the diverter the lower section of downpipe regularly separated from the diverter. This meant that rainwater did not enter the stormwater system and instead discharged across the ground.	This issue was addressed in a variety of ways by the parties who installed their tank, including through the use of tape and brackets. The easiest and most practicable solution would be for the kit to provide an additional downpipe bracket that could be used to secure the downpipe below the diverter to the house.	Low

Stress on batten caused by tank restraint strap

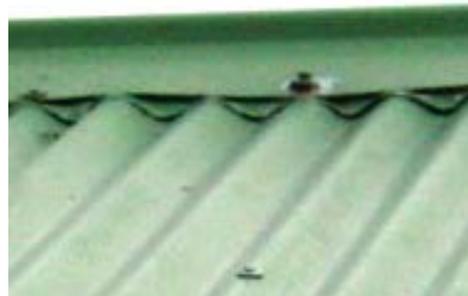
Loose ridge fixing

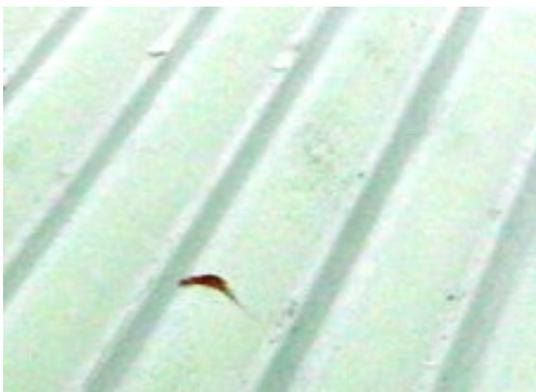
Missing corroded fixing

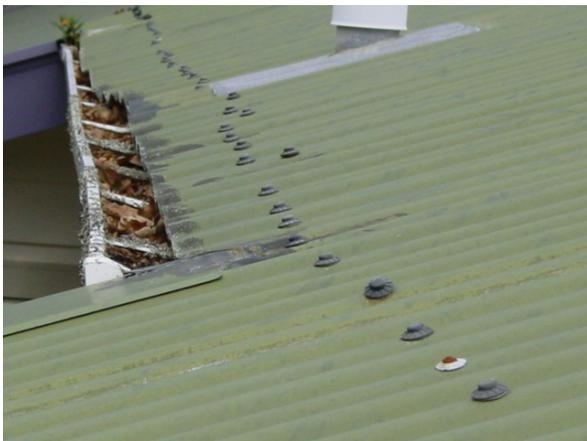
The guttering is Marley “OG” profile and in good condition, but heavily laden with organic matter.

Gutter clogged with leaf litter

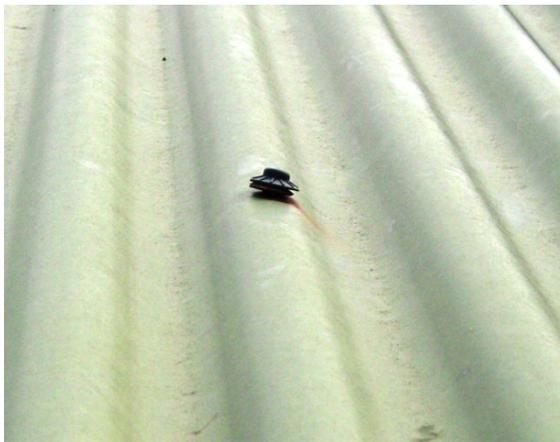
Fixings; galvanised “TEK” screws. Early type with neoprene caps which have suffered UV damage. Many of the fixings are loose and/or corroded.

State of fixings

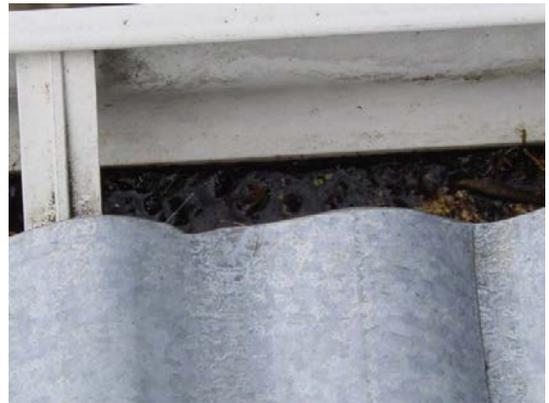
Guttering: Marley "OG" profile. Gutters are clogged with leaf litter which is retaining standing water.

Gutter clogged with leaf litter
