FULL-SCALE HOPPER TESTING OF LIME FLOWABILITY

Abstract

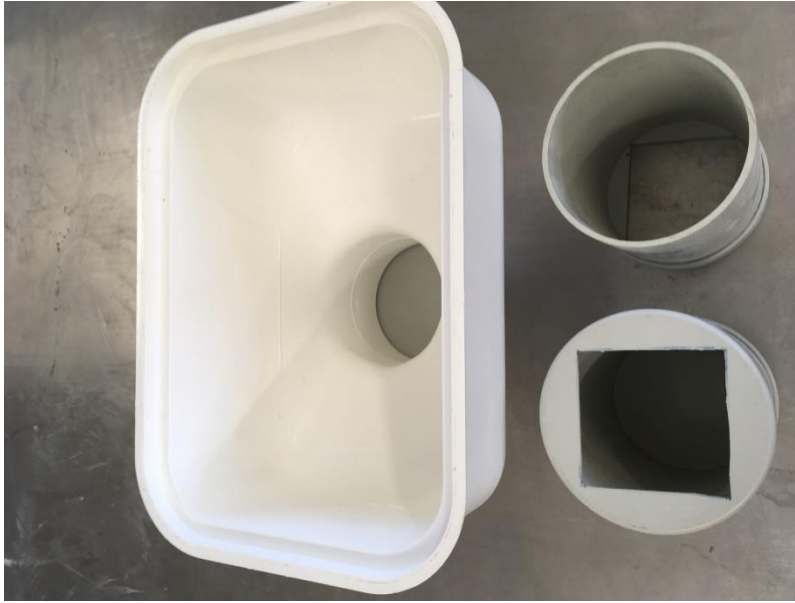
Figure 1: Three different devices for testing lime samples: scale model hopper made from PVC downspout (left) and two cylinders for testing flow from top and bottom.

The previously constructed test cylinder had approx. 2 kg capacity and correlated well with a hand squeeze test for clumping. However, this design was questioned as it required the sample to be turned upside to check the flowability, an operation that does not occur in practice. Therefore, a modified cylinder design was introduced that uses a trap door mechanism at the bottom so the lime does not need to be turned around. In addition, a sample-testing device created from a piece of PVC downspout, as shown in Figure 1. This “scale model hopper” holds approximately 5 kg of lime. In total, 3 different devices were used to test the flowability of the lime samples in the lab testing (shown in Figure 2). These devices were also used alongside the full-scale hopper testing.

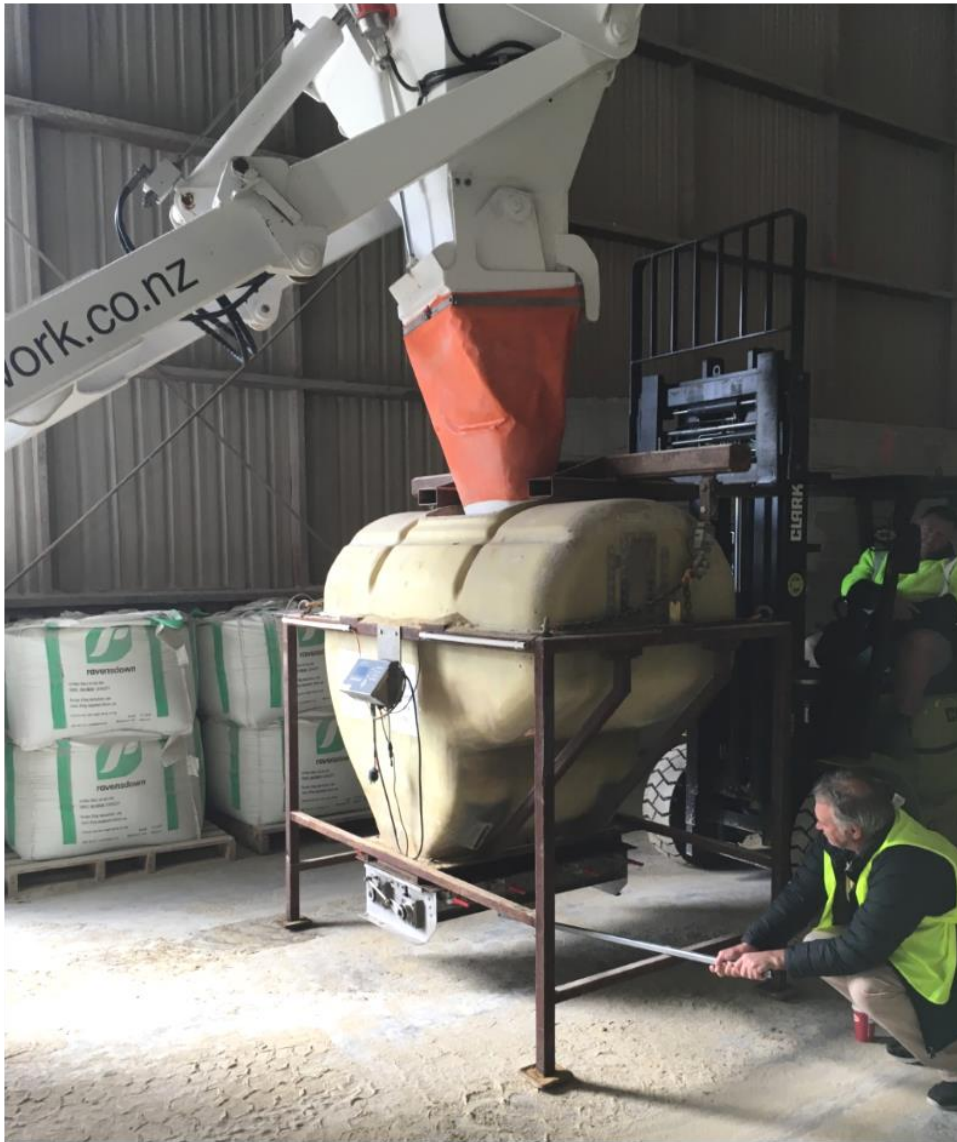
Figure 2: Full-scale hopper testing at Ravensdown in Wanganui.

Full-scale hopper testing was conducted at two locations: At Ravensdown in Wanganui on 7 Aug 2019, using an extra hopper (Figure 2), and at SuperAir in Hamilton on 20 Aug 2019 using the aircraft shown in Fig. 3. At Ravensdown Websters and Taueru limes were tested, and Supreme lime was tested at SuperAir. At both locations a GoPro camera was mounted facing down towards the hopper outlet. A 10 L water sprayer was used for wetting the lime, and a loader truck and shovels were used for mixing the water into the lime. 0.5 kg samples of the lime taken from the un-used piles were placed in sealed glass jars to be taken to Lincoln Agritech for measurements of moisture content and particle size distribution. Water was added to the dropped lime on the ground in increments of 1% by mass (e.g. for 1 tonne bag of lime this will be 10 L of water).

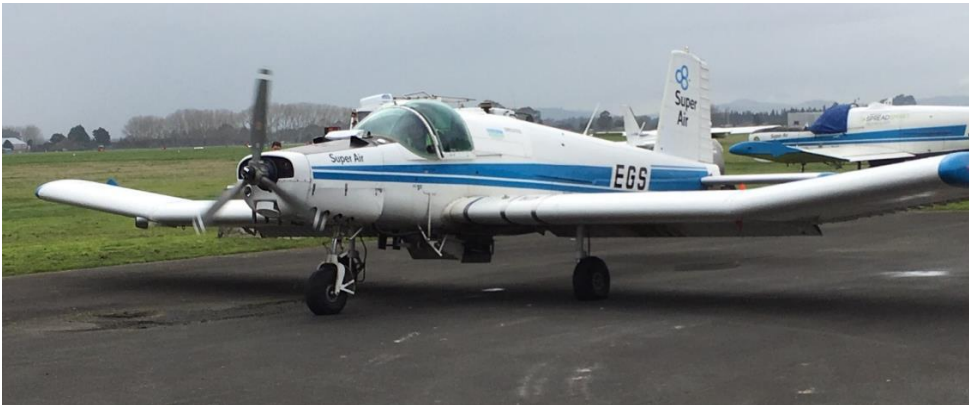
Figure 3: SuperAir plane in Hamilton with 1.2 tonne hopper used for testing.

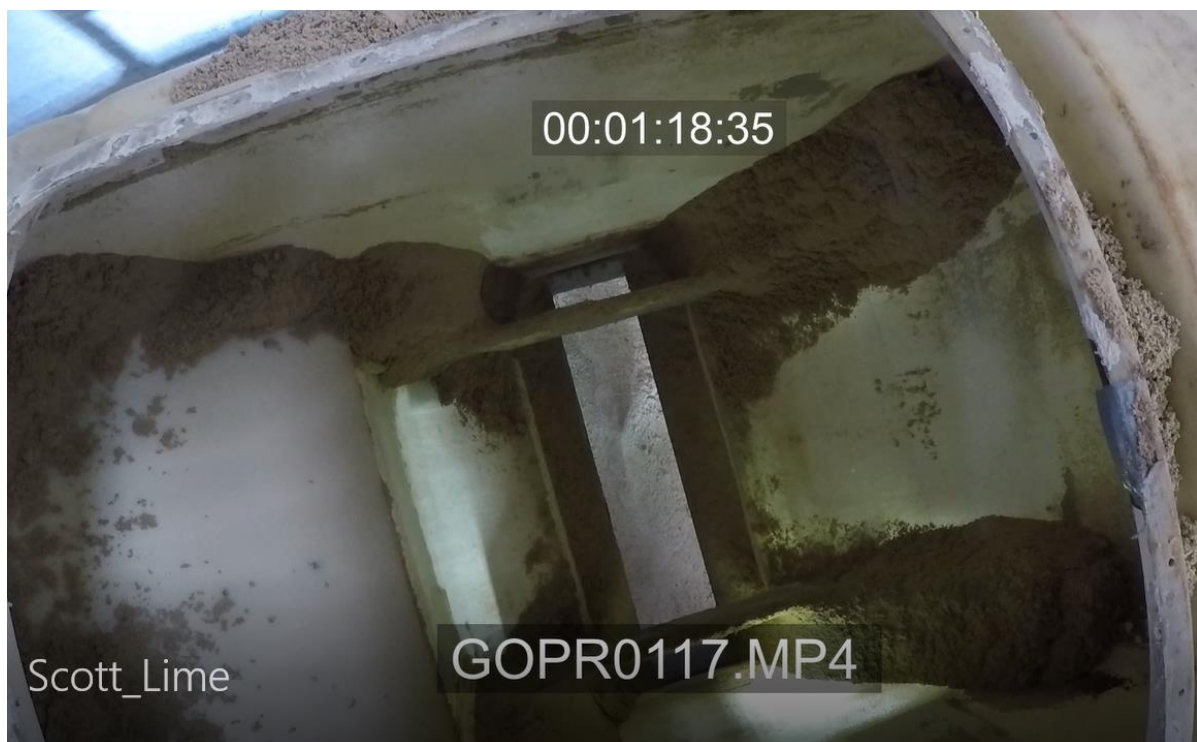
Figure 4: Screen shot of residual lime in hopper for highest moisture level tested (10%) with Webster's lime.

The Webster's lime proved more resilient to moisture addition than the Taueru lime, which was consistent with previous laboratory testing. Both limes had approximately 4% initial moisture content based on laboratory analysis of samples. At the highest moisture level tested with the Webster's lime (10%) quite a bit of lime stuck in the corners (Fig. 4), but in all cases the lime did flow out of the hopper and did not get hung up.

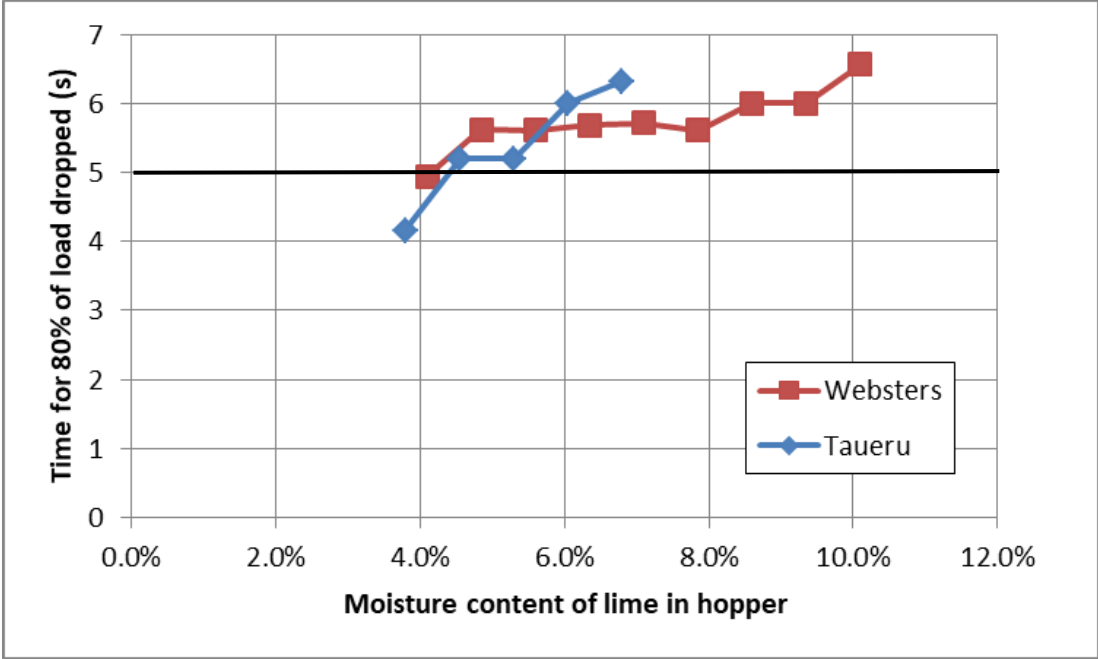
Figure 1: Time for 80% of the load to drop from the hopper as a function of moisture content for 2 different limes tested at Wanganui. Each data point is one measurement.

within 0.5 s of values determined from later analysis of the videos. The CAA jettison test time was then estimated by multiplying the time to drop the full load by 0.8. It was noted that the load dropped was not necessarily 100% of the full load, particularly as at higher moisture levels more of the lime stuck in the corners of the hopper (as in Fig. 4). Figure 5 shows the estimated jettison times as a function of lime moisture content for both limes tested. For most of the cases tested this exceeded the 5.0 s CAA requirement, but in all cases the lime flowed freely from the hopper without hanging or the need for shaking. The Webster’s lime exhibited very consistent behaviour up until 75 L of water was added to the 2-tonne pile (7.9% total water content by mass). At this point the lime formed one solid lump when squeezed in the hand (at lower moisture levels it would make 2 or more lumps). The pilot said at 45 L of water added (6.4% water content) he judged the lime to be marginal and would test it in the loader before topdressing it in the field, and he probably would not use the lime at the point where 60 L of water was added to the pile (7.1% total moisture content). The scale hopper test failed at 45 L of water added (6.4% moisture) and the cylinder tests failed at 60 to 75 L water added (7.1-7.9% moisture). The flowability of the Taueru lime degraded more quickly with moisture content than the Webster’s lime, and so it was tested to a lower total moisture level. At 45 L of water added (6.1% moisture) it was judged to fail the hand squeeze test (formed 1 lump). It failed both the cylinder and scale hopper tests at 30 L of water added (5.3% moisture).

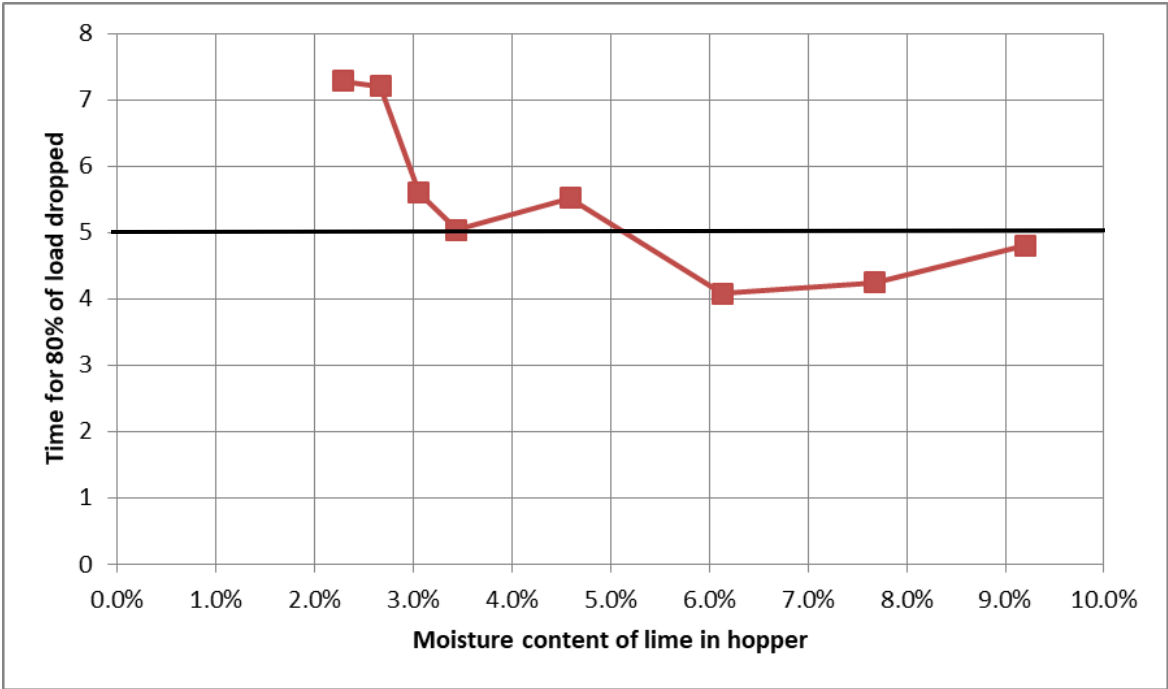
Figure 2: Jettison times for Supreme lime dropped from SuperAir plane in Hamilton as a function of lime moisture content. Each point is one measurement.

At SuperAir in Hamilton two 500-kg bags of Supreme lime were used in the testing. It was discovered after the testing by weighing the load in the hopper that the mass of lime used was around 1300 kg. Given that the bulk density of lime is higher than most fertilisers, the bags were likely filled to over the nominal 500 kg mass. The Supreme lime used exhibited the interesting behaviour that the flowability improved after a certain amount of water was added, and then the flowability degraded again above 6% moisture content (Fig. 6). At 50 L of water added to the 1.3-tonne lime load (6.1% total moisture content), the pilot reported that the hopper door was hard to open, but he would still find the lime suitable for topdressing. At 70 L of water added (7.7% moisture), the lime made 1 lump when squeezed. Another pilot who was present

at the time said he would not use the lime in that state, and the lime failed to discharge from the scale hopper. At 90 L of water added (9.2% moisture) the lime failed in the test cylinder, and was also difficult to get out of the loader and into the plane, though it still came out of the plane hopper in a reasonable amount of time (6 s).

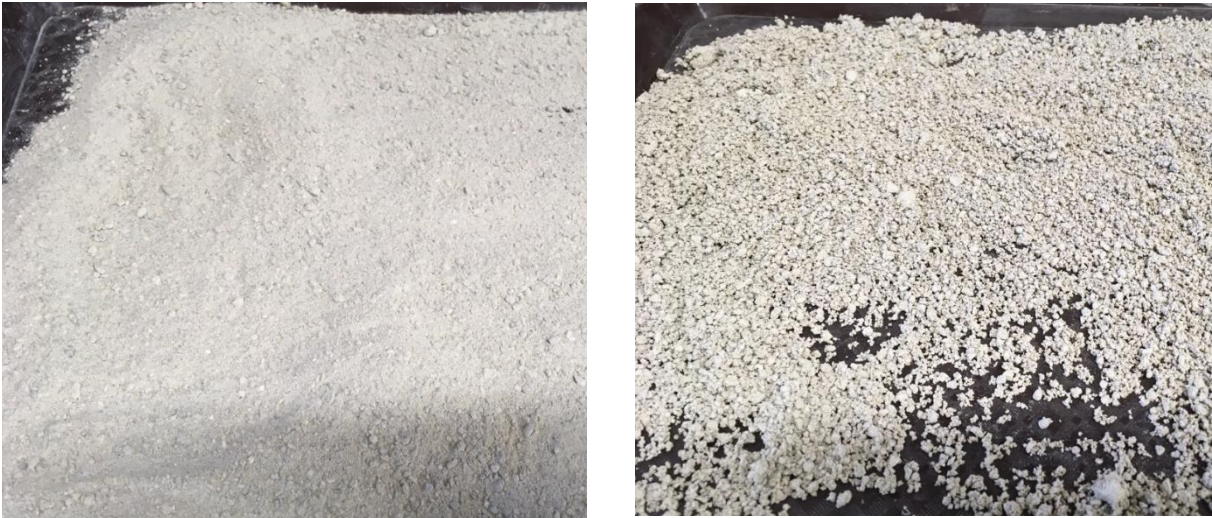
Figure 73: Samples of Supreme lime (left) from before start of testing, and (right) after testing.

The unexpected behaviour of the Supreme lime flowability with increasing water content appears to be due to unintended particle agglomeration. Figure 7 shows that the initial condition of the lime was quite different from the final state. Further, after the before and after-samples of the lime were dried, the sieving analysis showed that most of the fine particles of the lime

had been removed during the course of the testing. The median particle size increased from 538 to 923 μm , the fraction of particles less than 125 μm decreased from 18.4% to 1.9%, and the uniformity index (UI) also increased from 2.0 to 11.2. A review of the literature suggests wet agglomeration is responsible for the change in particle size distribution. Mehos & Kozicki (2011) and Kale et al. (2011) show that a wet agglomeration process that applies a shear force to the powder can be used to improve the flowability. In a test with powdered potash they found the agglomerated powder had decreased cohesion and wall friction and increased bulk density, all of which serve to improve flowability and reduce chances of arching in a hopper.

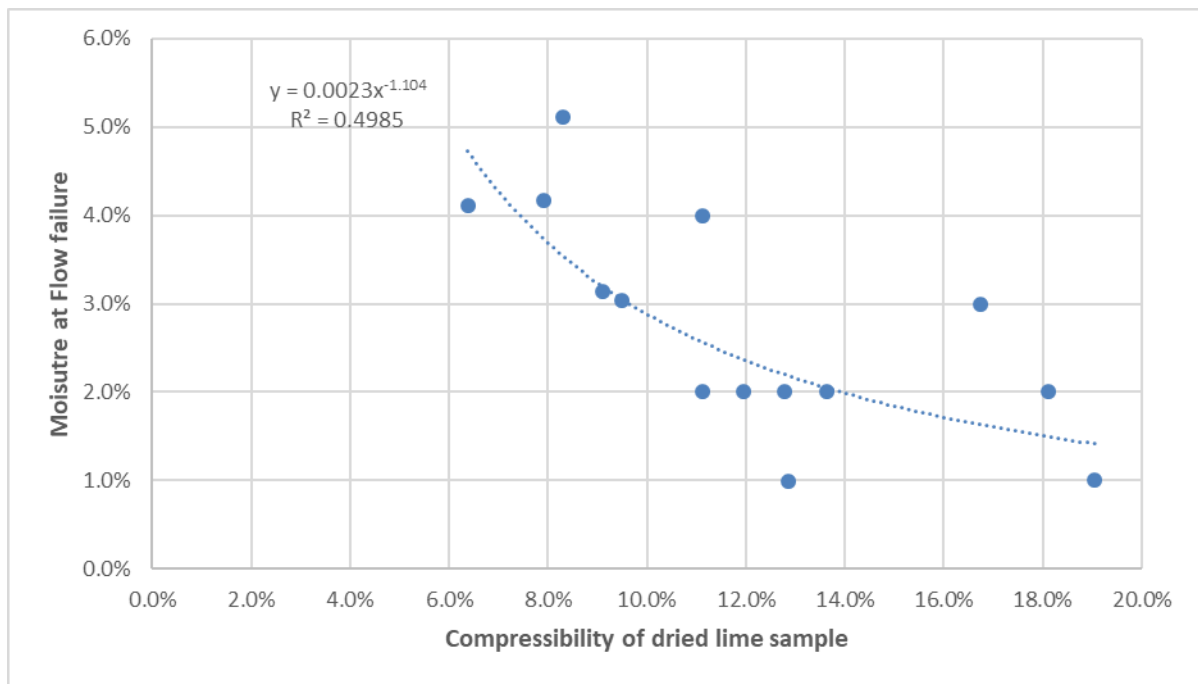
Figure 8: Correlation between the compressibility of dried lime (0% moisture) and the moisture level required for flow failure for all lime samples tested.

Compressibility of lime can be calculated as:

$$\text{Compressibility} = \frac{\text{tapped density} - \text{bulk density}}{\text{bulk density}}$$

The average compressibility at flow failure for these twelve limes is 20.4%. This compares very well with the finding in the literature of the previous project that the borderline between free flowing and non-free flowing is approximately 20–21% compressibility (de Campos & Ferreira, 2013).
