Wilson, T. M.; Stewart, C; Cole, J. W.; Johnston, D. M.; Cronin, S. J., 2009. Vulnerability of farm water supplies to volcanic ash, *GNS Science Report* 2009/01 114 p.

The aim of this project was to characterise the vulnerability of farm water supplies in New Zealand to volcanic ashfall, and to make management recommendations to reduce this vulnerability. In this report, we have:

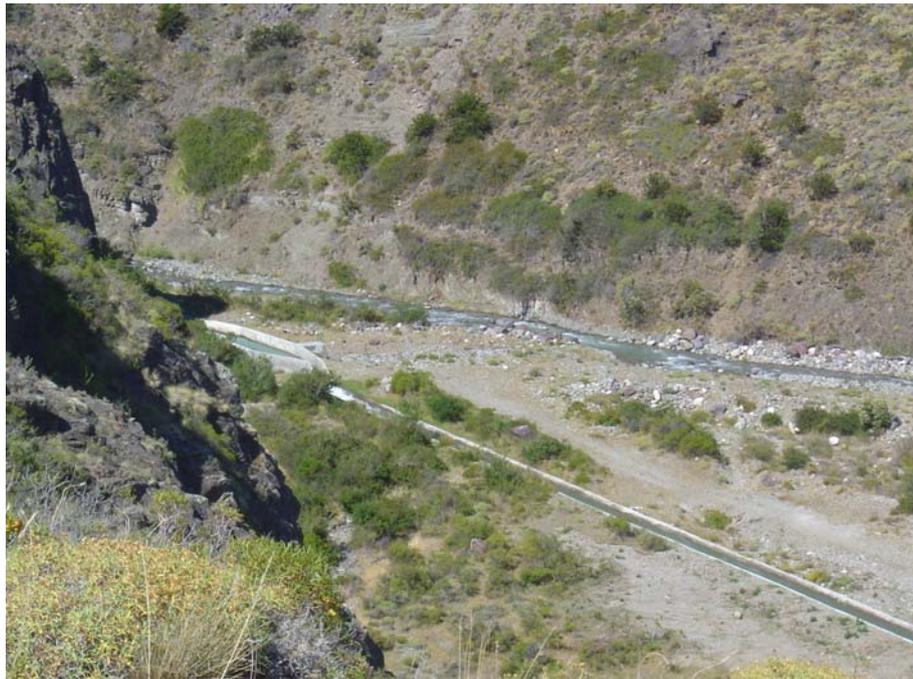
Figure 2.1 Intake from stream for flood irrigation system, Puerto Ingeniero Ibáñez, Chile

In areas with extensive systems of open channel flood irrigation systems, such as Los Antiguos and Puerto Ingeniero Ibáñez (Figures 2.1 and 2.2), irrigation ditches reportedly became blocked and had to be dug out manually. Problems persisted for a period of one to two years after the eruption owing to windblown ash recontaminating ditches. There were reportedly some problems with abrasional and corrosional damage to metal fittings in irrigation systems.

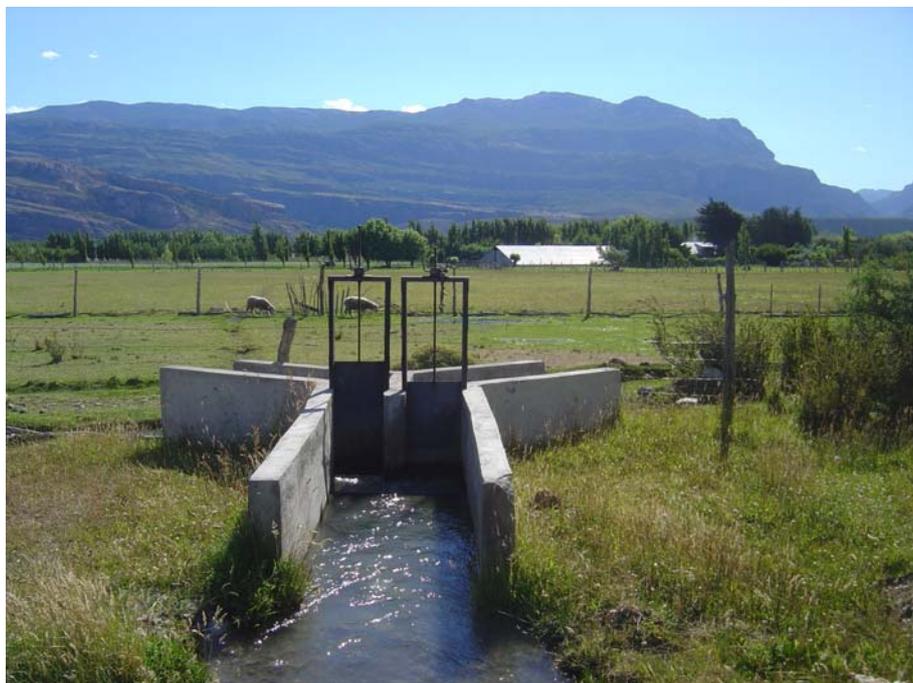
Figure 2.2 Open channel flood irrigation system, Puerto Ingeniero Ibáñez, Chile

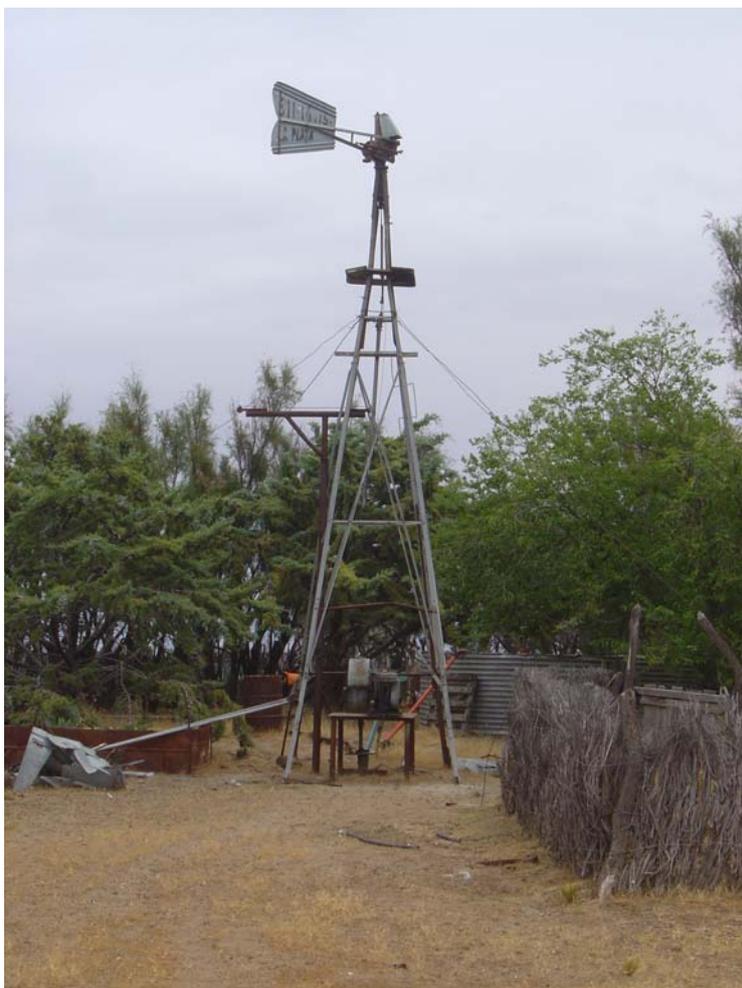
Figure 2.3 Wind-driven groundwater pump, Tres Cerros, coastal Santa Cruz

In general, municipal supplies were relatively unaffected by the ashfall as they are derived from either springs or groundwater wells. In Los Antiguos, water supply wells are dug to a depth of at least 6 metres, and the water supply was reportedly continuous (Inbar et al., 1995). However, an exception to this was in the coastal zone of Santa Cruz, where there is very little surface water and a heavy reliance on groundwater extracted using wind-driven pumps (Figure 2.3). Ash damaged the bearings of the windmills and thus disabled the water supply.

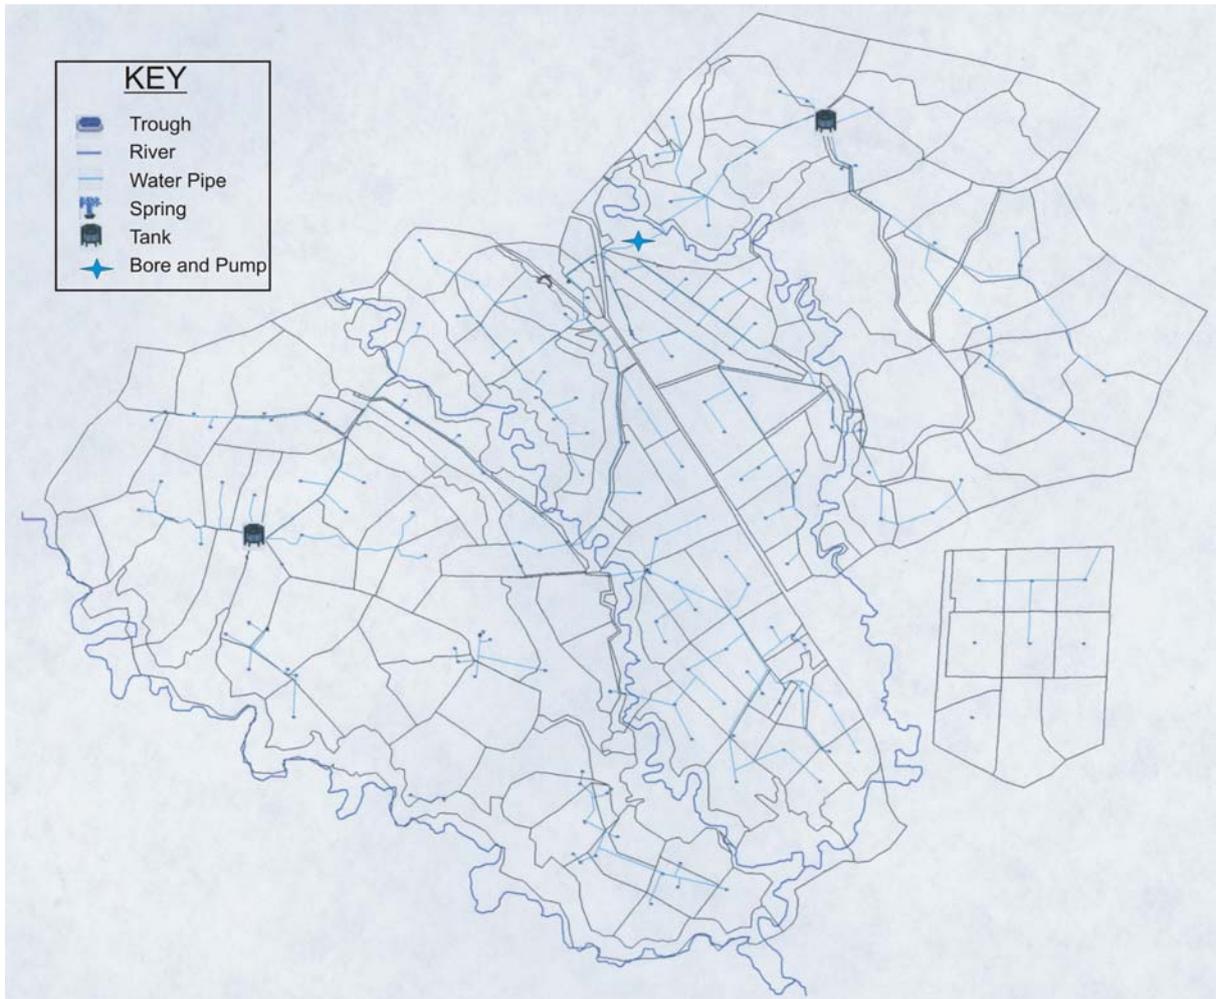
Figure 3.3 Water supply and distribution system, Study Farm 1
 There are four dams (small reservoirs) on the farm, although these are not preferred as a water source as stock (deer and cattle in particular) walk into them, eroding their banks and making the water turbid. A number of dams have been filled in as a result. The main dam is still in use and can be linked back into the farm water supply system if required.

The farm is supplied by a shallow 6 m (20 ft) deep, 2 m wide bore with a suction pipe. The water table is at approximately 3 m depth. The bore is approximately 100 m from the northern creek on the farm (Figure 3.3) and only supplies stock drinking water for the farm. Water is pumped to two 20,000 L tanks located at the northern and western ends of the farm (Figure 3.3) for water storage on topographic high points. These tanks feed the stock water troughs by gravity. The troughs are rectangular with a capacity of 200 L and are kept full by a ballcock tap (Figure 3.4). There are still some older-style 400 L troughs, but they can cause problems as deer like to wallow in the troughs; however they are easier to keep clean. The troughs are all concrete, and there are 159 altogether, placed at a frequency of one or two per paddock (blue dots in Figure 3.3).

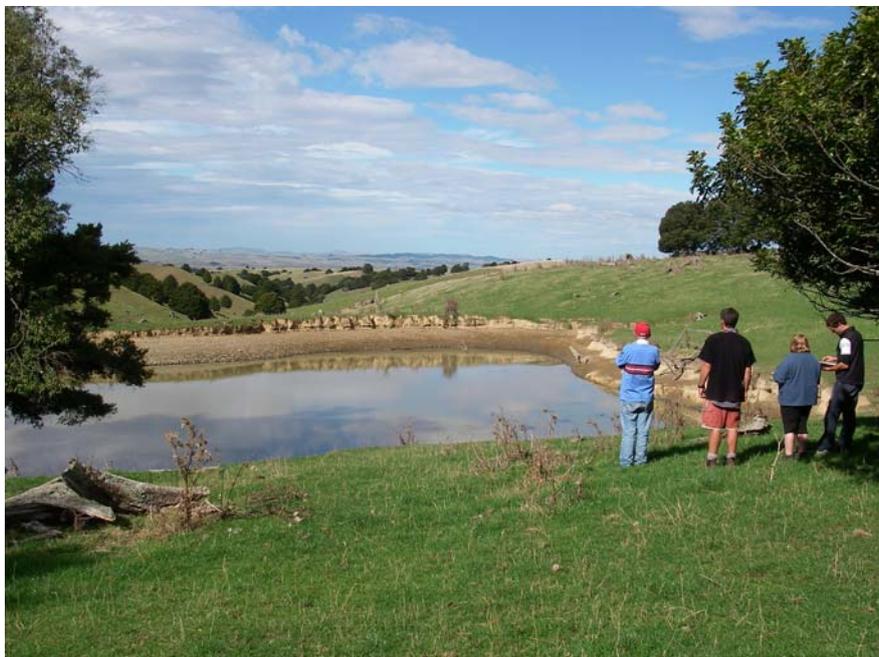
Figure 3.5 Dam, Study Farm 1

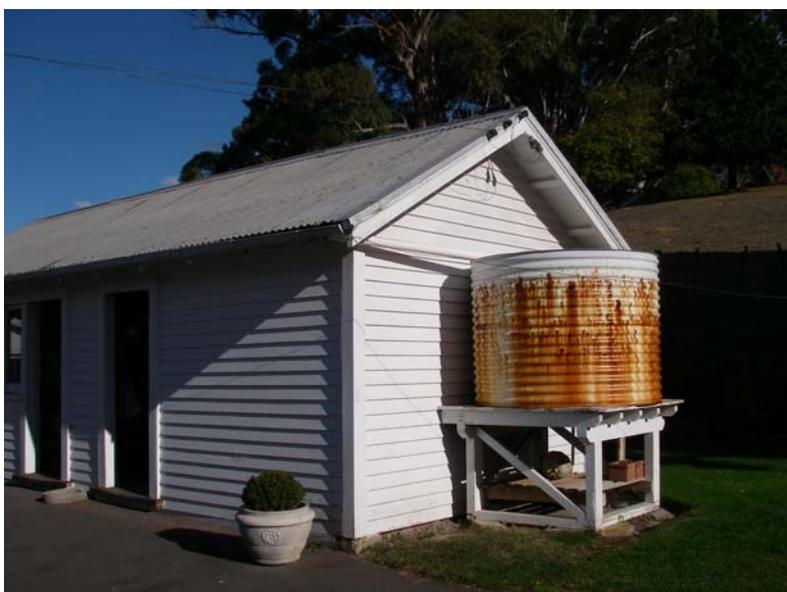
Figure 3.6 Rain water collection tank – for house supply

The water from the springs is limey, although there are no scaling problems reported with the farm water system. The house uses a roof water supply collected in a 40,000 L (10,000 gal) tank (Figure 3.6). There is the ability to switch the house onto the farm supply if required.

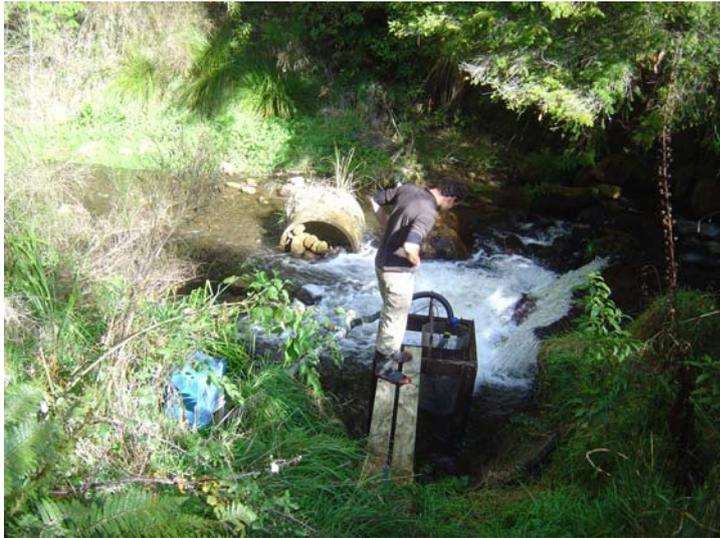
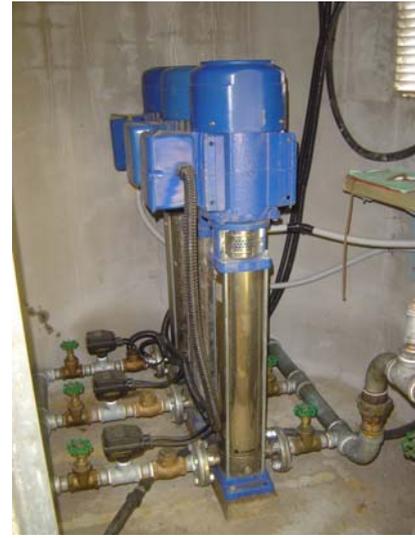
Figure 3.8 Intake area from surface water supply; multistage pumps
The farmer gave a brief account of how the farm's water supply has evolved over time:

This farm obtains its water supply from a spring several kilometres to the west. Water is pumped from a pool below a culvert (Figure 3.8). The intake is out of the main flow, making it less susceptible to flooding (it was not affected by a small flood in 2003 during which 60mm of rain fell in 40 minutes). Due to the turbulent nature of the stream, the intake is largely self-cleaning. Water is extracted by submersible pump to a settling tank, filtered and three multi-stage pumps pump water back to the farm (Figure 3.8).

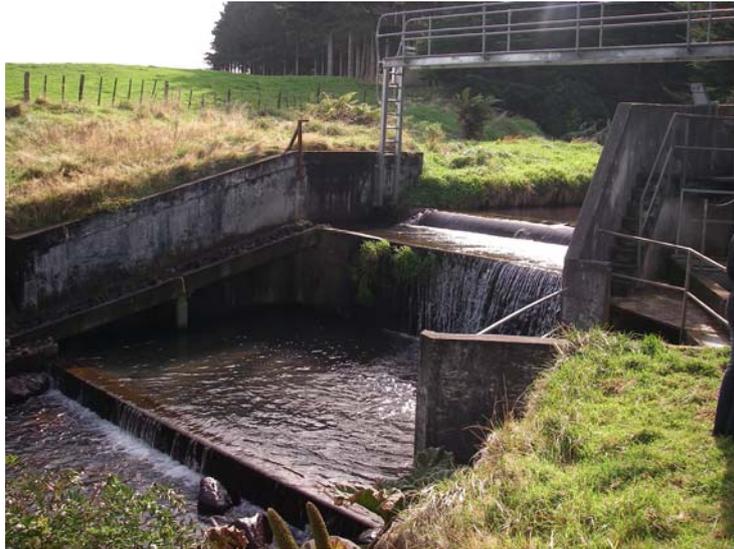
Figure 3.9 General view of intake with stream in foreground

The scheme has three intakes; the main intake is in the Mangawheroiti stream, with the other intakes in the Otakeho and Mangawhero streams, diverting flow to the Mangawheroiti. The intake structure on the Mangawheroiti stream coarsely filters water through a boom, metal screen and a bag, which removes unwanted material such as pine needles (Figure 3.9 and 3.10). The water flows under gravity (with some additional boost pumping) to the WTP.

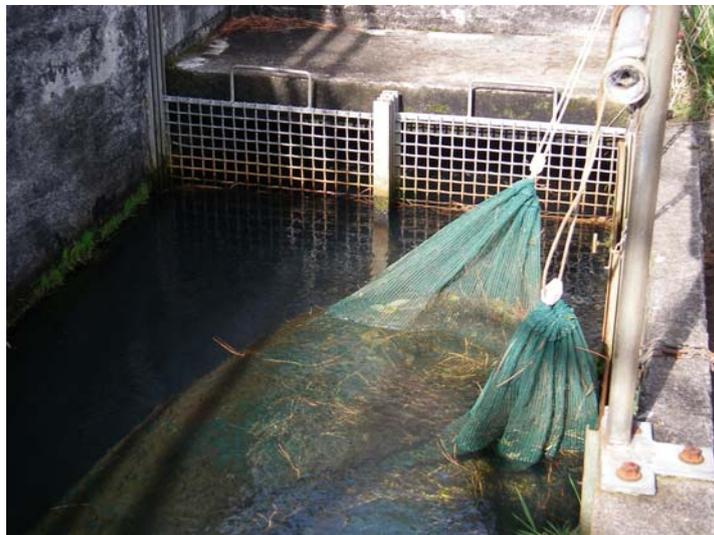
Figure 3.10 Filter bag

The water is gravity fed from the intake structure down to the water treatment plant (WTP) in Rowan Rd where it is treated (coagulation, flocculation, clarification, filtration, chlorination, and pH correction; Figure 3.11). There are two absorption clarifiers with a combined rating of $\sim 730 \text{ m}^3/\text{hr}$. There are five automatic valveless gravity sand filters also rated at $\sim 730 \text{ m}^3/\text{hr}$.

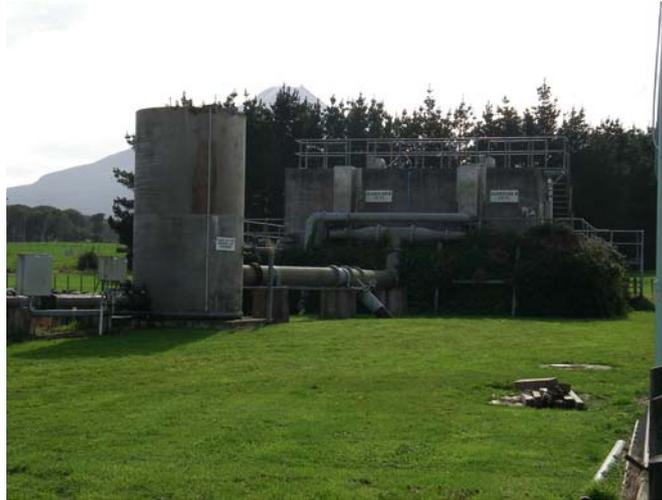
Figure 3.11 Water Treatment Plant – Waimate West Water Scheme

The site has significant electrical power demands for the treatment process. If the power stops, chemical dosing stops, clarifiers and filters cannot be backwashed and raw water booster pump stops. Production would reduce markedly during one day. The plant can be bypassed if required, but some equipment can be run with a portable generator and tractor PTO. There is also the capacity for emergency disinfection (chlorinator).

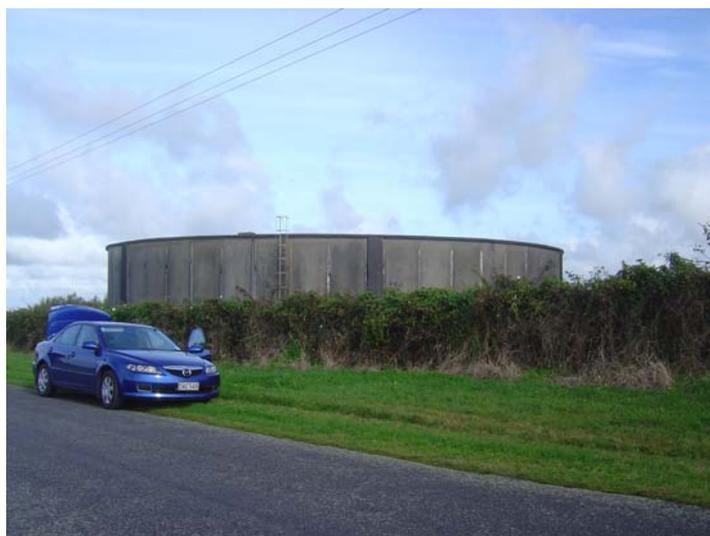
Figure 3.12 One of the two Waimate West scheme storage tanks

There is enough storage capacity for 18 hours supply (during high demand periods) or 3-4 days during winter when stock drinking water requirements are reduced. During peak demand (washing down the dairy shed) each reservoir will be drained by a third as the system cannot keep up with demand.

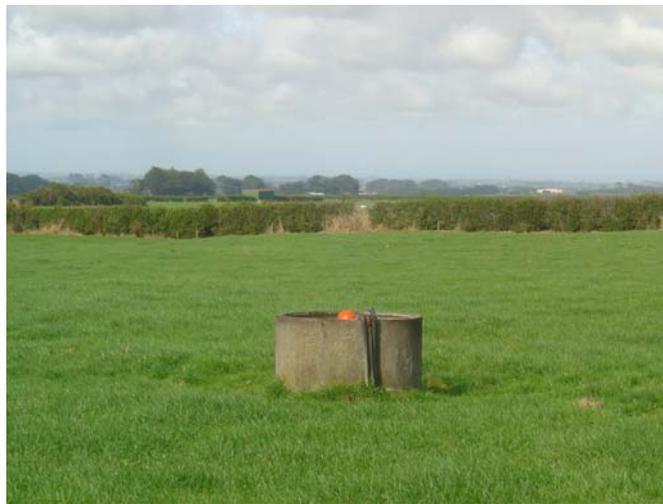
Figure 3.13 150 L round stock water trough

There are three intakes to the farm from the WWWS. The intakes feed an interconnected system which supplies all water requirements on the farm, including domestic supply, stock drinking water and dairy shed cleaning water. Water is piped directly to stock water troughs; there are 30 paddocks with four 150 L round troughs in each (120; Figure 3.13).

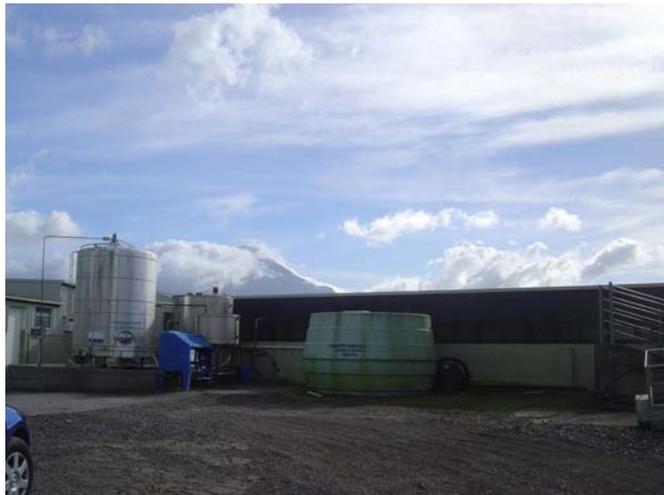
Figure 3.14 The dairy shed looking north towards Taranaki volcano – note the rain collection tank in the centre

A 4,000 gallon storage tank (~18,000 L) behind the milking shed is the only water storage on the farm, and is used to store water for washing the dairy shed (Figure 3.14). Supply to this tank is supplemented by rainwater from the roof of the dairy shed (the only catchment of rainwater for any use on the farm, including domestic supply).

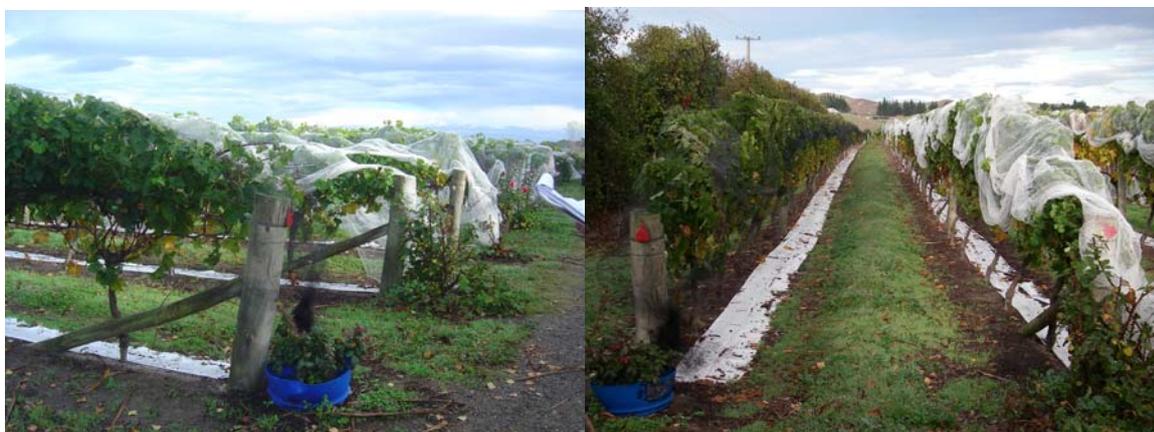
Vines are established on 500m lines each with two wires (Figure 3.16).

Figure 3.16 Vines

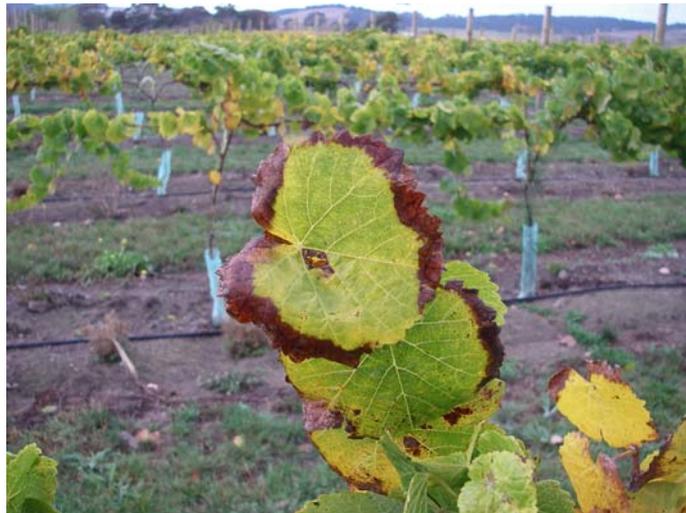
There are problems with easterly storms blowing salt spray (sea water vapour) onto the vines. This causes sensitive areas of the leaf to die (brown tipping; Figure 3.17). New leaves are reported to be most vulnerable, such as in those forming in the spring growth period. This is a coastal issue, impacting only vineyards in close proximity to the beach.

Figure 3.17 Vine leaves suffering damage from salt spray

To mitigate the effects of the salt spray, the irrigation system is turned on to try and dilute the salt spray. Trees have also been planted as windbreaks to try and block the wind/spray.

This is only really a problem for vineyards close to the sea. Some other vineyards have installed large (25mm diameter pipe) irrigators which they turn on to wash off the salt spray whenever the easterly storm is coming in. This may also be useful in event of an ashfall.

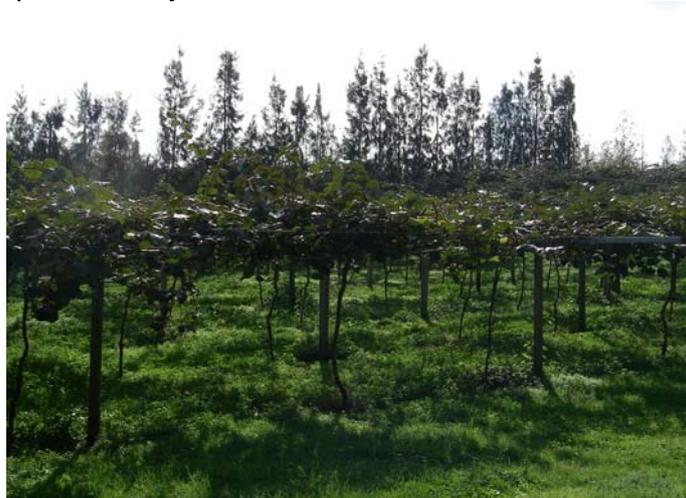
The farmers grow the 'Green' variety of kiwifruit, with approximately 1000 plants per hectare; each plant supported on a 6 ft pagoda system (Figure 3.18). Two out of three rows are

Figure 3.18 Kiwifruit plants and pagoda system.

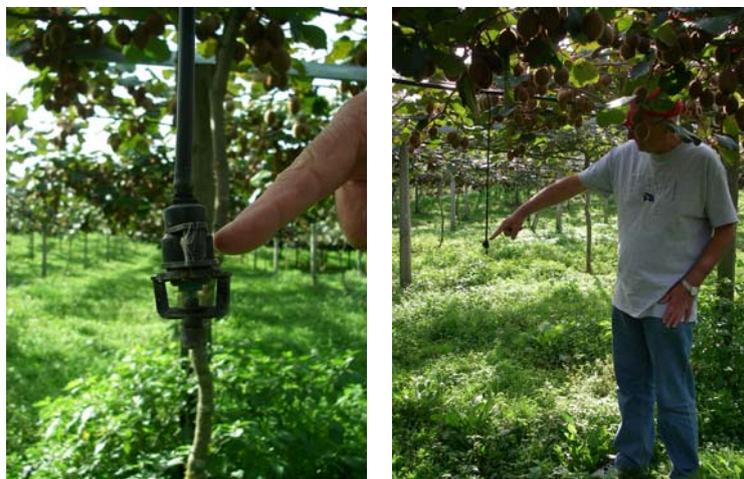
Figure 3.19 Drippers

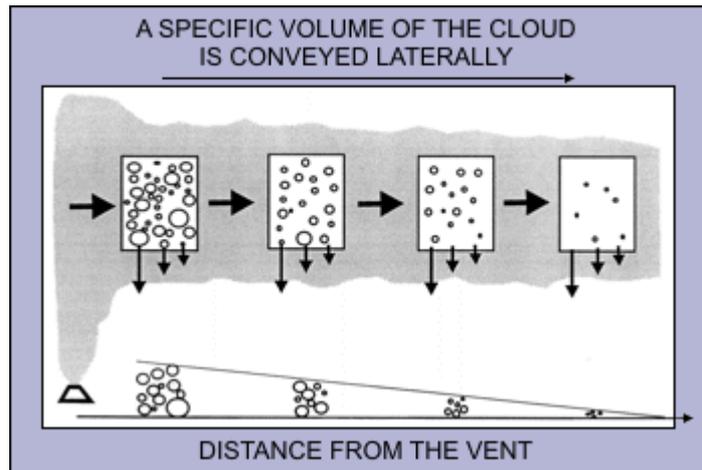
Figure 4.1 Changes in volcanic ash size distribution with distance from the vent

Volcanic risk depends on the proximity to active volcanic centres. Depth of ashfall normally declines with distance away from the vent. The size distribution of ashfall also changes as the plume travels away from the vent, with coarser particles falling closer to the vent and finer particles transported furthest (Figure 4.1). However, at any particular location the characteristics of the ashfall deposited can vary widely.

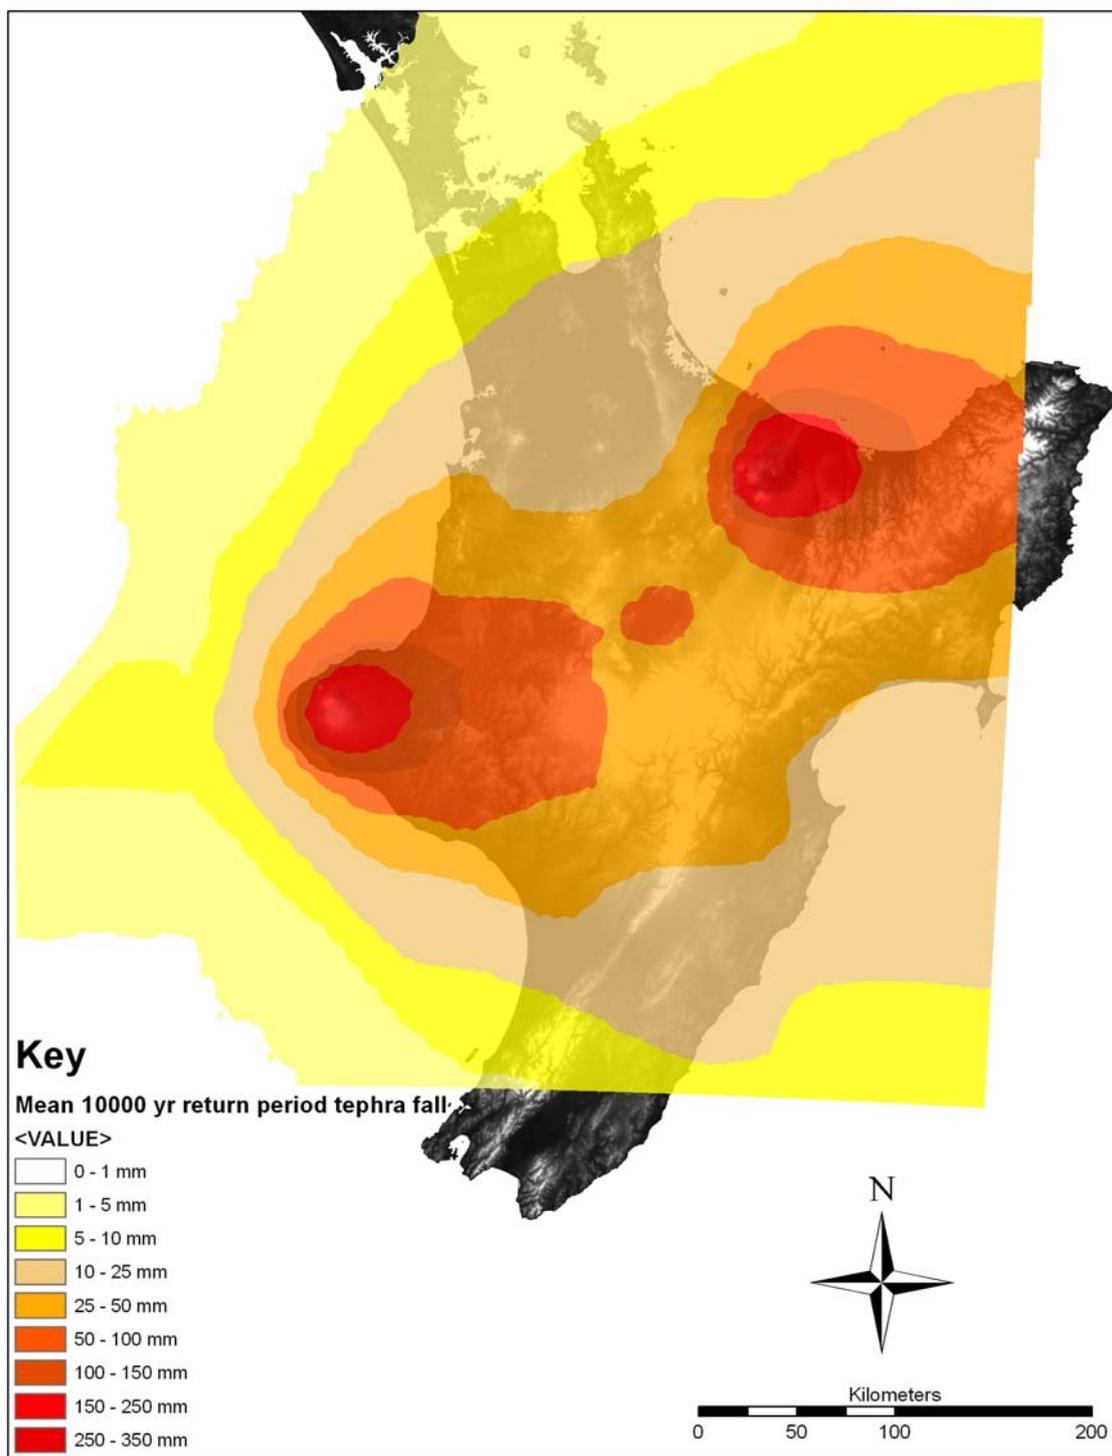
Figure 4.2 Mean 10,000 year return period ashfall thicknesses (Hurst and Smith, 2004)

A probabilistic ashfall map (Hurst and Smith, 2004) has been used here to define volcanic risk for each study farm (Figure 4.2). This model is derived from a method for quantifying the probability of a particular thickness of volcanic ash at any particular site using Monte Carlo methods and an ash dispersal model (“ASHFALL”). Hurst and Smith’s model uses a large number of eruption iterations and considers the mean accumulated ash thicknesses from multiple volcanic centres (including the Tongariro, Taupo and Okataina volcanic centres, White Island and Taranaki volcano; see Figure 1.1). Predicted accumulations of ashfall over a 10,000 year period are shown in Figure 4.2. Data for each study farm are shown in Table 4.4.

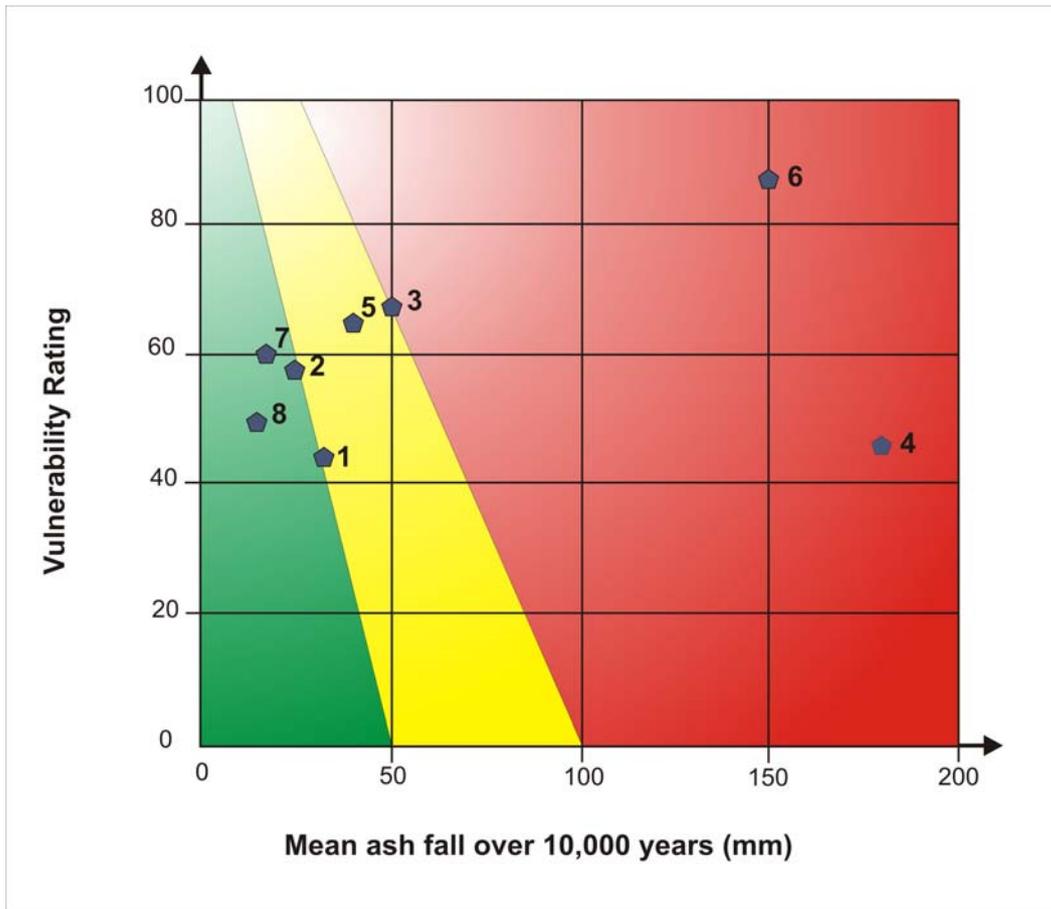
KEY	
■	High Risk
■	Medium Risk
■	Low Risk
1	Study Farm 1 - Sheep and Beef (Hawkes Bay)
2	Study Farm 2 - Sheep and Beef (Hawkes Bay)
3	Study Farm 3 - Sheep and Beef (Taupo)
4	Study Farm 4 - Dairy (Rerewhakaaitu)
5	Study Farm 5 - Dairy (Reporoa)
6	Study Farm 6 - Dairy (Taranaki)
7	Study Farm 7 - Vineyard (Hastings)
8	Study Farm 8 - Kiwifruit Orchard (Cambridge)

Figure 4.3 Overall risk of study farms of volcanic ashfall impacts on their water supplies

The other study farms plot more closely together, with Study Farm 8 probably the least at risk overall due to a lower risk from volcanic hazards, and only moderate vulnerability in its water supply.

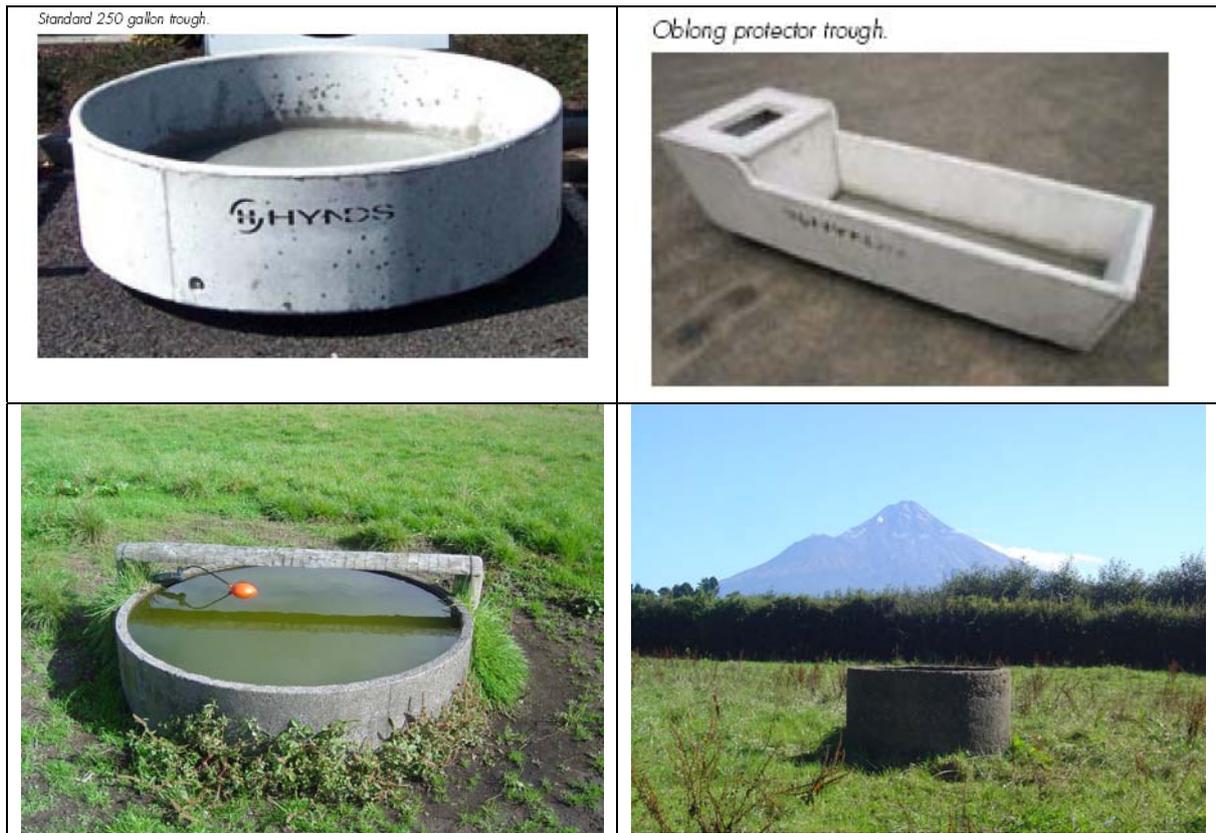
Figure 6.1 Stock watering troughs used in New Zealand

In general, livestock on New Zealand farms drink from concrete watering troughs. A range of troughs commonly used in New Zealand are shown in Figure 6.1. The water level is maintained with a float and cutoff valve several centimetres below the top to avoid overflow which can lead to boggy conditions around the trough.

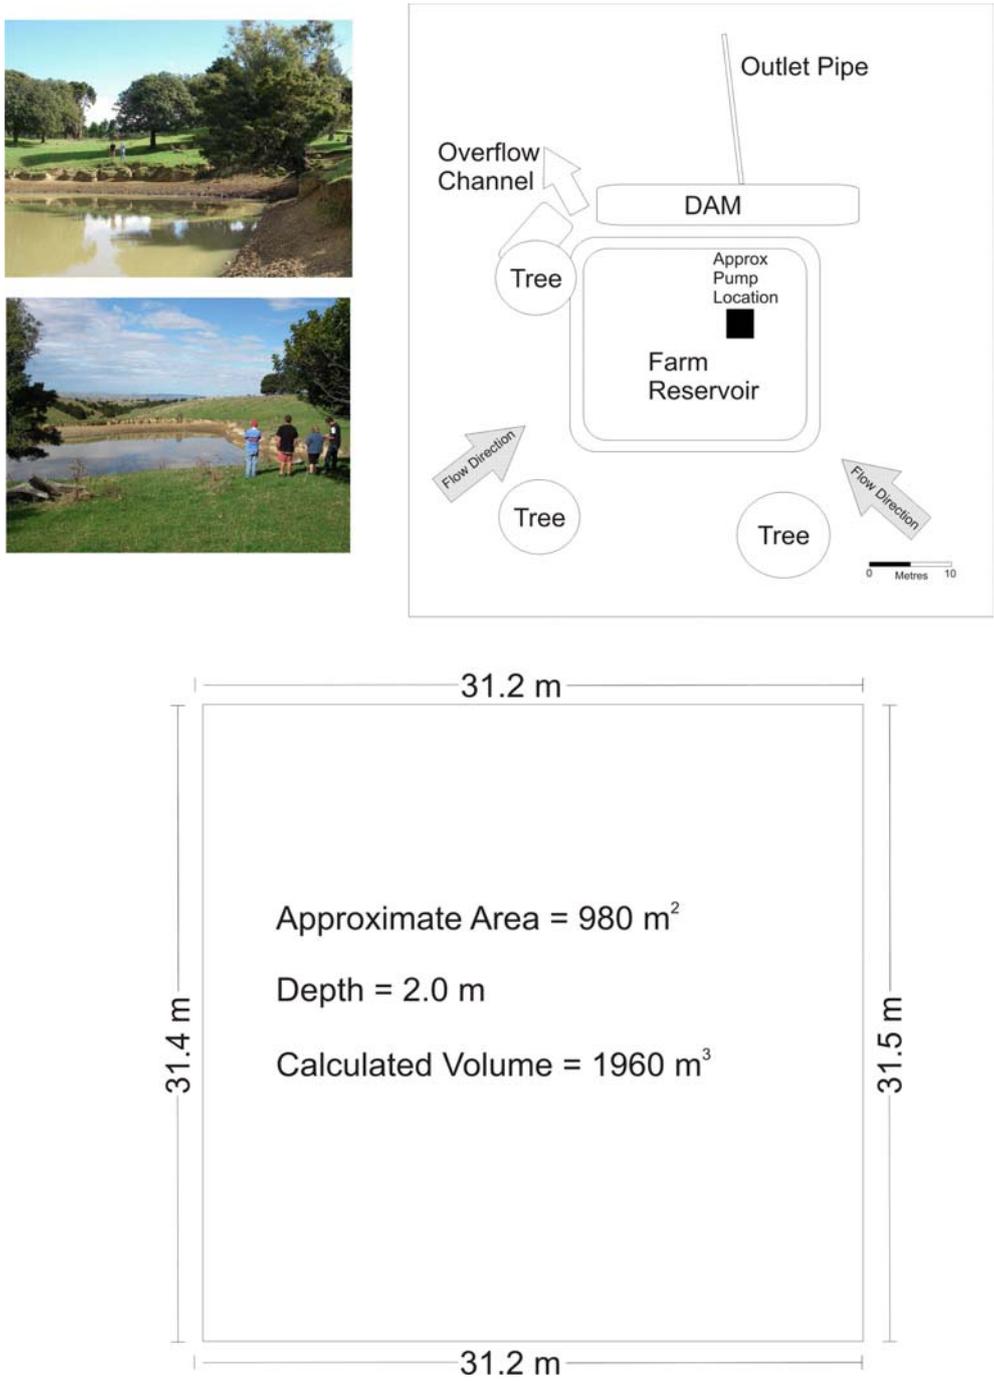
Figure 6.2 Study Farm 1 reservoir, Hawke's Bay

Ponds formed by damming streams are used as reservoirs for livestock watering and irrigation. We have applied the model to the reservoir illustrated in Figure 6.2; results are shown in Table 6.3.

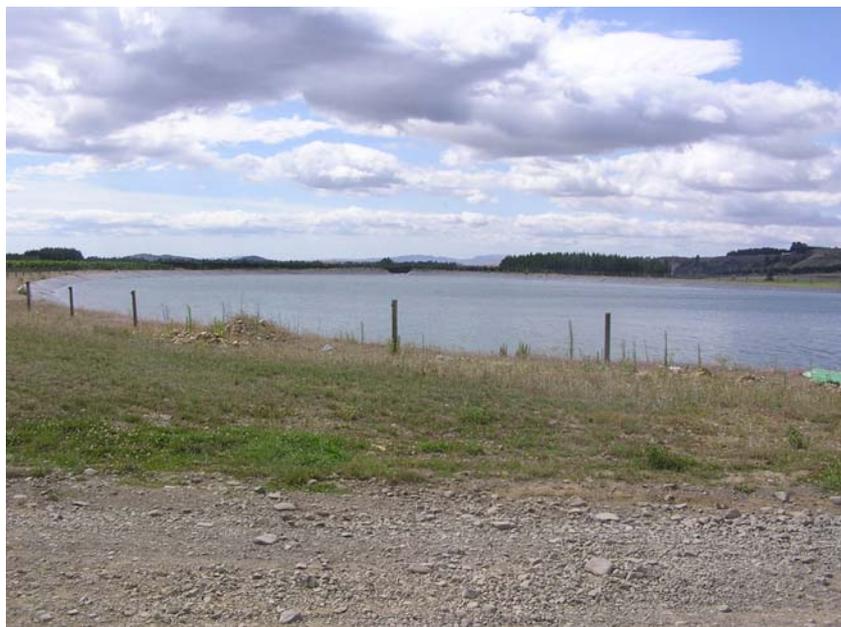
Irrigation systems vary in their vulnerability to volcanic ashfall. Systems that rely on groundwater abstraction and that do not have above-ground storage are relatively invulnerable. However, storage reservoirs are vulnerable to ashfall. An example of a storage reservoir on a Hawke's Bay vineyard is shown in Figure 6.3. The dimensions of this reservoir are 30 m x 20 m x 5 m deep, giving a contamination potential A/V of 0.2.

Figure 6.3 Irrigation reservoir, Hawke's Bay

For 1 mm ashfall, the total volume of ashfall on the surface of this reservoir will be 0.6 m³. This is equal to 600 kg ash, using a density of 1 kg/L for freshly fallen ash (Stewart et al., 2006). When divided by the volume of the reservoir, this gives a suspended solid concentration of 600/3000 kg/m³, or 200 mg/L. Comparing this to the guideline values described above, this level of suspended solids is expected to cause problems, assuming the deposited ashfall remains in suspension.

Thus, just 1 mm ashfall on a five-metre deep irrigation reservoir can be expected to cause problems owing to the presence of suspended particles. Problems will intensify with greater thicknesses of ashfall and for shallower reservoirs.

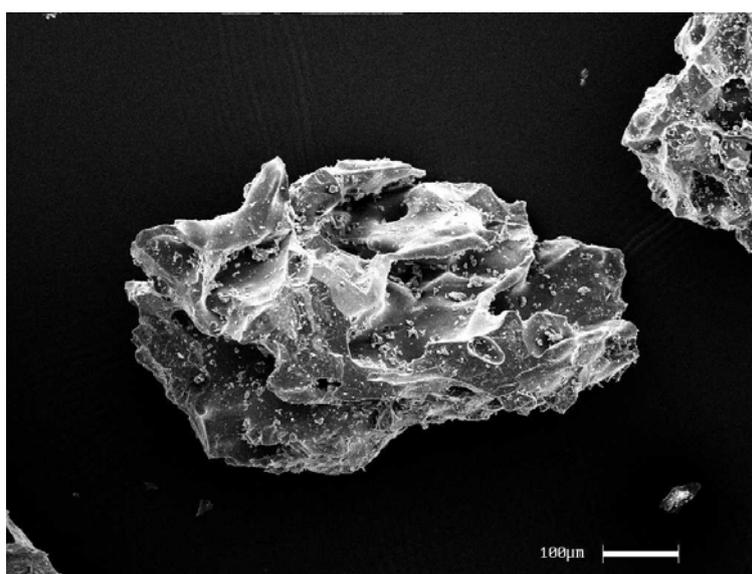
Figure A1 Scanning Electron Microscope image of a basaltic ash particle from the 1886 Tarawera eruption from Tarawera Volcano, New Zealand (Scott Barnard, pers comm., 2007)

Volcanic ash is readily remobilised when dry, very electrically conductive when wet, and highly abrasive, particularly as most ash is made up primarily of glass shards (Figure 2.1; Heiken and Wohletz, 1985).

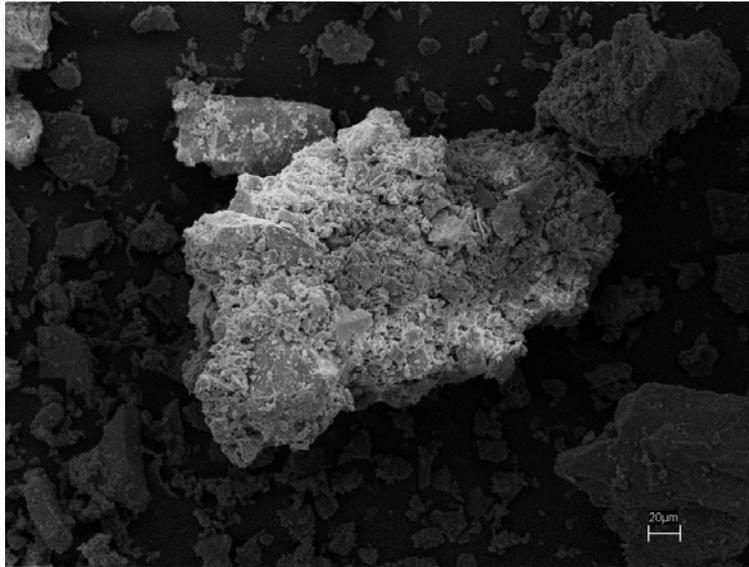
Figure A2 Scanning Electron Microscope image of a basaltic-andesite ash particle sampled from a block-and-ash flow of the 2006 eruption from Merapi Volcano, Indonesia (Wilson and Kaye, unpublished data)
