Wardman, J.; Sword-Daniels, V.; Stewart, C. and Wilson, T. 2012. Impact assessment of the May 2010 eruption of Pacaya volcano, Guatemala, GNS Science Report 2012/09. 90 p.

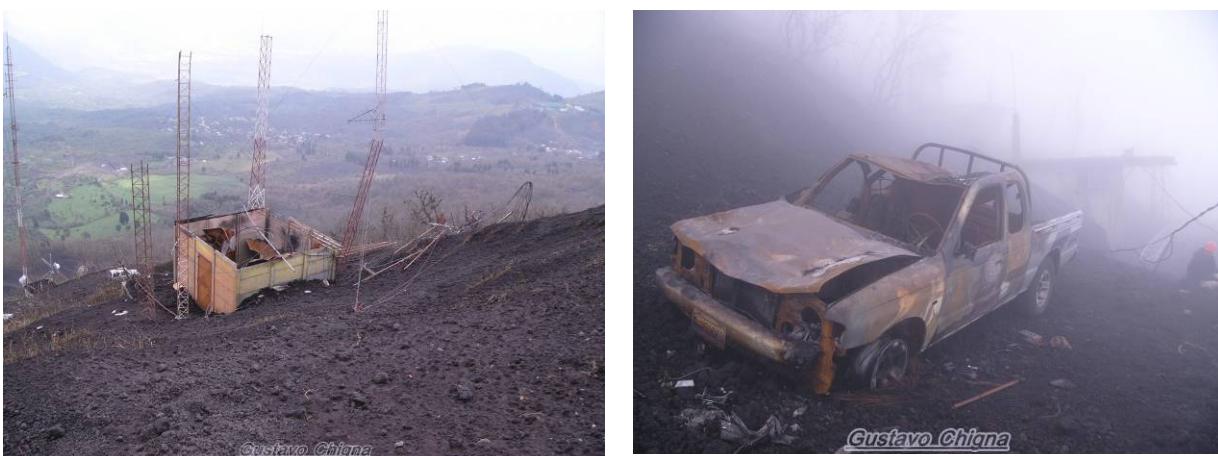
The report by Escobar Wolf (2011) includes a thorough assessment of the impacts of ballistic clasts ejected during the paroxysmal phase of the eruption. At Cerro Chino crater, approximately 1 km from the vent, clasts exceeding 0.5 m in size (long axis) fell, smashing concrete roofs, destroying vehicles both by impact and by starting fires, and knocking down radio towers (Figure 2.10). A news reporter in the vicinity at the time was killed, and others injured.

Figure 2.10 Ballistic clast damage to radio masts, building and vehicle in vicinity of Cerro Chino (photos: Gustavo Chigna, INSIVUMEH).

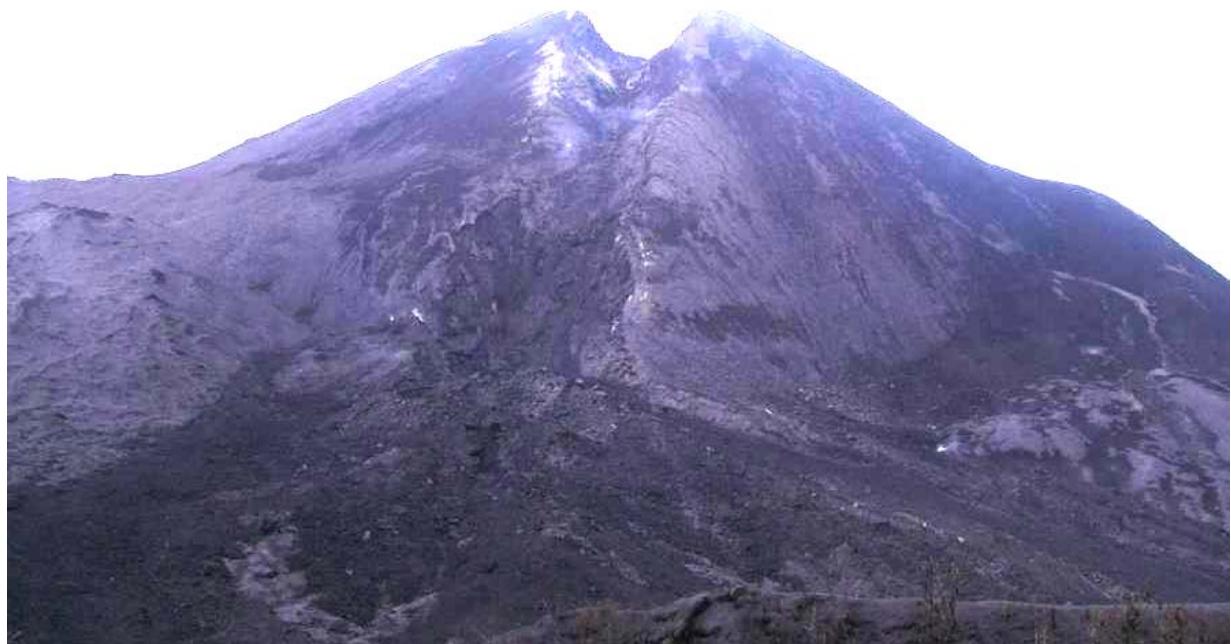
The May 2010 eruptions created a new NNW-trending trough on the flank of MacKenney Cone (Figure 2.14). Considering both the maximum height of the plume of 3 km above the vent and a minimum estimated tephra volume of $1.3 \times 10^7 \text{ m}^3$ (Escobar Wolf, 2011), the 27 May 2010 eruption of Pacaya can be classed as VEI 2-3.

Figure 2.14 Post-May 2010 NNW trending trough on MacKenney Cone (compare to Figure 2.4)(photo: INSIVUMEH).

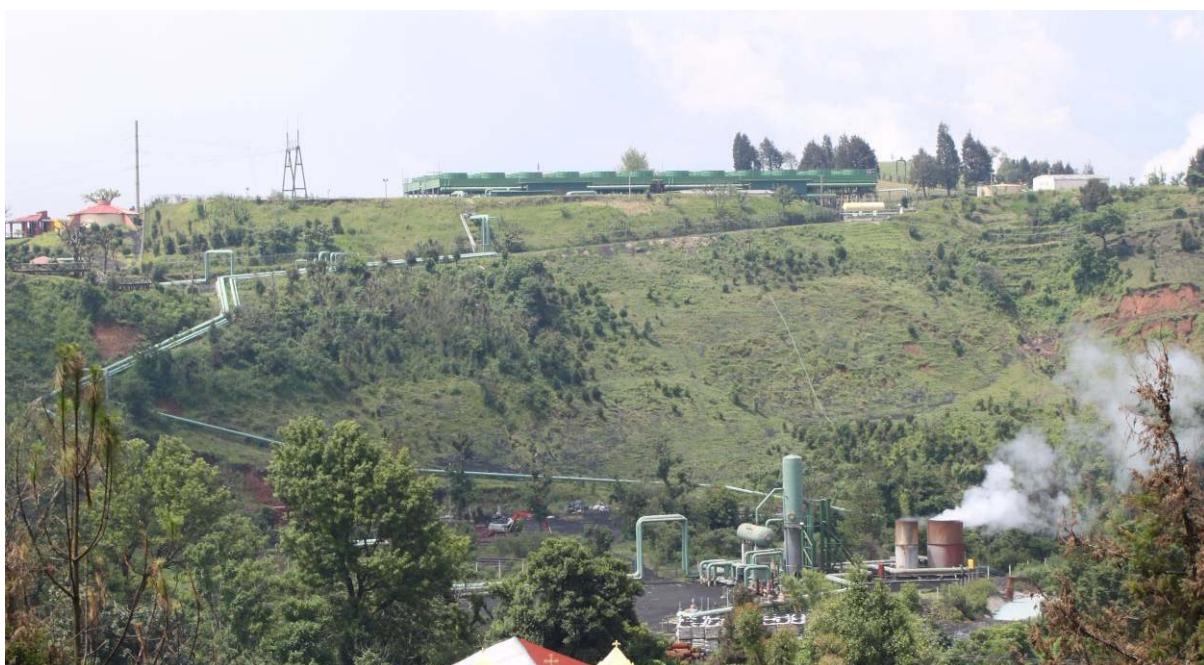
During the 27 May 2010 eruption, the San Francisco de Sales area received an estimated 20 cm of tephra, ranging from coarse (e.g. >1.5 mm) to lapilli-sized. Ballistic bombs and blocks (up to 25 cm diameter long axis) also fell in this area, and extensive damage was caused locally. At the Amatitlán plant, the worst damage was to steam condenser fans and roofs. As the fans were uncovered, fan blades suffered abrasion damage from tephra fall as well as denting and bending from falling blocks which rendered the damaged units nonoperational (Amatitlán plant operator). Three fan blades needed to be replaced. Cleaning of fans was slow (days to weeks), as it required the use of vacuum cleaners to remove particles from the intricate arrangement of fan blades, cooling fins and condenser coils. Operations were discontinued immediately after the eruption and the plant remained offline for three weeks while cleaning and repairs were carried out.

Figure 3.1 Amatitlán geothermal plant.

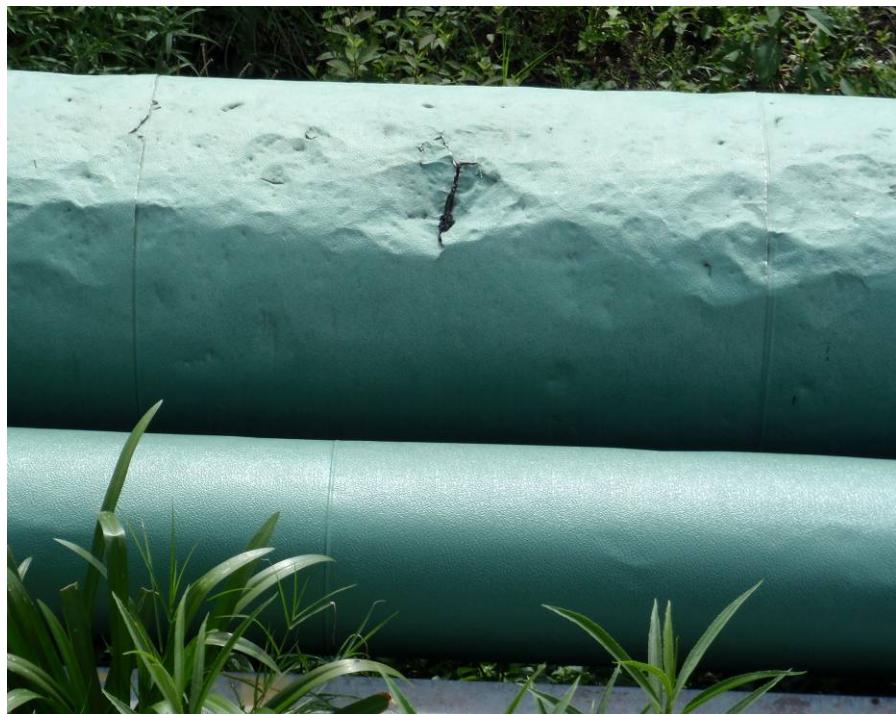
Other issues encountered by plant personnel were minor denting of the intake and outlet pipe cladding (Figure 3.2) and the removal of tephra from the switchyard gravel. No pipes required replacement or repair and no reduction in thermal efficiency was observed. Removal of tephra from switchyard gravel required complete sieving over a several day period to separate it from the volcanic material. Tephra was removed from the switchyard gravel due to health concerns over the material being broken up further and creating a fine dust that could have caused respiratory problems. No issues of corrosion were reported. Also, no ceramic insulation (insulators and bushings) was damaged by the ballistics.

Figure 3.2 Superficially damaged pipe cladding at the Amatitlán geothermal power plant (dent is approximately 20 cm wide).

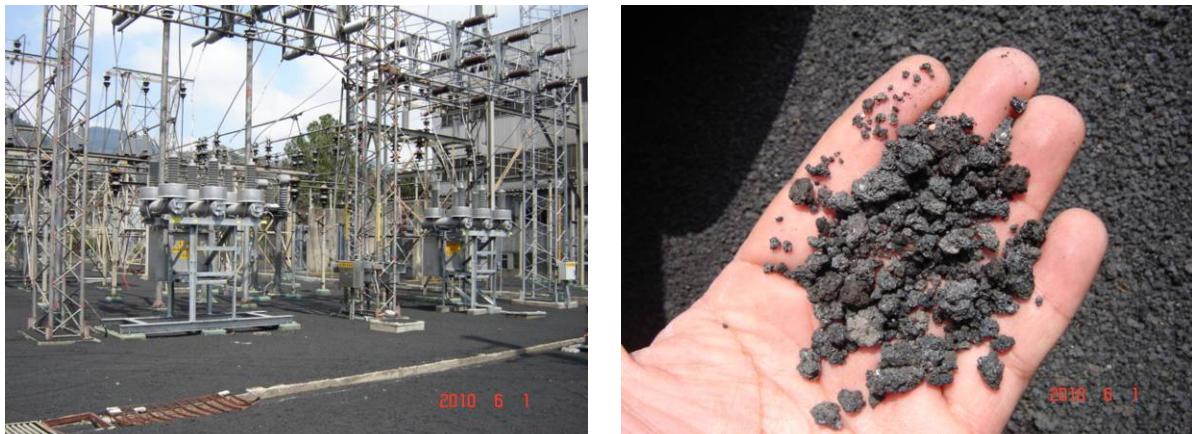
Figure 3.4 Coarse tephra deposited at Laguna substation (see Figure 3.5 for location)(photos: EEGSA)

The EEGSA substations that received the most tephra fall were scheduled for extensive offline cleaning on May 29 and 30. However, the onset of tropical storm Agatha hindered the cleaning procedure and large amounts of tephra remained on substation equipment during the early hours of the storm. The combination of tephra contamination, together with heavy rain from the storm, caused further faulting (flashovers) on the system, with several interruptions occurring throughout the event (29-30 May)(EEGSA network operator). With the passing of Agatha it was found that the rains had sufficiently cleaned all substation equipment and none but the Laguna substation (located ~5 km from the vent) required further cleaning (Figure 3.4). Power transformer bushings were said to be the most important components to clean, as flashover across the bushing would likely cause irreparable damage to the transformer. The transformers themselves were described as being the most problematic and difficult apparatus to wash free of tephra because of the intricate array of cooling fins and sensitive components vulnerable to further damage from abrasion or water/tephra ingress. As a preventive measure, tephra was cleaned from transformer radiator fins to allow sufficient heat transfer and cooling of the apparatus.

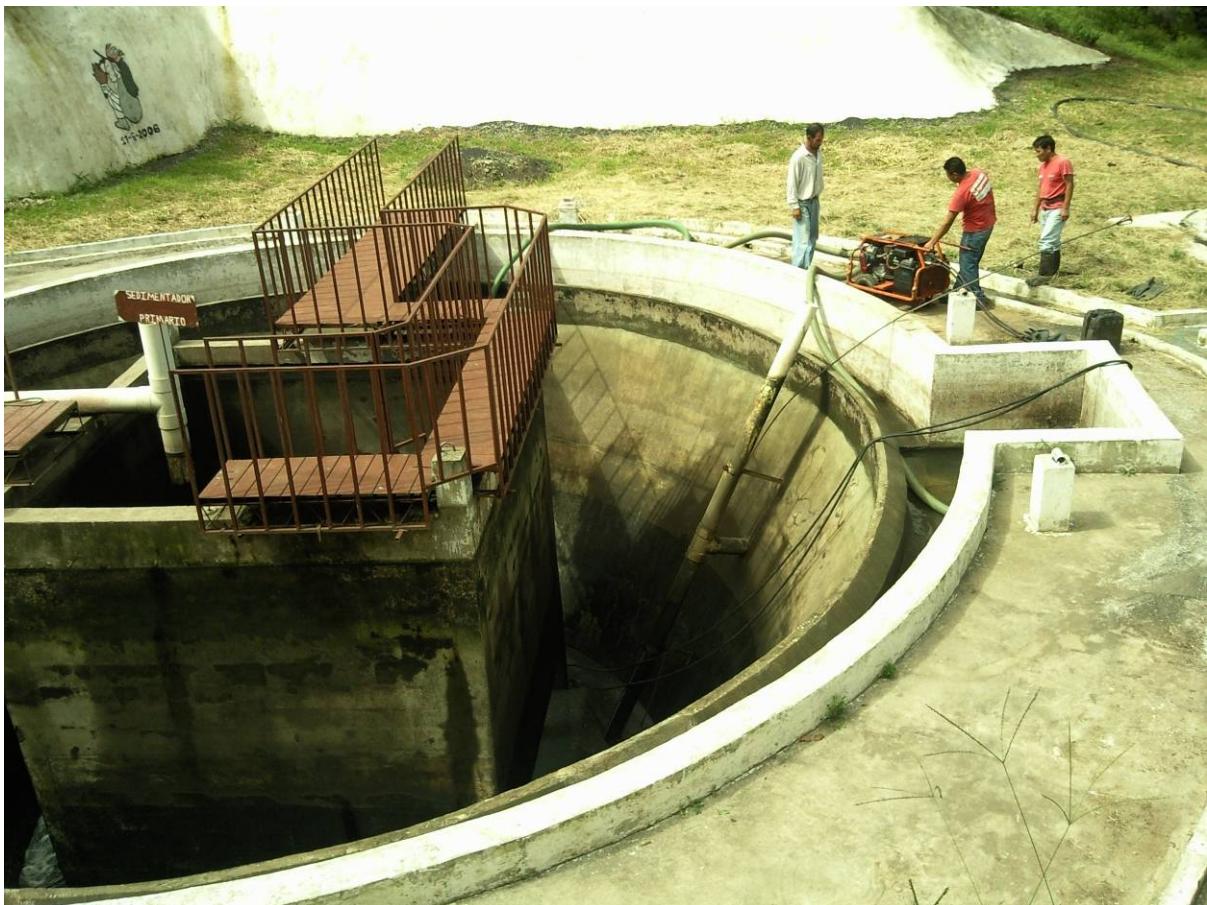
Figure 3.6 Cleaning out Imhoff tank at University of San Carlos, Guatemala City (photo: Mapreco).

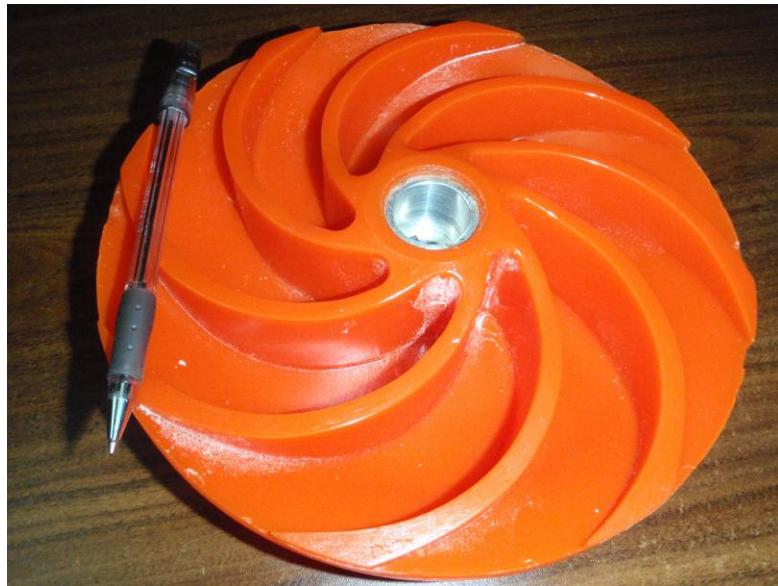
In general, the tephra was difficult to handle. It was heavy and abrasive and could not be moved with a hose very easily. It was also heterogeneous in grain size (Appendix 3).

Figure 3.7 Sludge pump propeller of the same type that suffered severe abrasional damage from volcanic tephra.

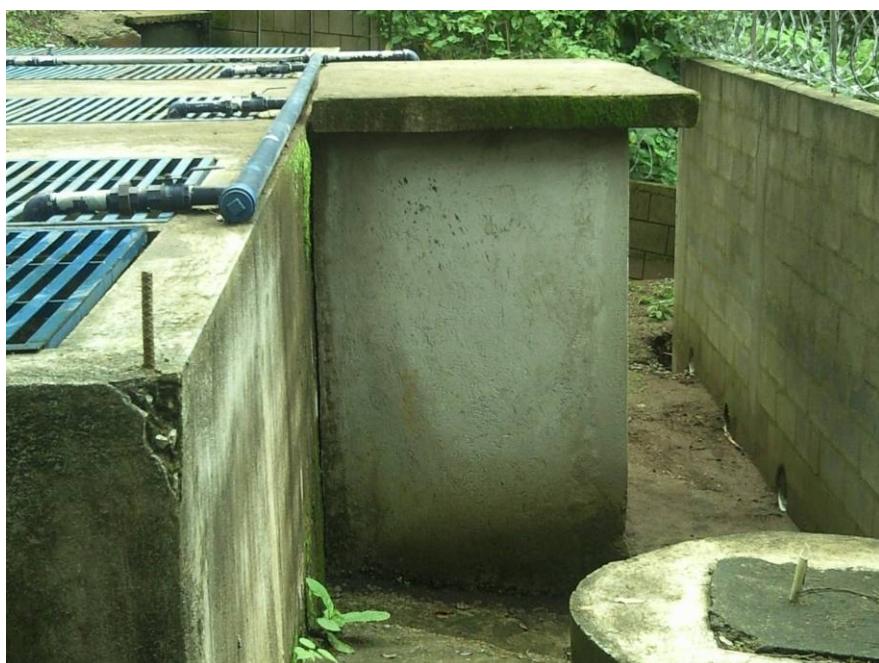
Figure 3.8 Aerobic digestion tank, small-scale wastewater treatment plant serving condominium development (photo: Mapreco).

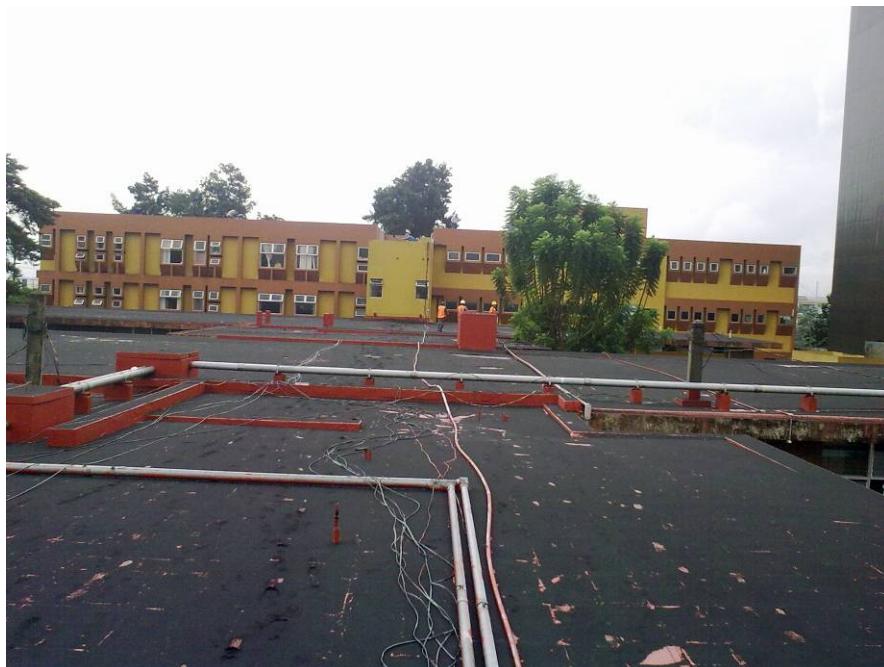
Cleanup efforts were directed towards the roofs, to prevent further rains from washing it into drainpipes and blocking them. It took three to four days to clear tephra from the roof. Maintenance staff kindly provided us with photos of the cleanup (Figures 3.10 and 3.11).

Figure 3.10 Roof of hospital B covered in tephra.

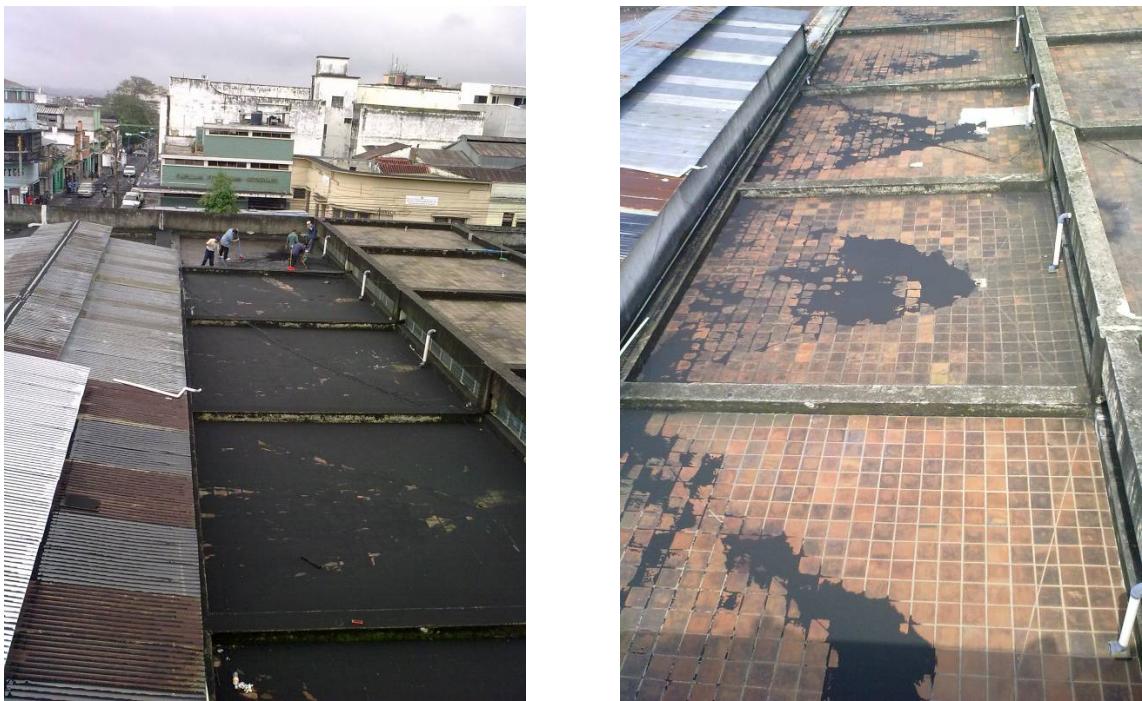
Figure 3.11 Cleanup of tephra from roof in progress (left), and abrasion damage to surface coating on roof (right).

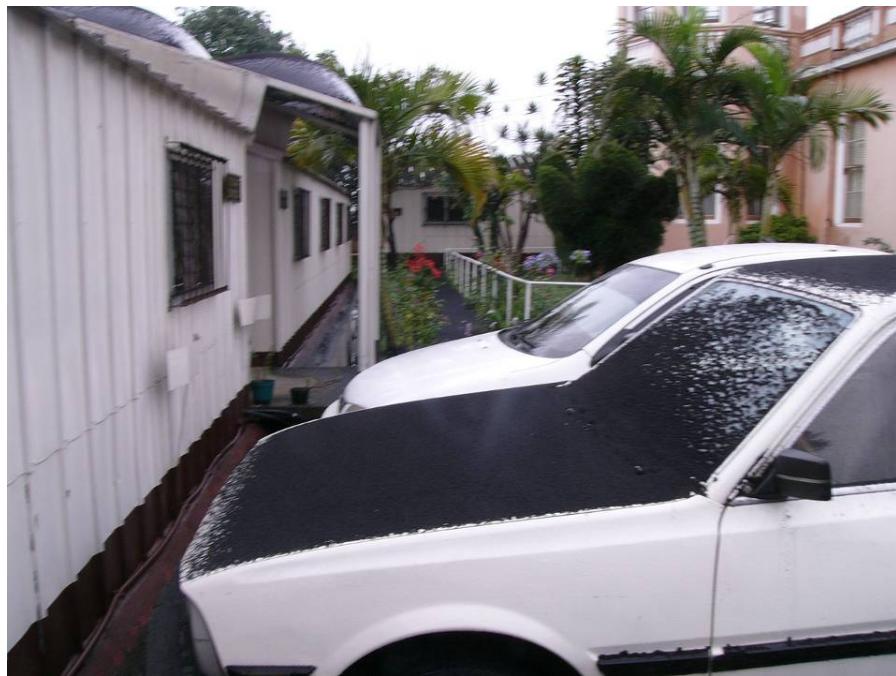
Figure 3.13 Coarse, sand-sized basaltic tephra covering vehicle (photo: Gustavo Chigna, INSIVUMEH).

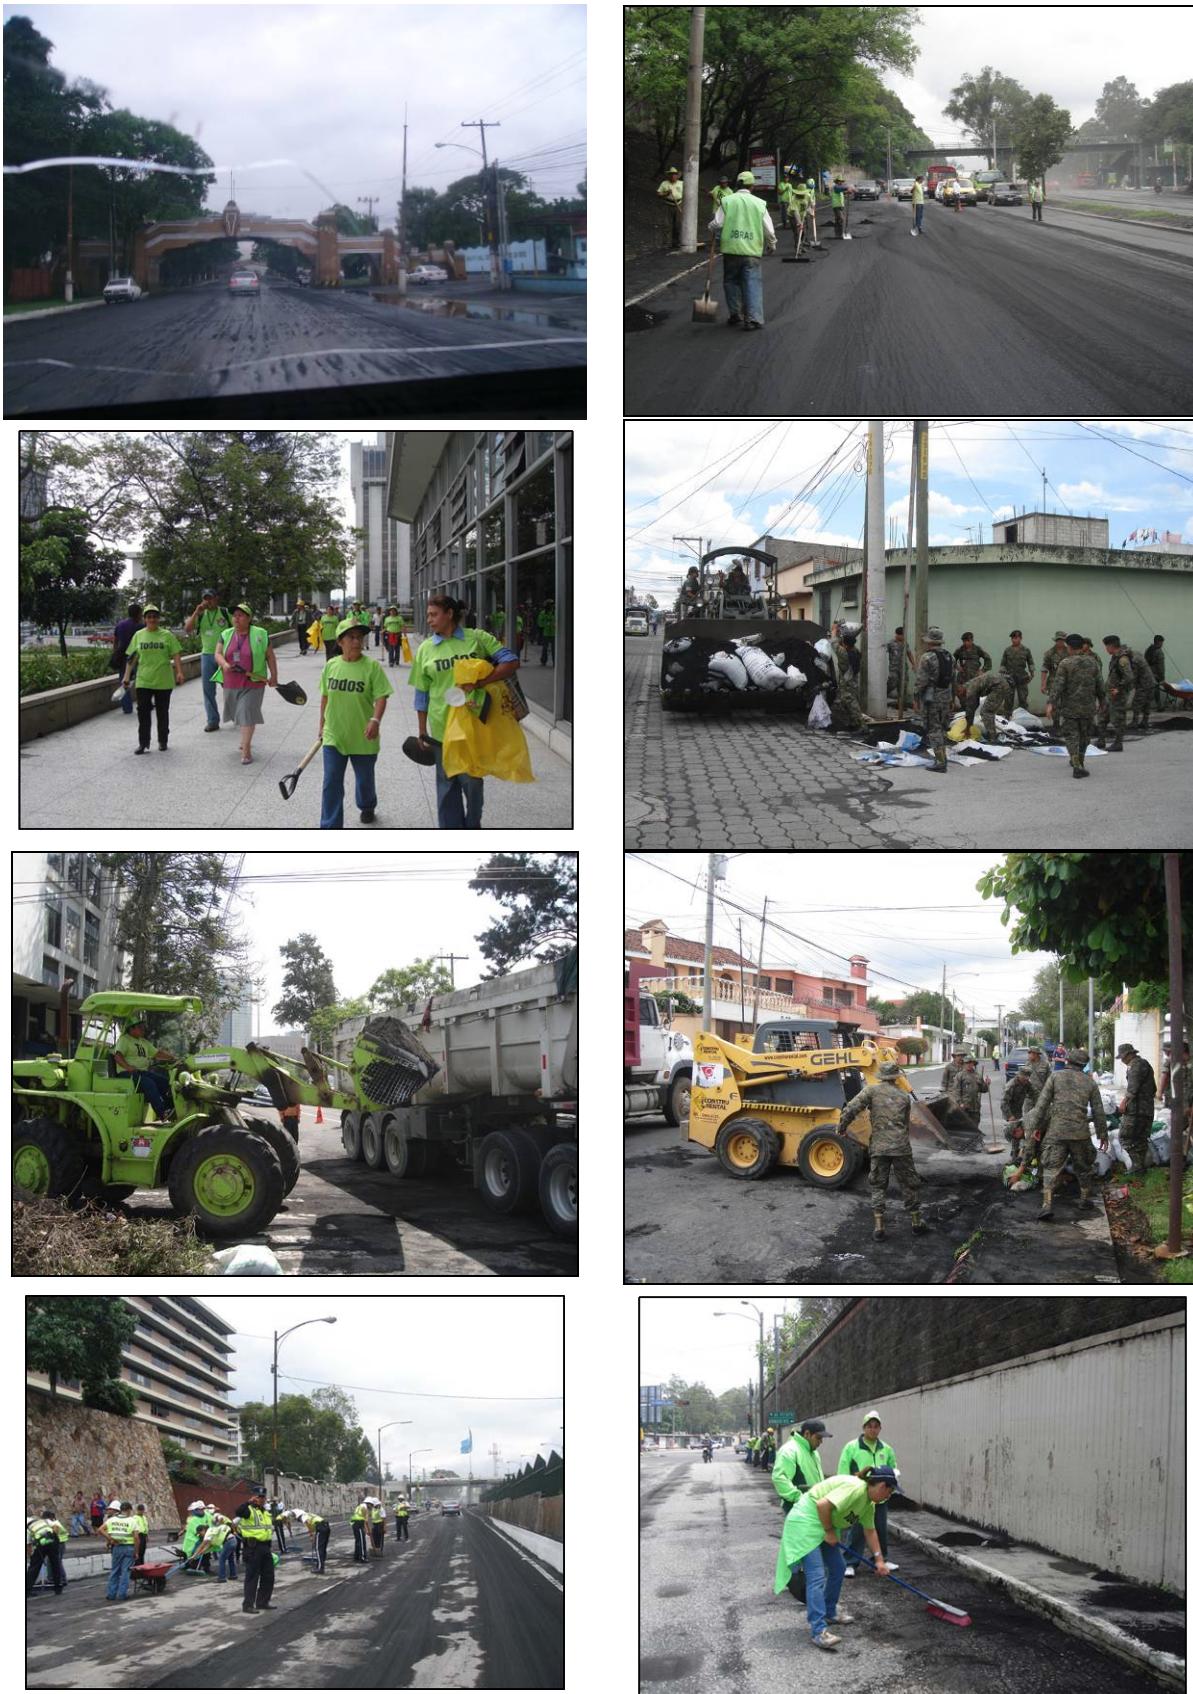
Figure 3.14 Cleanup of Guatemala City (photos: Director of Works, Municipality of Guatemala City and Gustavo Chigna, INSIVUMEH).

As well as the ready access to heavy machinery, another factor in the success of the cleanup was the clear communication with the public. The public were instructed to clear tephra from their own properties (roofs and yards), and to pile the bags up on the street frontage or to take them to designated collection points. Collection bags were donated by sugar and cement companies. Streets were cleaned with street sweepers or by people using brooms and shovels. The tephra was loaded onto lorries either by hand or using small excavators. The cost of heavy machinery hire is shown in Table 3.1, and photos illustrating the cleanup operations are shown in Figure 3.14. The cleanup lasted three weeks.

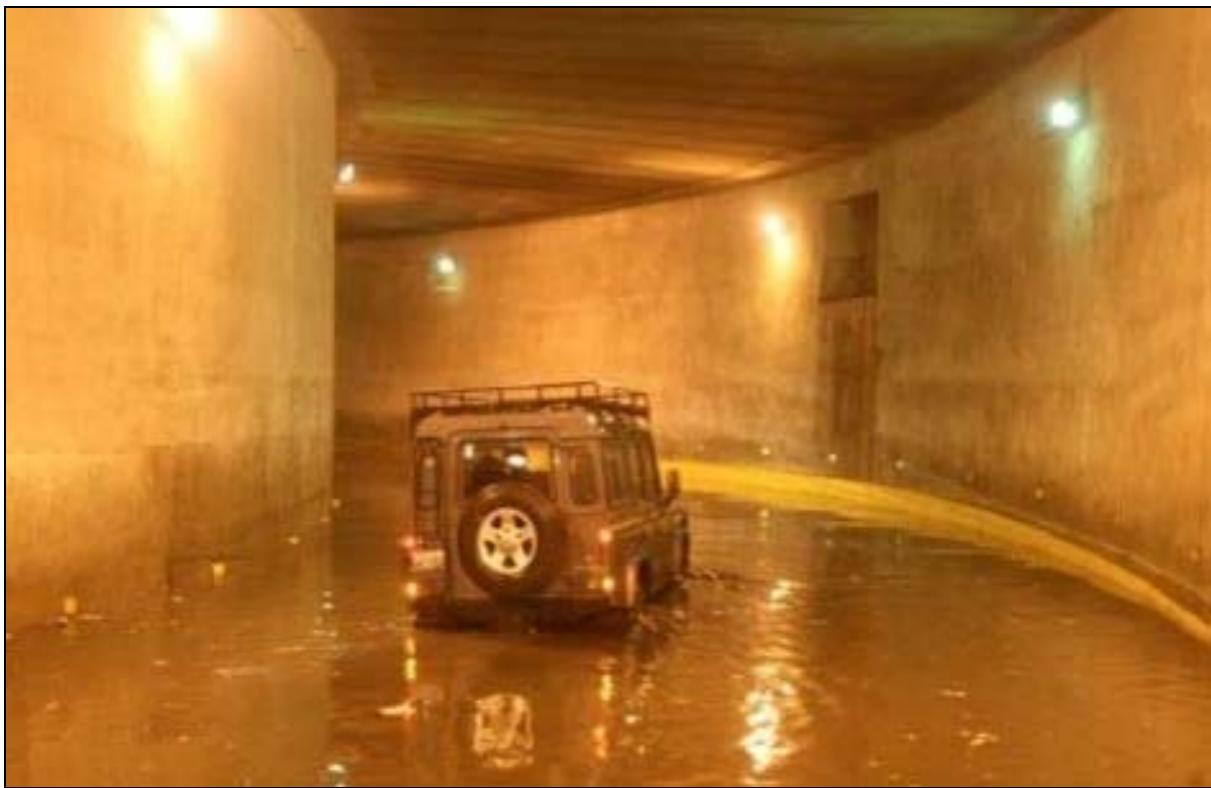
Figure 3.16 Flooded underpass, Guatemala City, early June 2010 (photo: Director of Works, Guatemala City municipality).

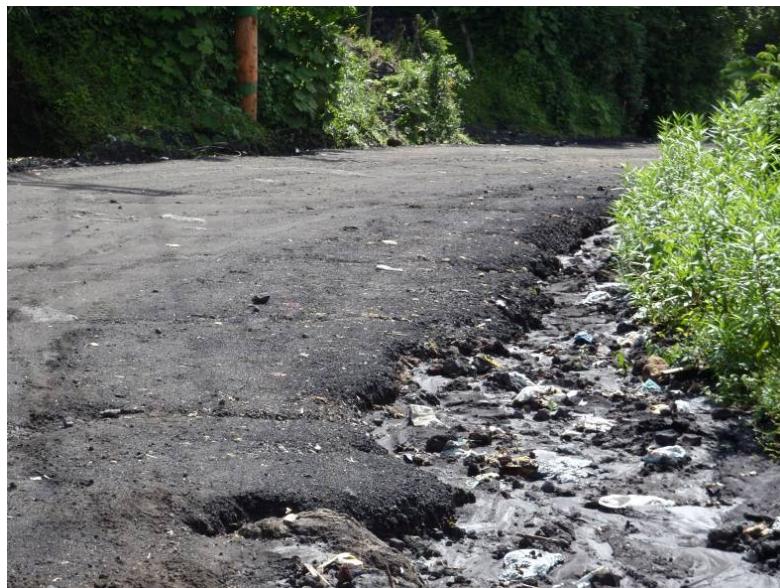
The road linking the small settlements of El Cedro and San Francisco de Sales (Figure 1.3) received approximately 20 cm of tephra fall, ranging in size from sand-sized up to approximately 3 cm diameter. According to a local guide in San Francisco de Sales, there was no vehicle access to the town on the day after the eruption as the road was too slippery. The road was not cleared, but eventually the surface compacted down and a new road surface was formed on top of the tephra layer (Figure 3.17).

Figure 3.17 Road to San Francisco de Sales, showing compacted tephra road surface.

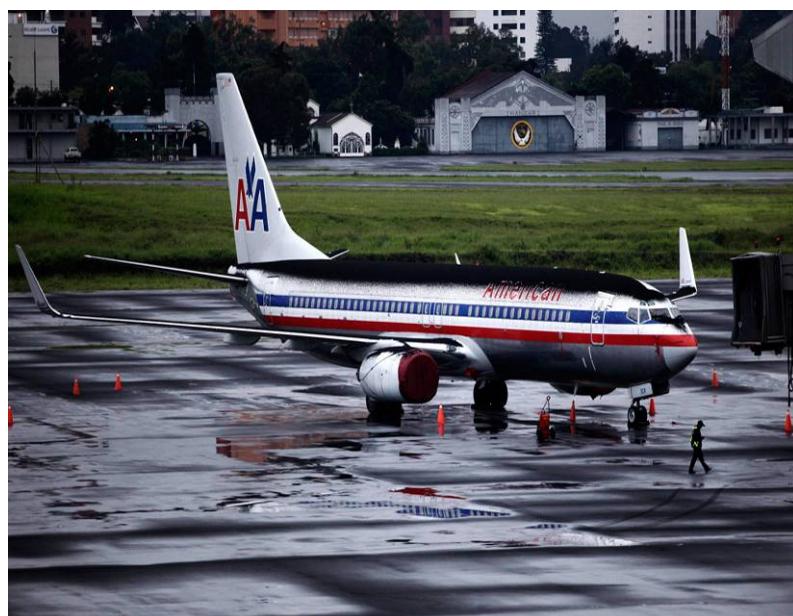
Figure 3.18 American Airlines flight at La Aurora airport following eruption of Pacaya volcano (photo: Gustavo Chigna, INSIVUMEH).

Approximately 2-3 cm of coarse basaltic tephra fell on La Aurora airport. The main reason for the airport closure was to allow for cleanup of the airport, rather than because of airborne tephra hazards to aircraft (which was limited by the short duration of the tephra fall). There was also a high level of concern about the impacts of remobilised tephra on jet engines.

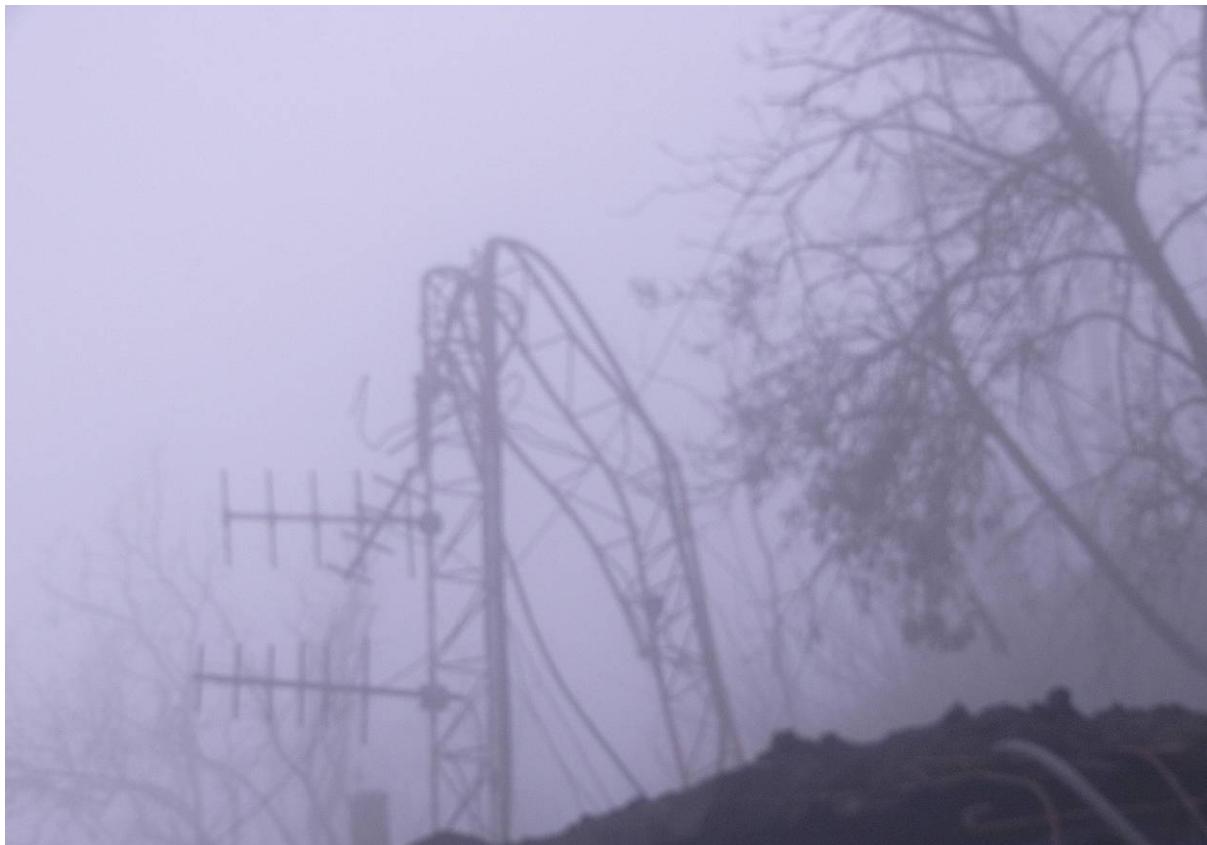
Images acquired from INSIVUMEH show a collapsed telecommunications tower in the area of Cerro Chino (see Figure 1.3 for location) due to ballistics (Figure 3.19).

Figure 3.19 A radio communications tower on Cerro Chino that buckled from ballistic and block impacts (photo: Gustavo Chigna, INSIVUMEH).

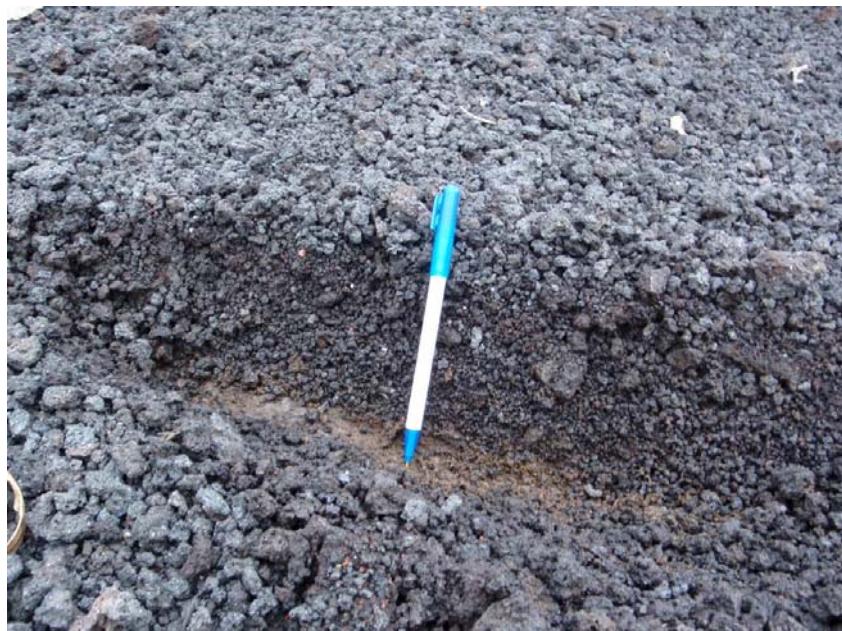
Up to 20 cm of coarse-grained lapilli fell on San Francisco de Sales and Calderas. After compaction, tephra deposits were approximately 10-12 cm thick at the time of our visit (Figure 4.1).

Figure 4.1 Ground cover of coarse lapilli (tephra layer is ~10 cm thick), San Francisco de Sales, 19/9/2011).

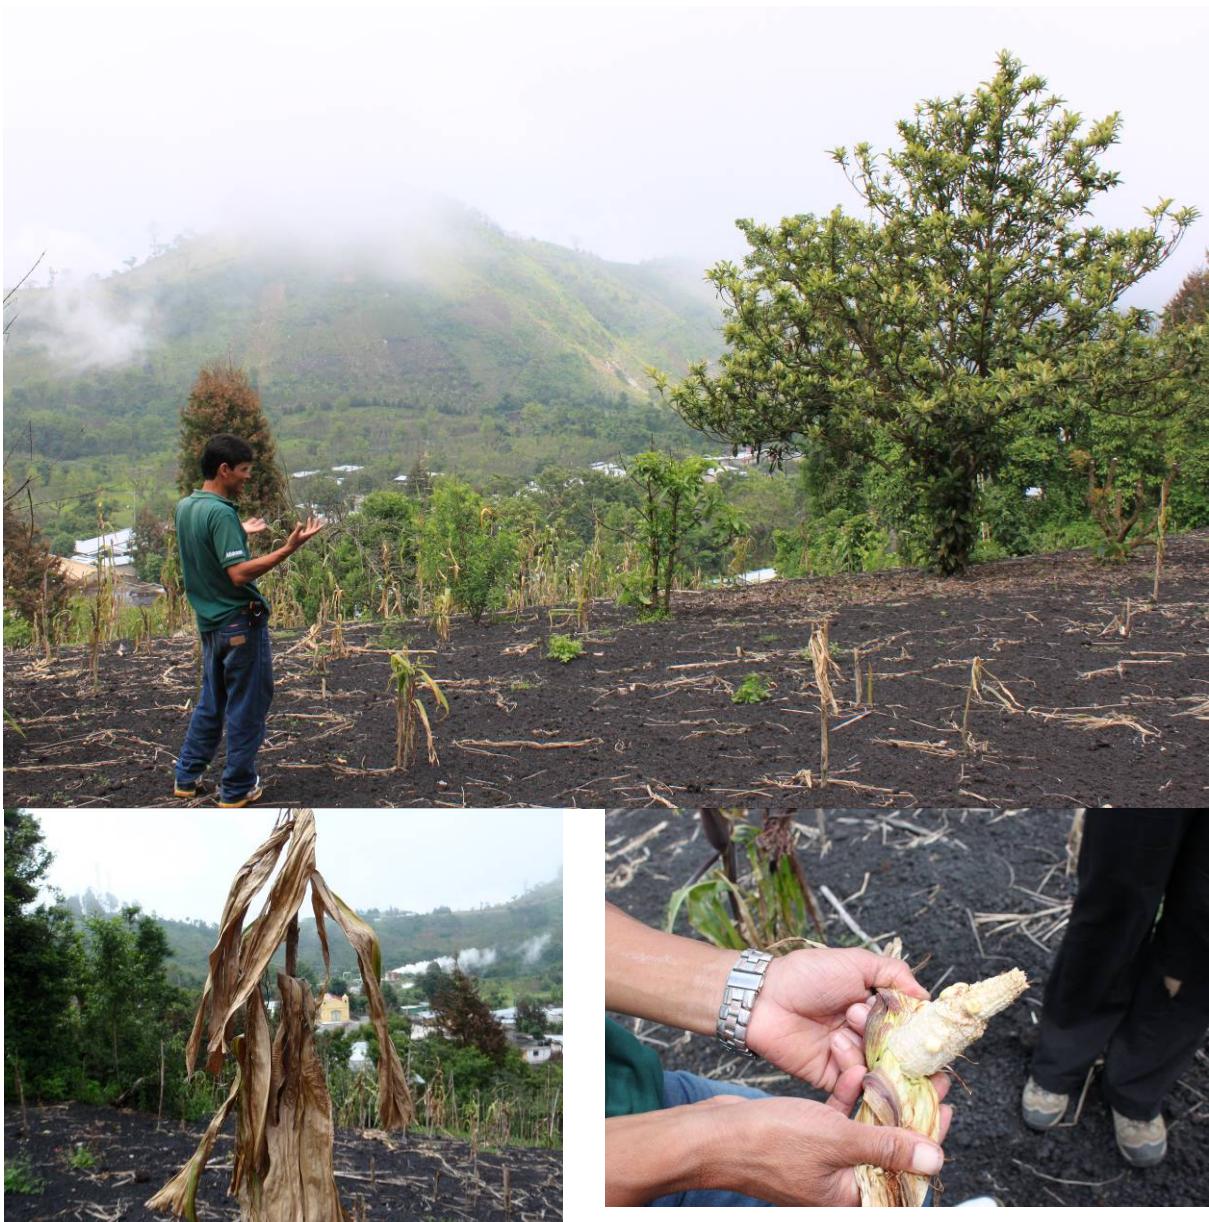
Figure 4.2 Farmer surveys his damaged maize crops, San Francisco de Sales (19/9/2011).

The lapilli fall caused extensive damage to crops in this region (Figure 4.2). The area also received larger ballistic clasts (lower right of Figure 4.2), some of them incandescent. The local farmer reported that crops suffered both crush damage and burn damage. There may also have been acid damage but no further information was available on this topic. No crops could be harvested after the 27 May eruption.

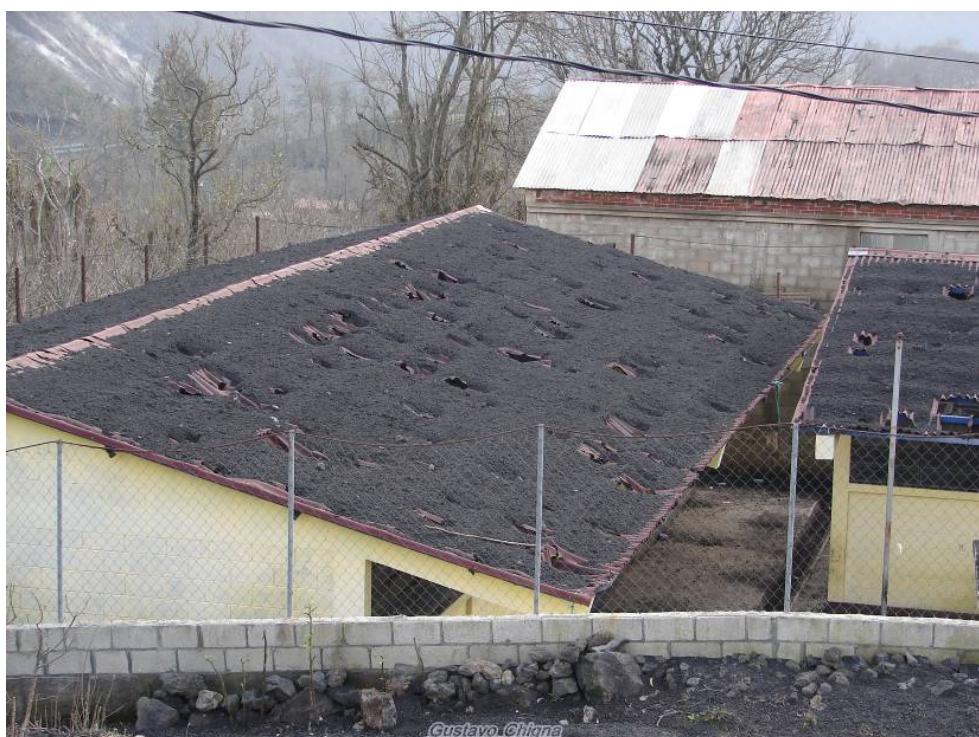
Figure 4.3 Ballistic damage to roof, San Francisco de Sales (located approximately 3 km north of the vent). Ballistics in this area reached 25 cm in diameter (long axis) (photo: Gustavo Chigna, INSIVUMEH).

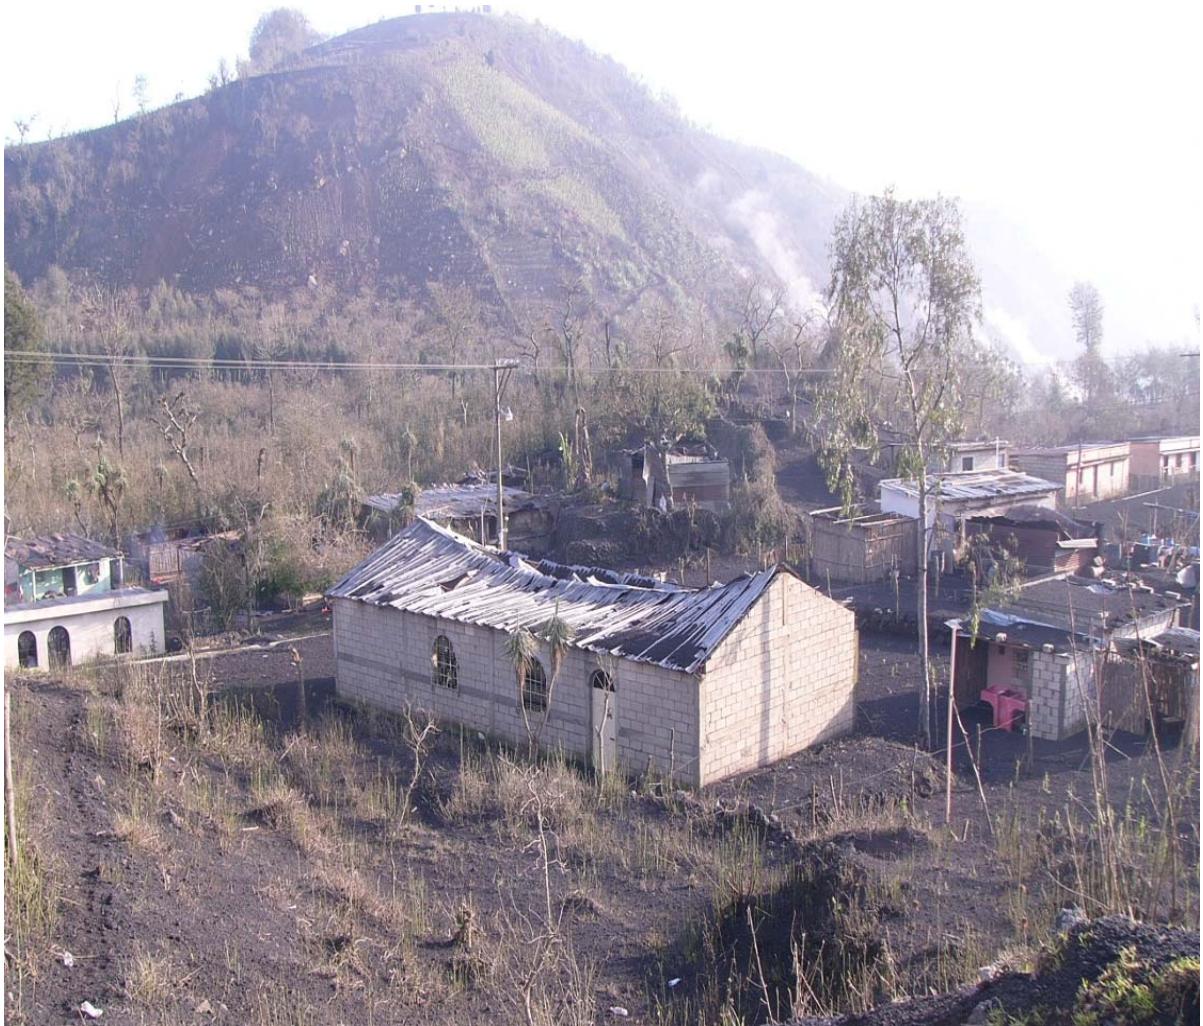
Figure 4.4 Roof collapse due to tephra loading, San Francisco de Sales (photo: Gustavo Chigna, INSIVUMEH).

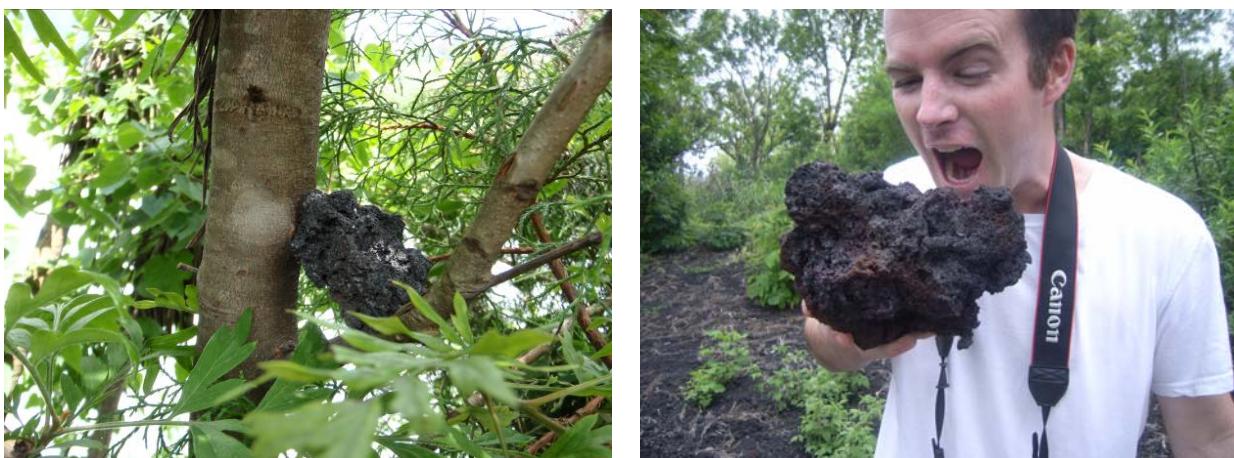
Figure 4.5 Ballistic clasts in vicinity of San Francisco de Sales, 19 September 2010. (approximately 20 cm long axis).

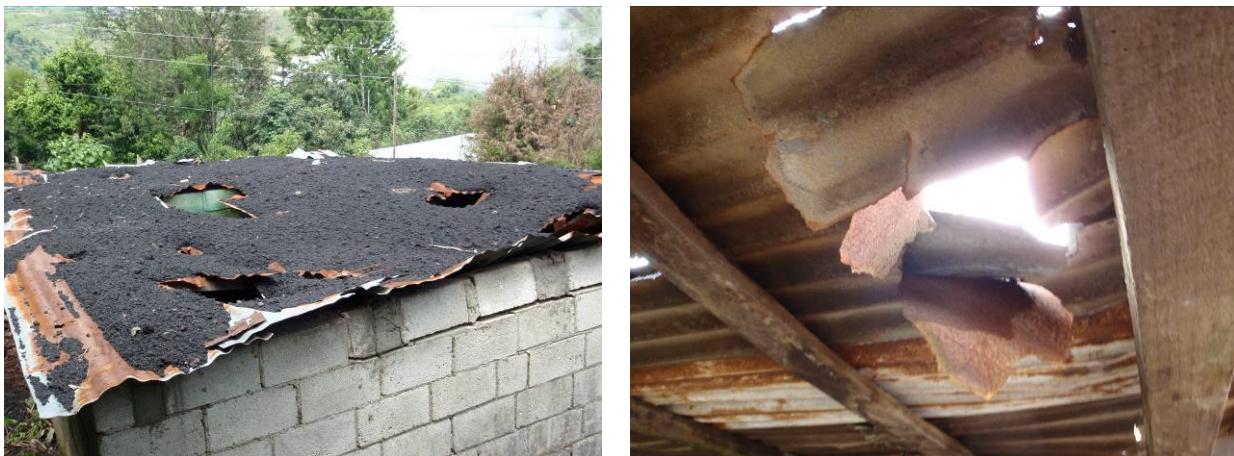
Figure 4.6 Tephra deposition and ballistic damage to roofs, San Francisco de Sales, 19 September 2010.
