Fraser, S.; Leonard, G.S.; Matsuo, I. and Murakami, H. 2012. Tsunami evacuation: Lessons from the Great East Japan earthquake and tsunami of March 11<sup>th</sup> 2011, *GNS Science Report* 2012/17. 89 p.

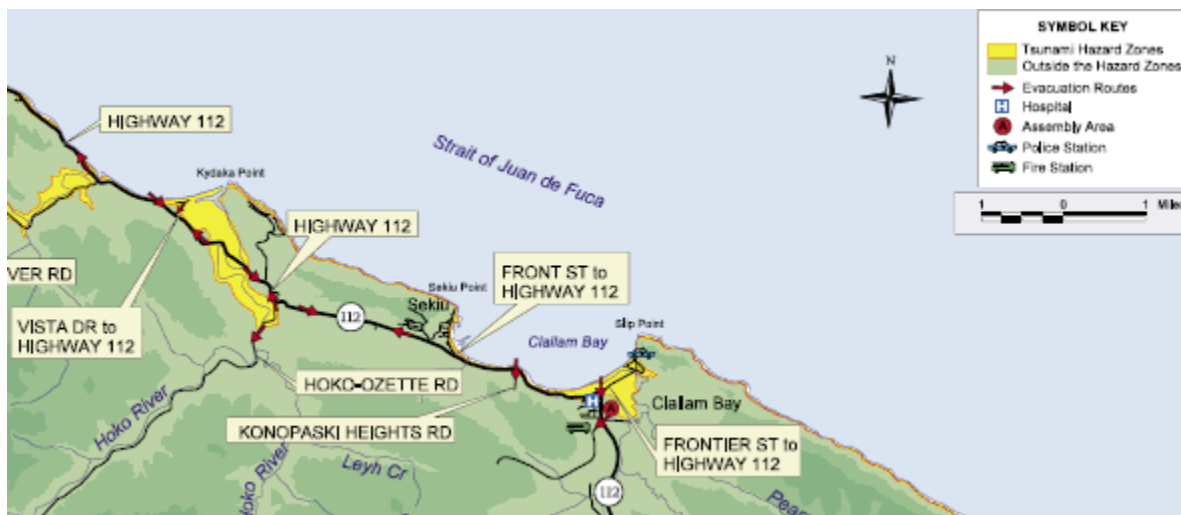
Figure 2 Excerpt from the tsunami evacuation map Clallam Bay, Clallam County, Washington. This map uses 2 zones, local sites of importance (fire department, etc.), evacuation routes and assembly areas (Clallam County Emergency Management, n d).

The provision of evacuation maps is a major initiative covering over 20 different locations. Some maps use three zones of 'greatest risk', 'marginal risk' and 'higher ground', evacuation routes, assembly areas, roads, rivers and place names (Figure 2). Other maps use only two zones: 'tsunami hazard zone' and 'outside of hazard zones', for example in Clallam County (Figure 3). These maps are provided with additional information as part of a short brochure. In the planning of evacuation routes and assembly areas, Washington EMD and the Department of Natural Resources assess landslide and liquefaction hazards which may impede evacuation.

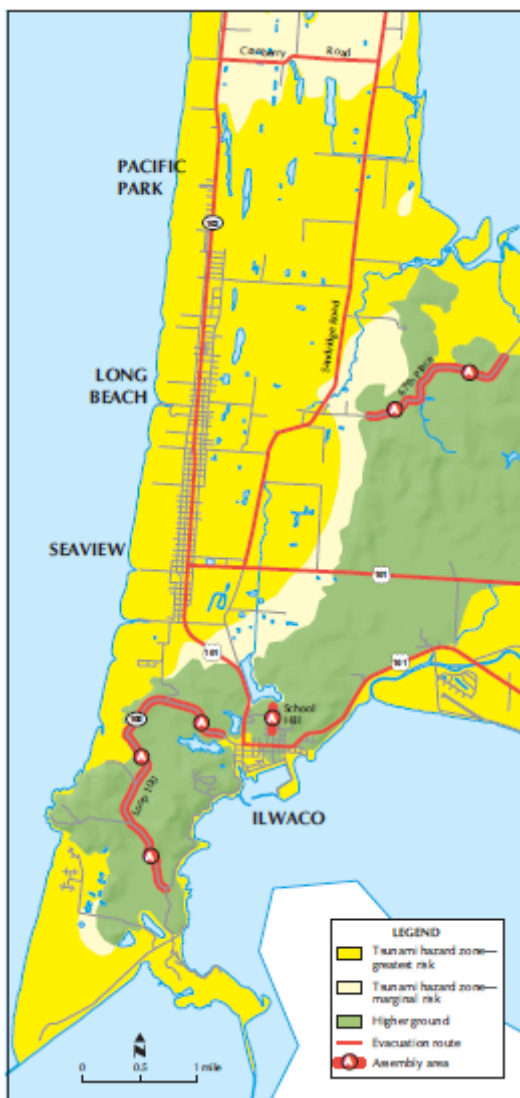
Figure 3 An example evacuation map in Washington. This map is for Long Beach and Ilwaco, Pacific County, and illustrates the use of 3 zones, evacuation routes and assembly areas (Pacific County Emergency Management, 2007).

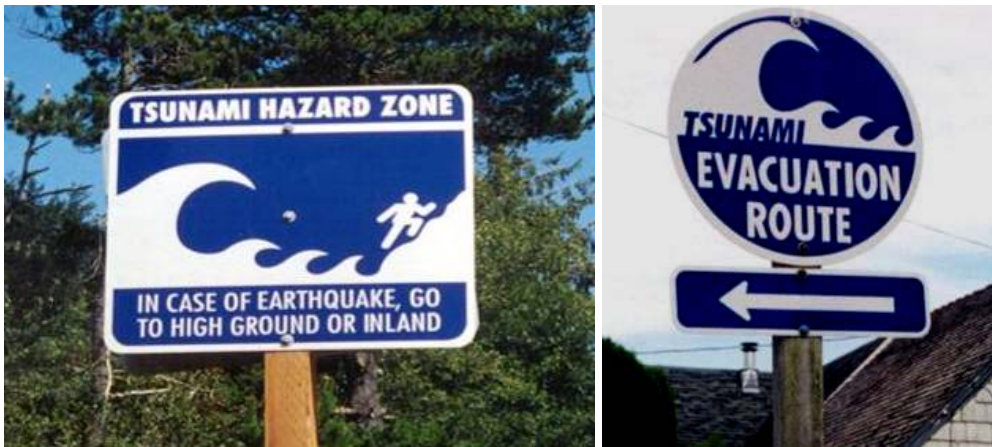
Figure 4 'Tsunami Hazard Zone' sign with instructions to evacuate to high ground or inland in response to an earthquake.

Figure 5 'Tsunami Evacuation Route' sign with arrow depicting the direction of evacuation. These signs are placed regularly along roads in tsunami hazard zones.

Signs for hazard zones and evacuation routes are standardised along the Pacific Coast, with signs indicating the tsunami hazard zone with brief instructions regarding natural warnings (Figure 4) and evacuation route signage (Figure 5).

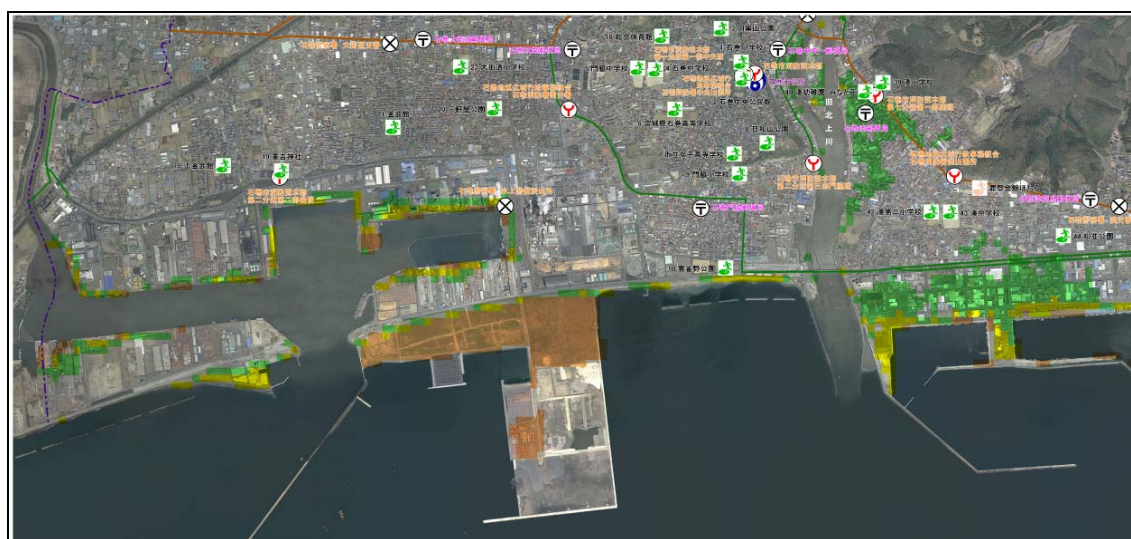
Figure 13 Excerpt from the Ishinomaki tsunami hazard map with evacuation refuges (Ishinomaki City, n d).

Hazard or evacuation zone style varies between maps. Some maps use variable colouring to indicate modelled inundation depth (Figure 10, Figure 11, Figure 13); others provide only a single colour delineation of inundation extent in historic events (Figure 8, Figure 12).

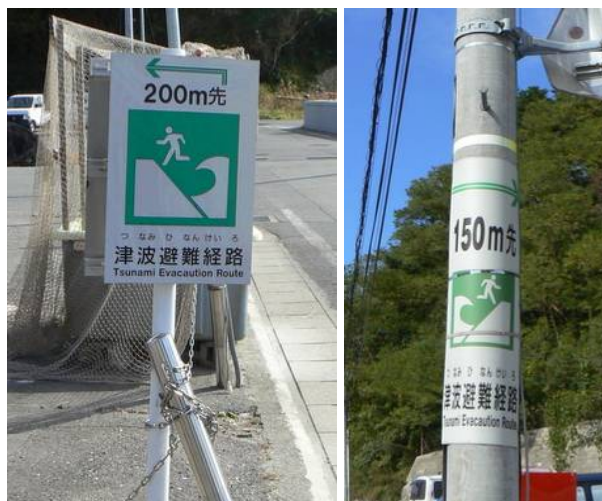
Figure 17 Tsunami evacuation route direction and distance sign displayed on a sign in Hitachihamacho, Miyako City.

Figure 18 Tsunami evacuation route direction and distance sign displayed on a lamp-post in Hitachihamacho, Miyako City.

Evacuation route signs in Miyako City and Matsushima Town commonly include the distance to safe places, in addition to a directional arrow. There is consistent use of the green symbol depicting evacuation to high ground (Figure 17 to Figure 20). Matsushima Town also has information boards displaying a schematic map of the entire evacuation route and location of the designated assembly point on the evacuation route (Figure 19) in addition to signs painted onto the pavement in town (Figure 20). This style is not consistent for all signs in Matsushima, however: Figure 21 shows a more basic sign indicating just the direction of evacuation. The inclusion of distance on evacuation route signs is not currently included in signage standards for New Zealand (MCDEM, 2008b) or Washington.

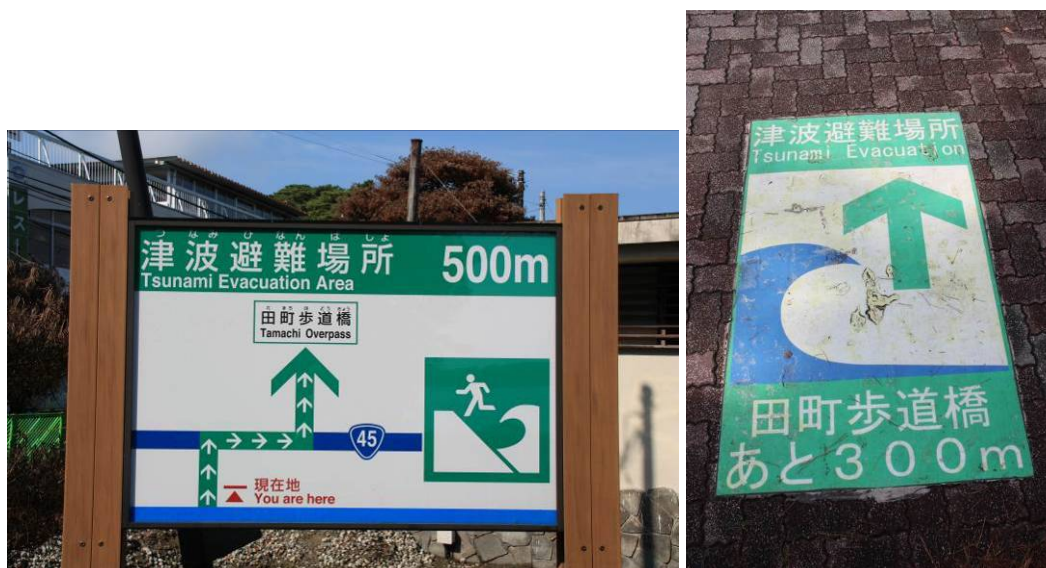
Figure 19 Tsunami evacuation route information board and directions (with distance to safe location) in Matsushima Town, Miyagi Prefecture.

Figure 20 Tsunami evacuation route sign with direction and distance to safe location painted on the pavement in Matsushima Town, Miyagi Prefecture.

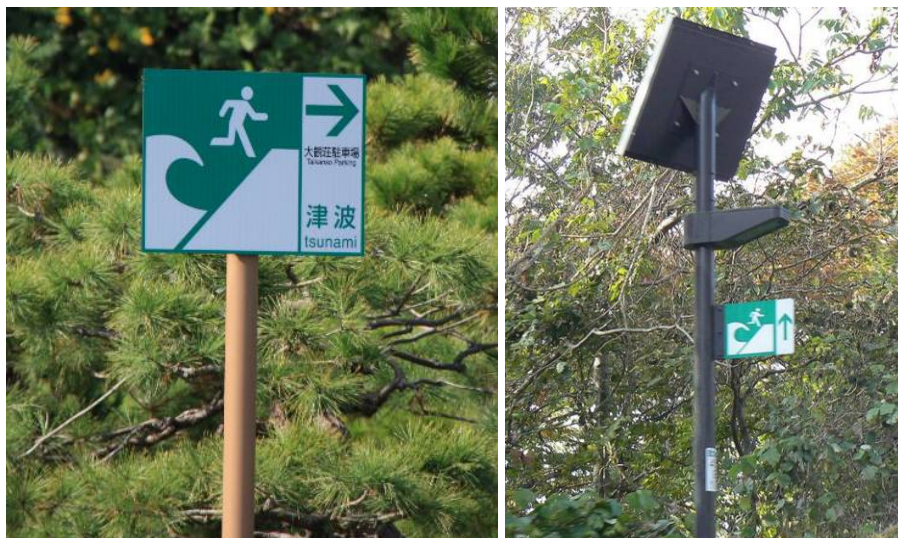
Figure 21 A sign in Matsushima Town, displaying the tsunami evacuation route.

Figure 22 Tsunami evacuation route sign with solar powered lamp, on a road leading to high ground out of Tarō Town.

Tarō Town has signs posted regularly at short distances (20-30 m) along the road out of the Town towards high ground. These signs are mounted on posts with solar powered lamps for night-time use (Figure 22).

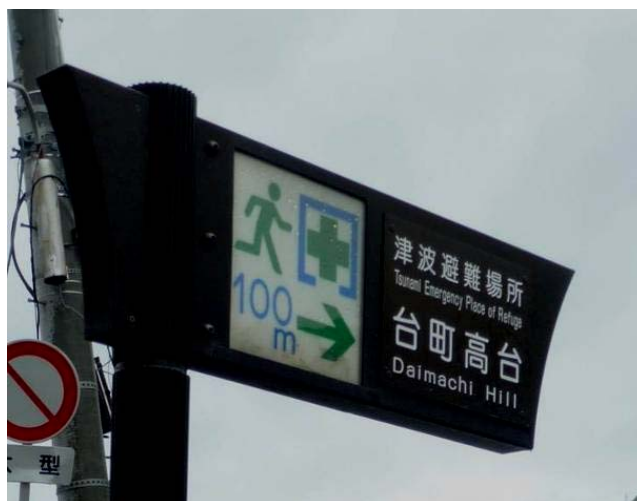
Figure 23 Evacuation route sign in Ōfunato City, indicating the distance to a “tsunami emergency place of refuge”. Photo courtesy of EEFIT.

Ōfunato City uses signs indicating the walking route direction and distance to safe refuges, providing the name of the refuge in English and Japanese (Figure 23). The city also uses signs which light up at night.

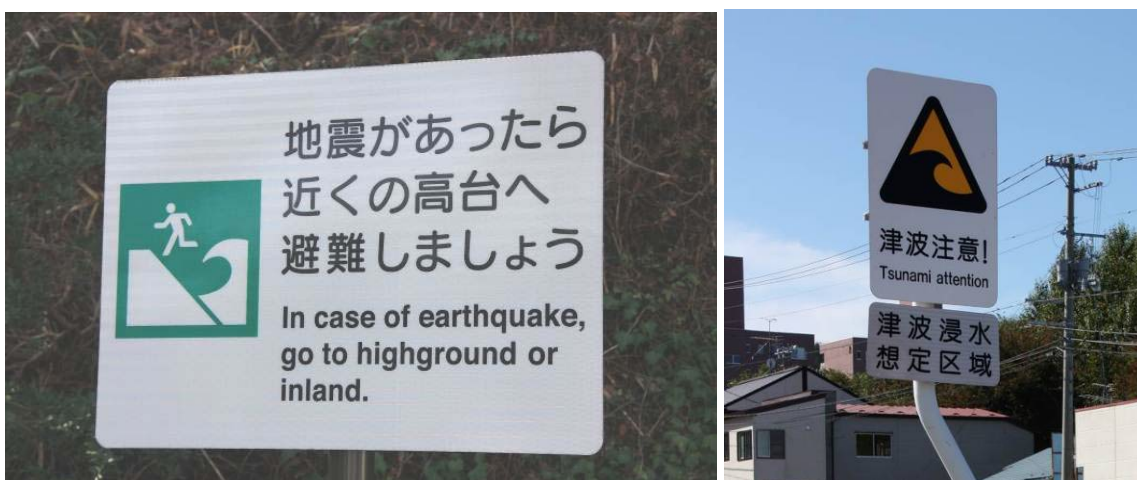
Figure 24 A sign in the centre of Matsushima Town, advising evacuation on experiencing an earthquake.

Figure 25 A sign indicating tsunami hazard, on a road out of Kamaishi City. Translation reads: “Tsunami Attention! Tsunami inundation hazard zone”.

In addition to the information boards and pavement-mounted signs in Matsushima Town, we also observed an example of natural warning education in the centre of town, situated close to several tourist sites (Figure 24). This sign displays the standard green icon representing evacuation to high ground.

Another style of tsunami warning sign was observed on a road out of Kamaishi (Figure 25); this symbol is consistent with other signs observed in the district in terms of the yellow and

black icon used, but this symbol not seen in any other districts, which appear to only use the green evacuation symbols. Both the green and yellow symbols have been accepted as ISO international standards after being proposed by Japan. However, both New Zealand and Washington use a blue sign style very similar to each other, which is common in other countries. All signs discussed above have bilingual text for at least the basic information, enhancing understanding further than recognition of the tsunami symbol for people with little understanding of Japanese text.

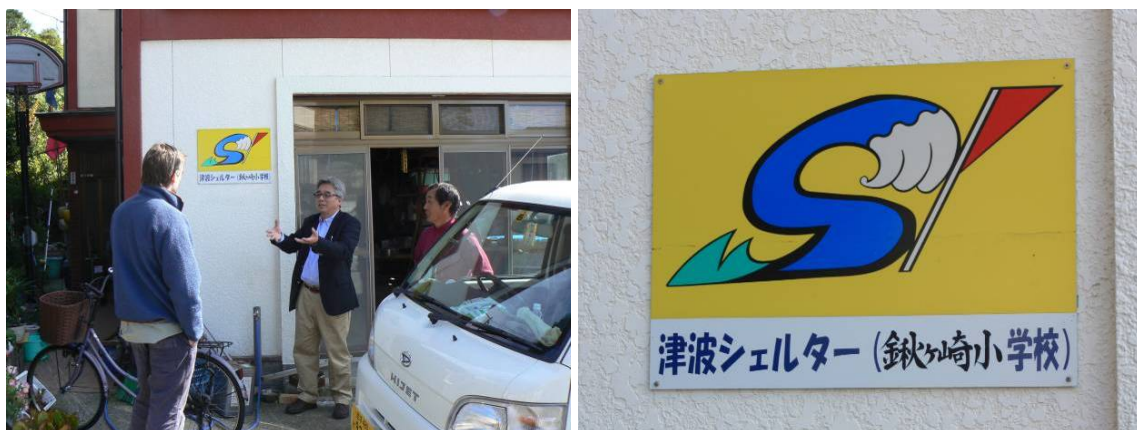
Figure 26 Tsunami evacuation muster point for children in Hitachihamacho, Miyako City.

Figure 27 Close-up view of tsunami evacuation muster point for children in Hitachihamacho, Miyako City. Translation reads: “Tsunami shelter (Kuwasaki elementary school)”.

A muster point for use in evacuation of children was seen in Hitachihamacho, Miyako City (Figure 26, Figure 27). This sign is located on the wall of a house on the road at the base of a hill. The owner of the house told us that children are instructed to gather at this sign and evacuate up the hill together.

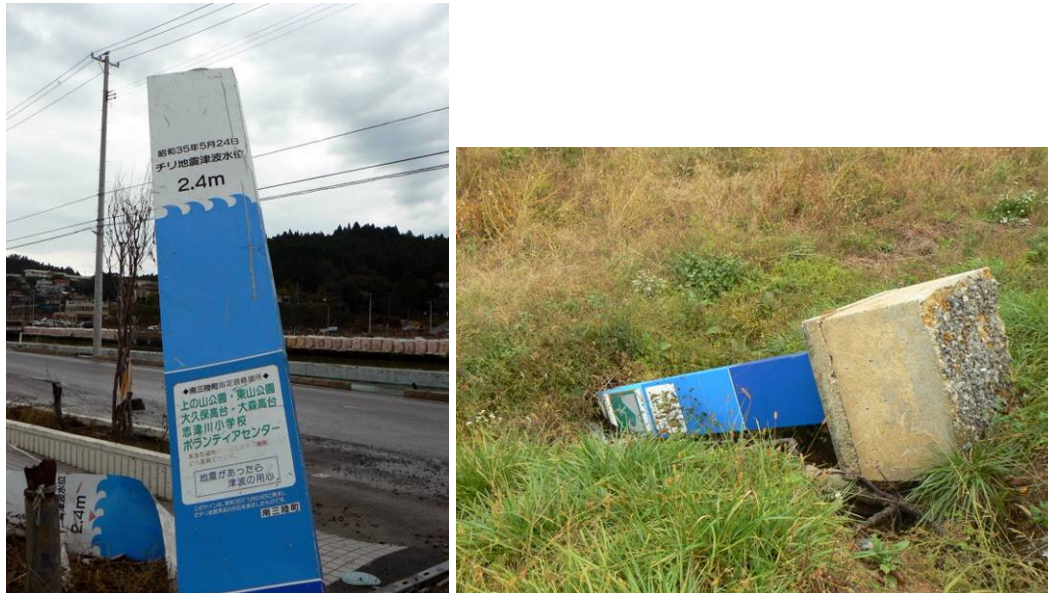
Figure 28 A marker post indicating past inundation height in central Minami-Sanriku Town. The Japanese text gives notification that the Shizugawa hospital is a designated vertical evacuation building. The Japanese text informs people to evacuate to designated evacuation places such as parks, highlands, and Shizugawa elementary school and Shizugawa hospital.

Figure 29 A marker post indicating past inundation height in central Minami-Sanriku Town. This marker was found close to a care home (1 km inland), and displays the standard icon representing evacuation to high ground.

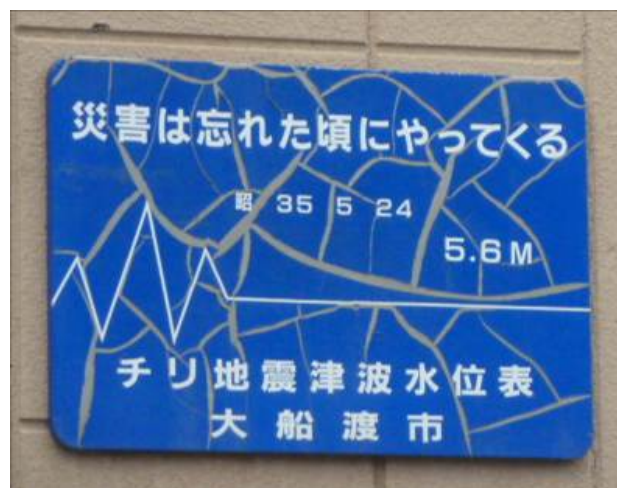
Figure 30 Tsunami height marker on a building wall in Ōfunato City, indicating the maximum inundation height at this point during the Chile tsunami on May 24<sup>th</sup> 1960. Photograph courtesy of EEFIT.

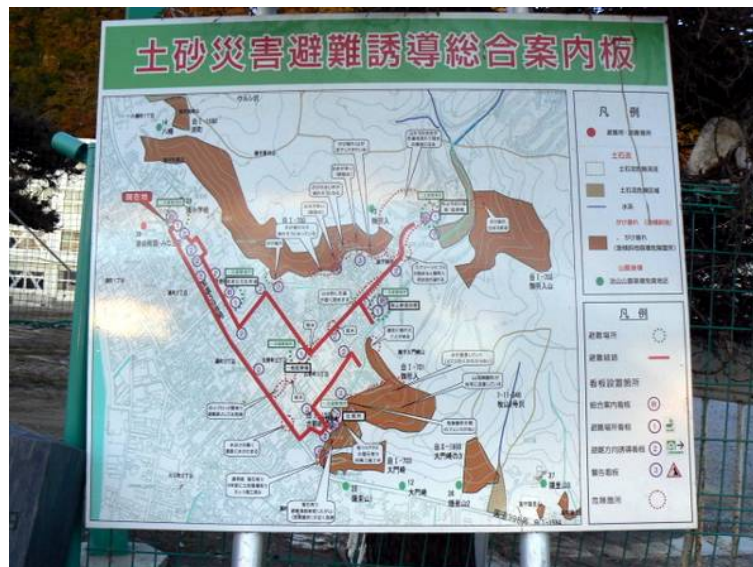
Figure 31 Landslide hazard and evacuation map on an information board in Ishinomaki City.

In Ishinomaki, we observed a map which focussed on the local landslide hazard and evacuation routes designed for landslide only (Figure 31). This map shows evacuation routes to shelters which are away from steep hillsides, but encourage evacuation into areas close to the banks of the Kitakami River. On March 11<sup>th</sup> 2011, the specified evacuation shelters were inundated by tsunami flow from the river channel. This illustrates the need for information boards and signs to include multiple hazards where this is appropriate.

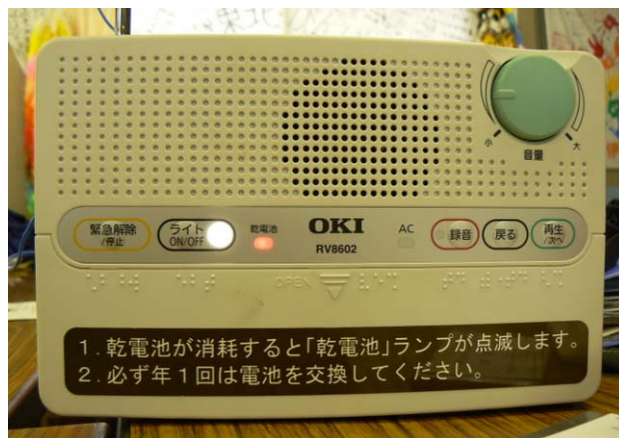
Figure 32 A wireless receiver shown by civil protection officials in Minami-Sanriku. These units are rented by the local government to every household in the town, and resulted in effective warning dissemination on March 11<sup>th</sup> 2011.

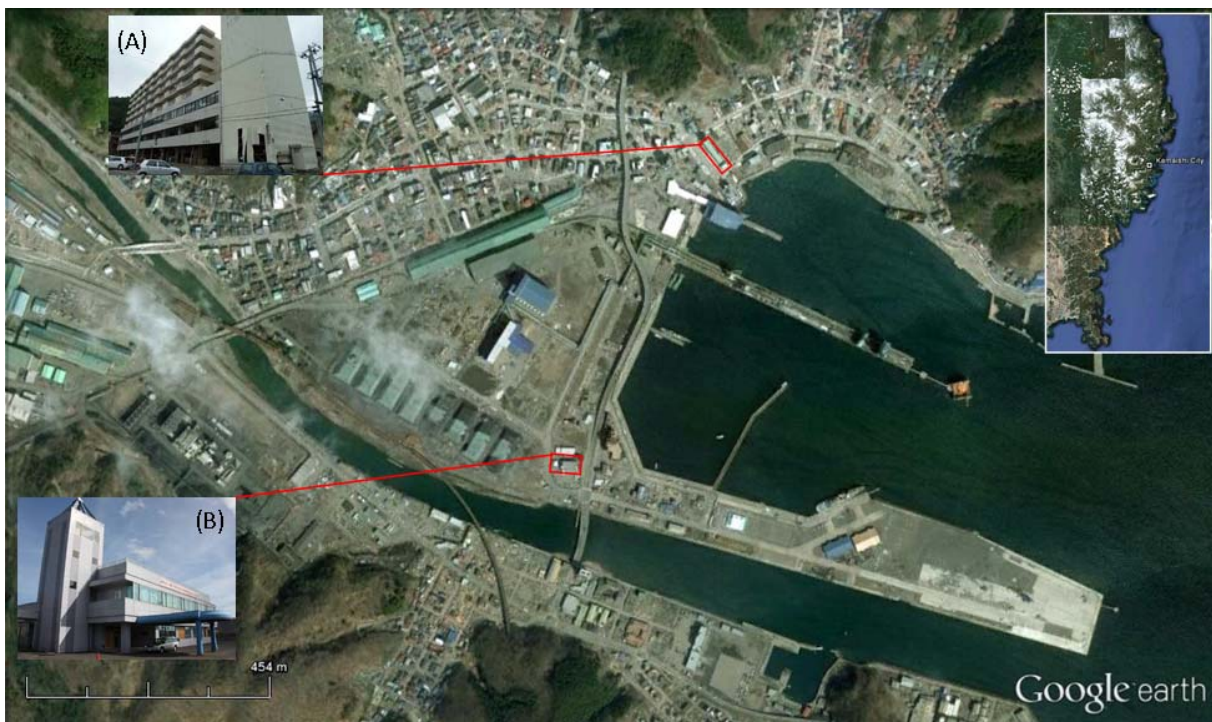
Figure 34 Designated evacuation locations in Kamaishi City. An estimated 50 people evacuated to this apartment block (A) and government offices (B). The entire area shown was inundated; inundation depth was 8 m in the vicinity of building (A).

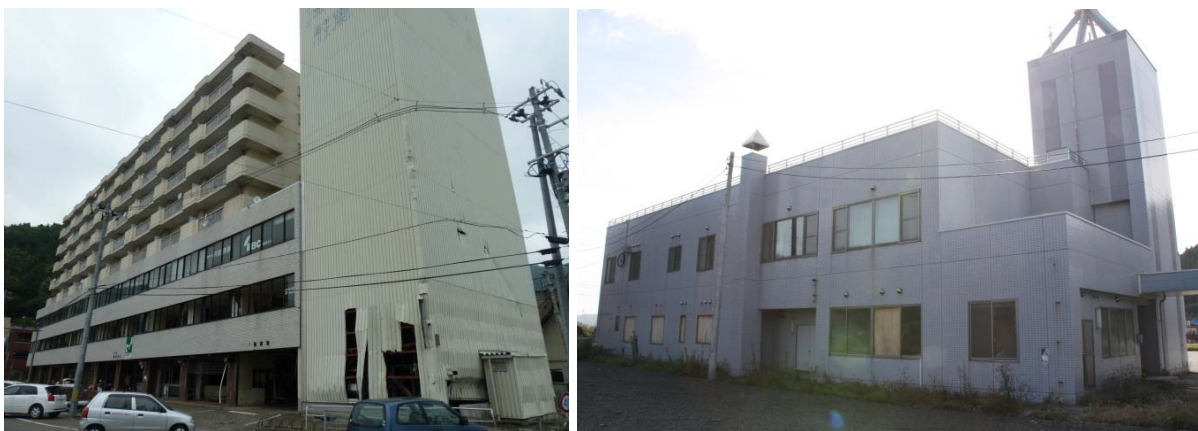
Figure 35 Apartment block in Kamaishi City, which was inundated to the 3<sup>rd</sup> storey

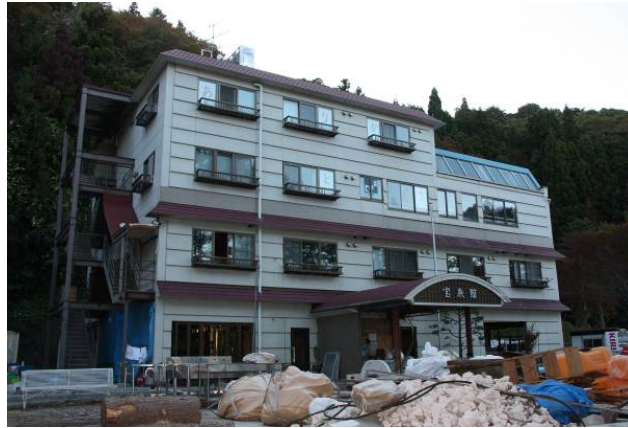
Figure 37 The Hotel Horaikan at Unosumai, Kamaishi City, with official signage displayed at the 3<sup>rd</sup> floor and very little external damage. The hotel was inundated to the ceiling of the 2<sup>nd</sup> storey

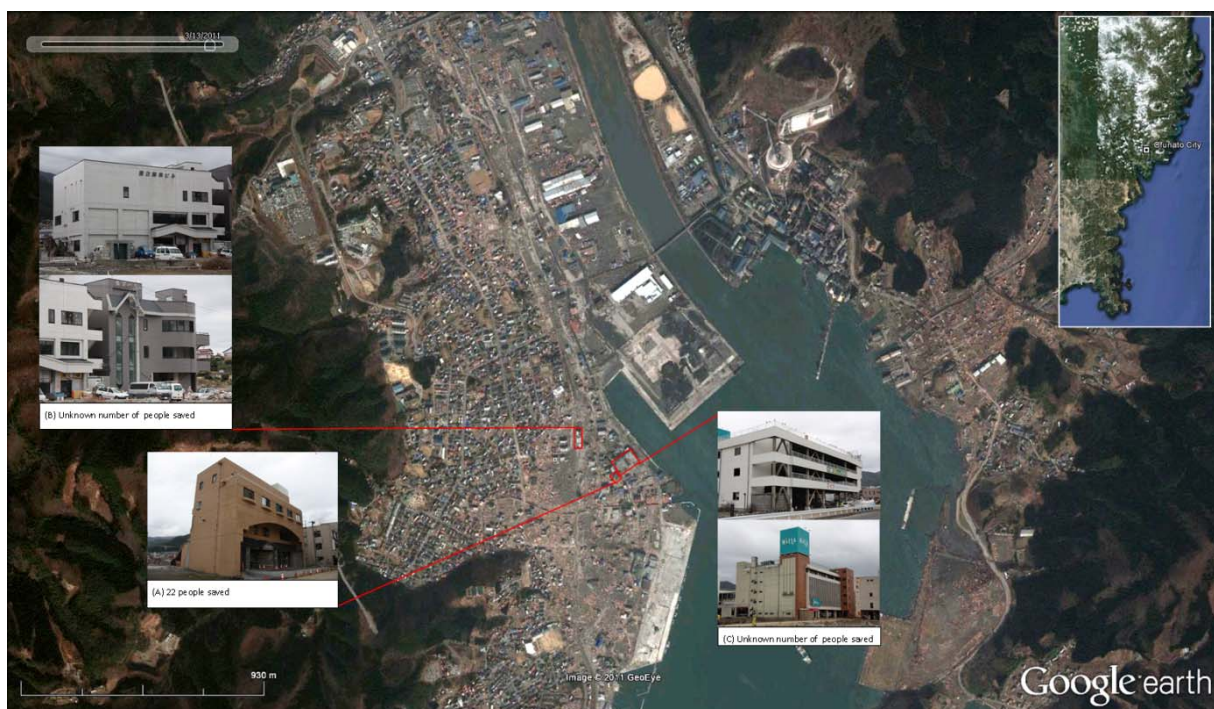
Figure 38 Locations of 5 designated vertical evacuation location visited in the downtown area of Ōfunato City: (A) Plaza Hotel; (B) Yasuka office/apartment buildings; (C) Maiya Shopping Centre and car park.

Seven buildings in Ōfunato City were recognised by the community and municipal government as vertical evacuation buildings, five of which we visited during our field visit (Figure 38). These were not officially designated as they did not meet the standards set by the 2005 government guidelines due to their construction prior to 1981. As result, the buildings are defined through informal arrangements with the building owners. This arrangement is in place for the Maiya shopping centre and adjacent multi-storey car park (Figure 39 and 40), Yasuka private commercial and apartment blocks (Figures 41 and 42), Plaza Hotel (Figure 43 and 44), Fukutomi Hotel, Kesenuma Banking building, Nokyo Credit Co-operative building, and the Wedding Plaza. Despite the construction of these buildings prior to latest seismic requirements, they were not significantly damaged in this earthquake. The only structure less than 4-storeys in height is the RC construction Wedding Plaza, which was inundated almost to its roof but survived intact. Inundation height in the vicinity of these buildings was around 3-storeys (9-10 m height; EEFIT, 2011).

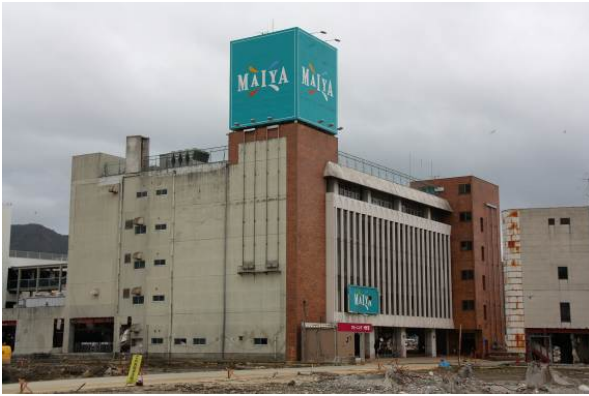
Figure 39 Maiya shopping centre, which was inundated to the 3<sup>rd</sup> storey

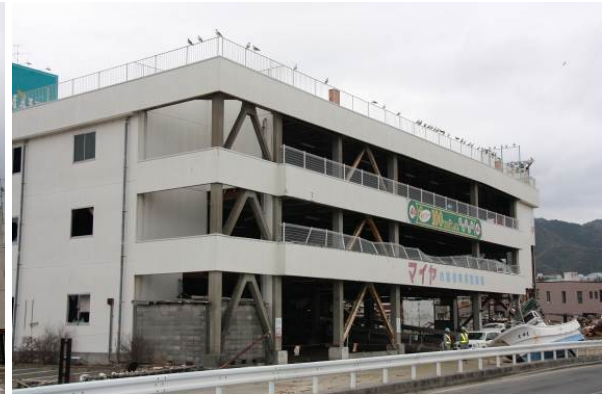
Figure 40 Maiya multi-storey car park showing damaged railing at the 2<sup>nd</sup> storey.

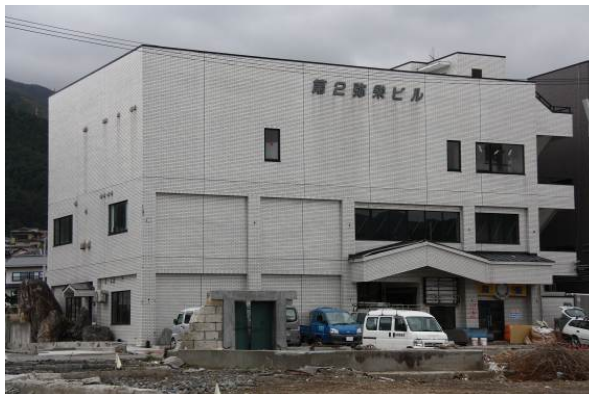
Figure 41 Yasuka private commercial and apartment block number 1 shows very little exterior damage.

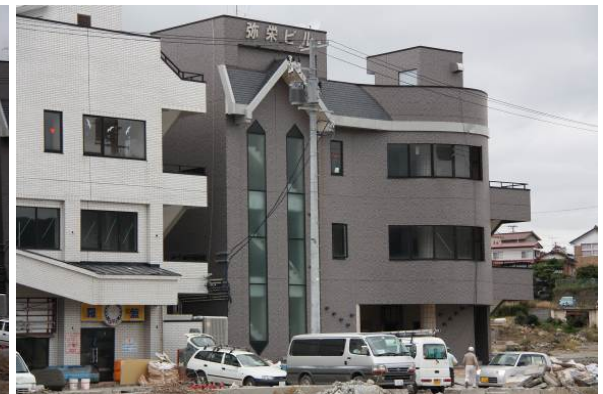
Figure 42 Yasuka private commercial and apartment block number 2 is adjacent to block number 1 and was being refurbished at the time of our visit

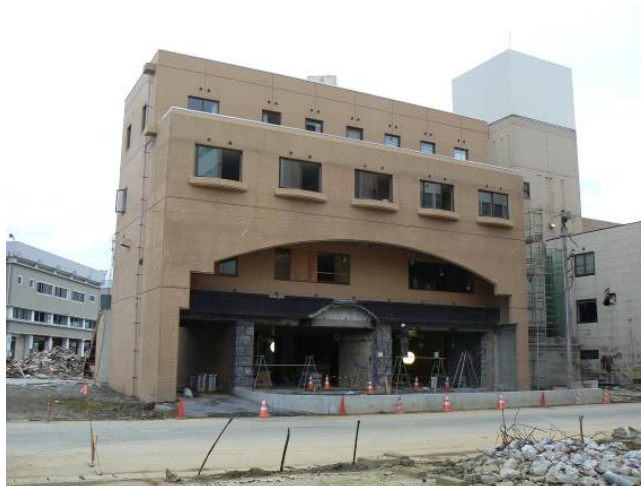
Figure 43 The Plaza Hotel, which was being refurbished at the time of our visit

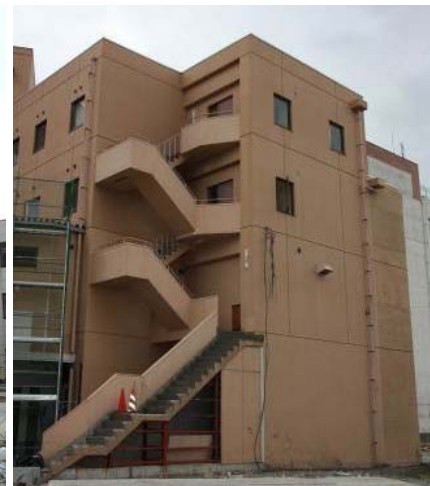
Figure 44 External stairs giving access to the 4<sup>th</sup> storey of the Plaza Hotel

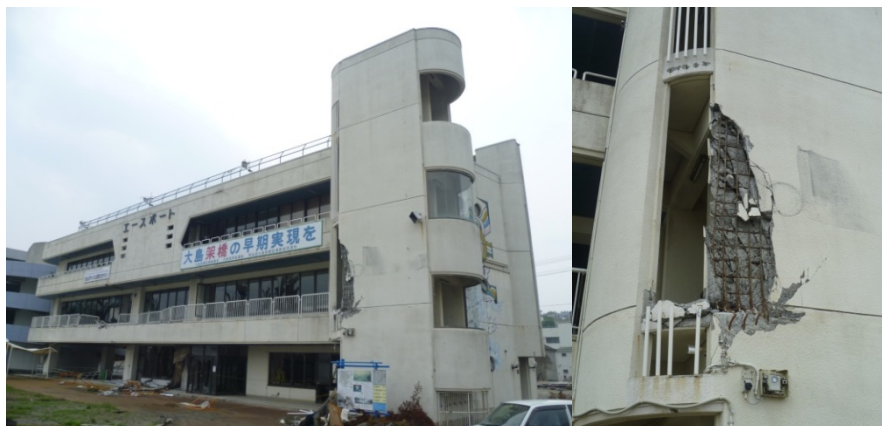
Figure 46 An office building in the inner harbour was unused on March 11<sup>th</sup>. This building sustained debris damage to the external stairs (front right) which face the harbour. Minor scour occurred along the seaward face of the building, and around the base of the external stairs.

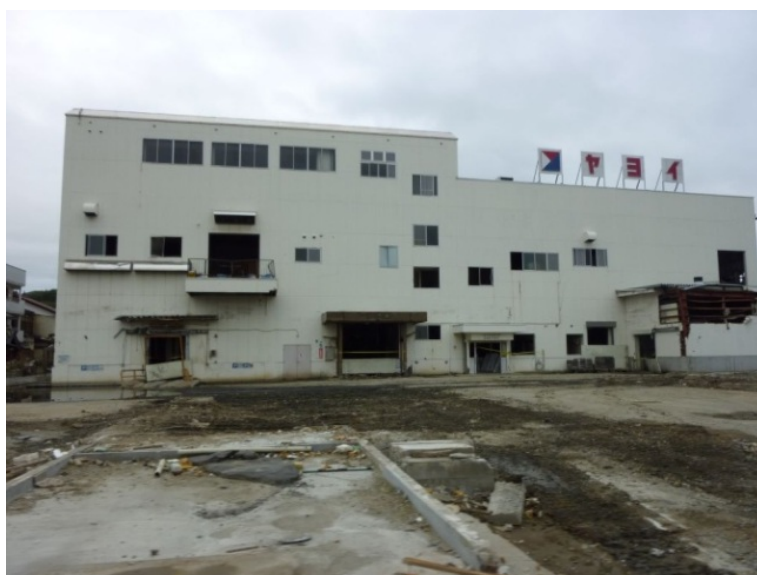
Figure 47 The Yoyoi food factory, where 400 people took refuge. Inundation height was around 8 m here.

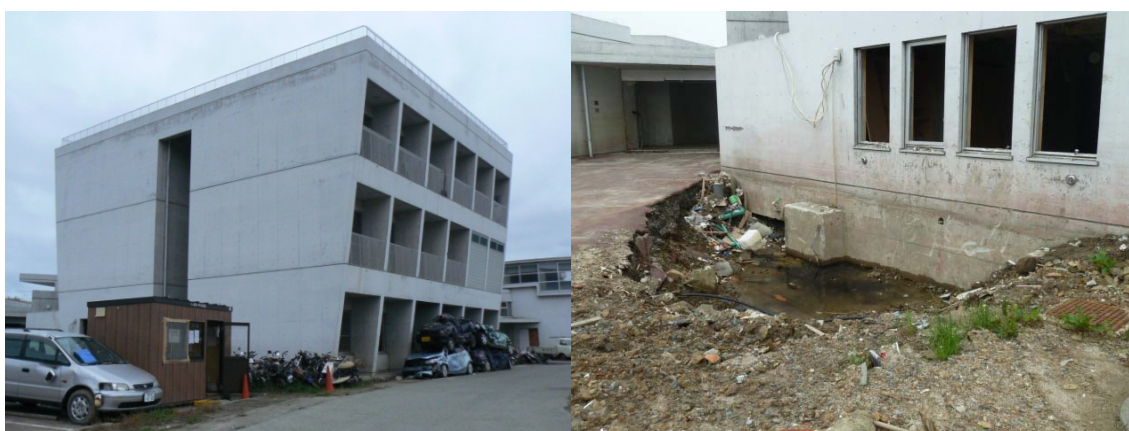
Figure 48 An elderly persons' welfare centre which was inundated to around 8 m height. Scour up to 2 m deep occurred on the near side of the building in this photograph. Extensive damage occurred immediately inland of this building, while 80 survived on the upper floors.

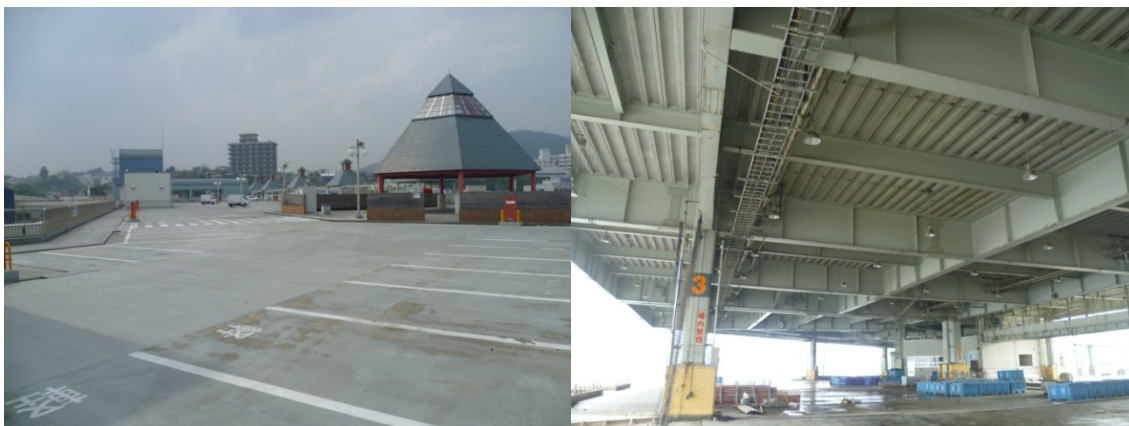
Figure 49 The large open car park roof space above the fish market provided refuge to 1000 people. This structure is at the harbour front and inundation almost reached roof level. The open steel structure enabled tsunami flow at the 1<sup>st</sup> storey.

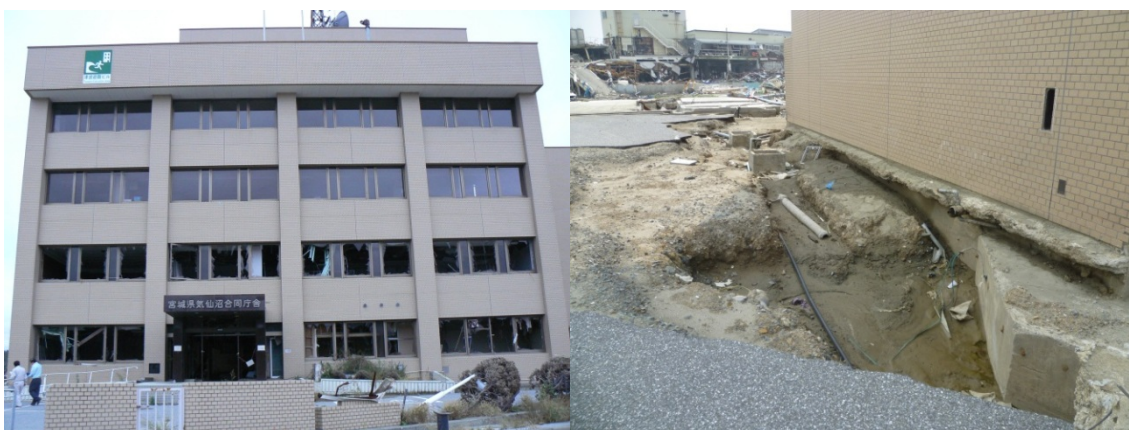
Figure 50 The Prefectural Government offices suffered extensive scour and heavy inundation of 8 m. This building was constructed after 2004 and displays tsunami vertical evacuation signage at roof level. 200 people survived the tsunami in this building

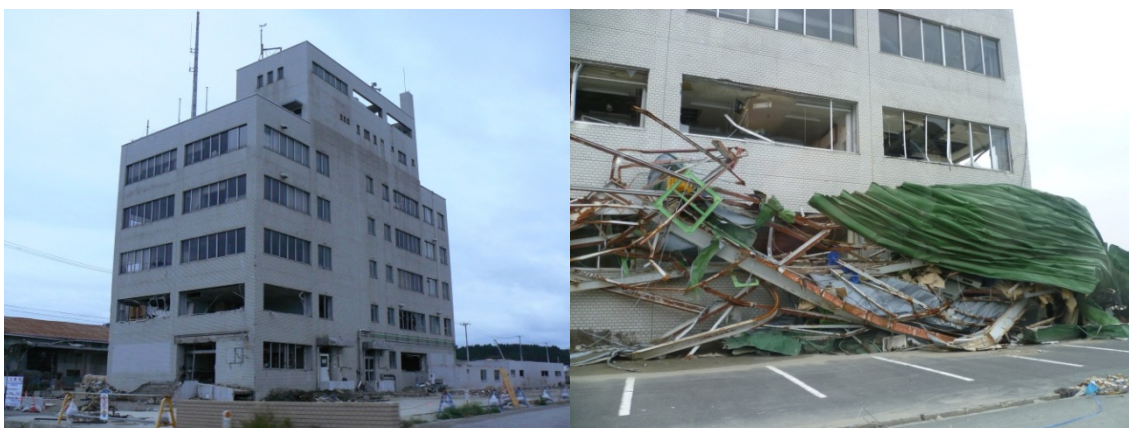
Figure 51 The National Government office, where 120 people took refuge from the tsunami. This building is adjacent to the Prefectural Government offices and was left undamaged when light steel structures were washed into it. The lower two storeys were inundated.

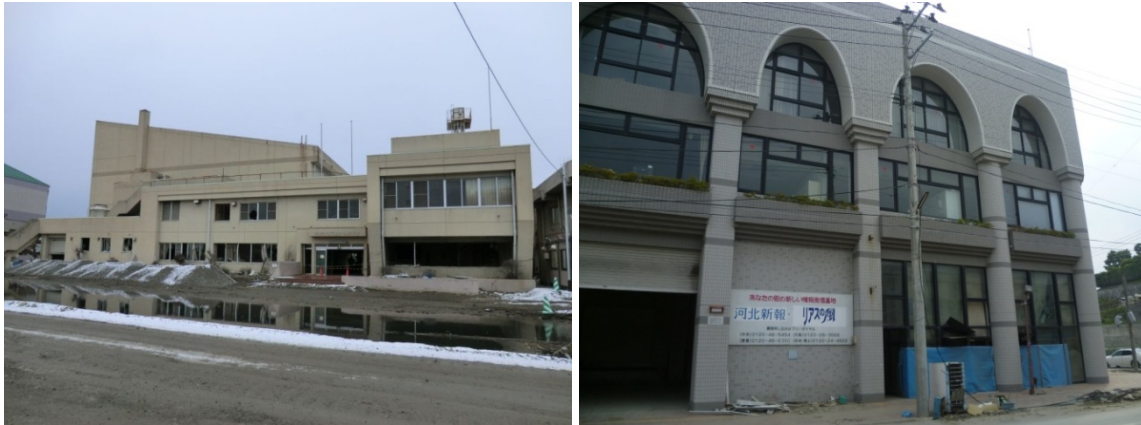
Figure 52 Kesennuma central community centre, where 450 people took refuge when they evacuated nearby buildings

Figure 53 The Kahoku Newspaper offices were inundated to at least the ceiling of the 1<sup>st</sup> storey. 71 people took refuge here.

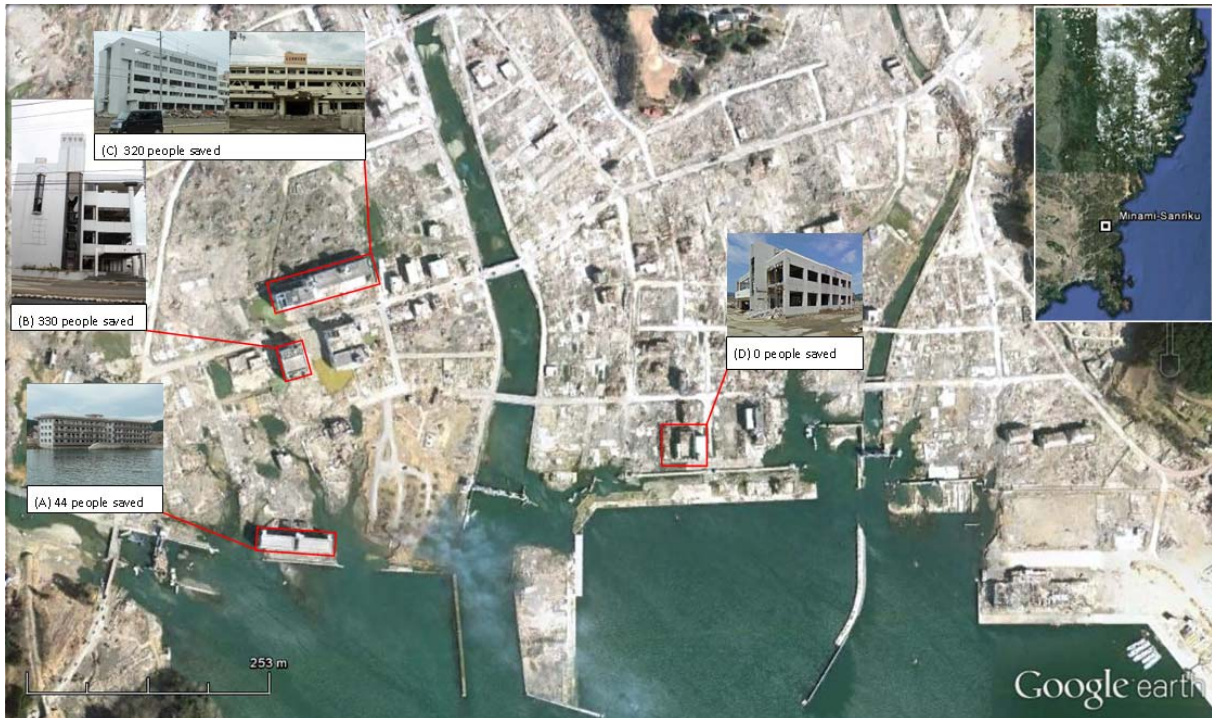
Figure 54 Locations of designated tsunami evacuation buildings in Minami-Sanriku Town: (A) Matsubara apartments; (B) Takano Kaikan building; (C) Shizugawa Hospital; (D) Fisheries Co-operative. Significant scour can be seen where seawater is encroaching around building (A) and to the east of building (D).

Following experiences of March 11<sup>th</sup>, the disaster prevention official in Minami-Sanriku recommends that all vertical evacuation buildings should be higher than 5-storeys. Evacuation towers may be considered in the town for the future but as was the case before March 11<sup>th</sup>, primary advice will be to evacuate to higher ground rather using buildings or towers. These should remain a last resort due to the potential for people to become isolated in buildings and require rescue later.

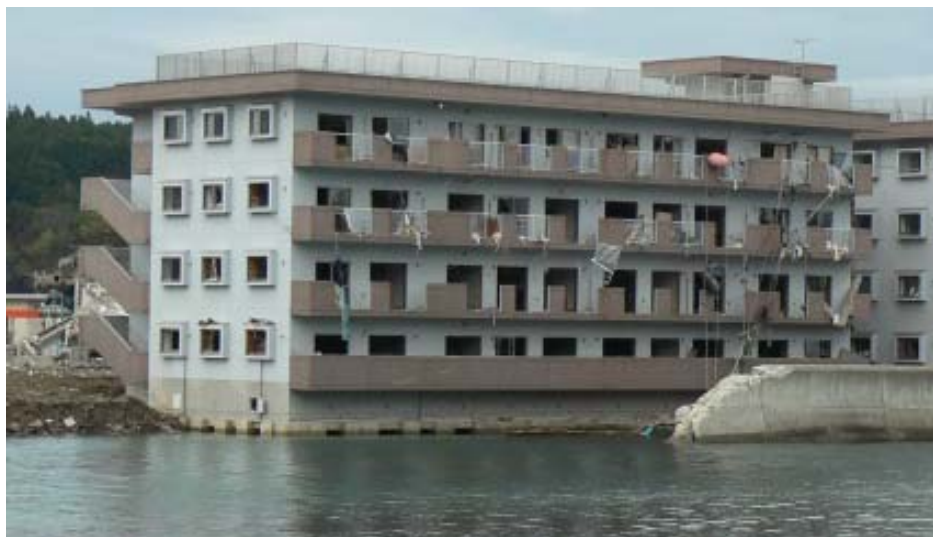
Figure 55 Matsubara apartment block viewed from the seaward side with waterborne debris to the 4<sup>th</sup> storey. The low seawall has been destroyed in the tsunami return flow and was sheltered in part by the apartment building. The foundations of this building are exposed above the water level due to extensive scour.

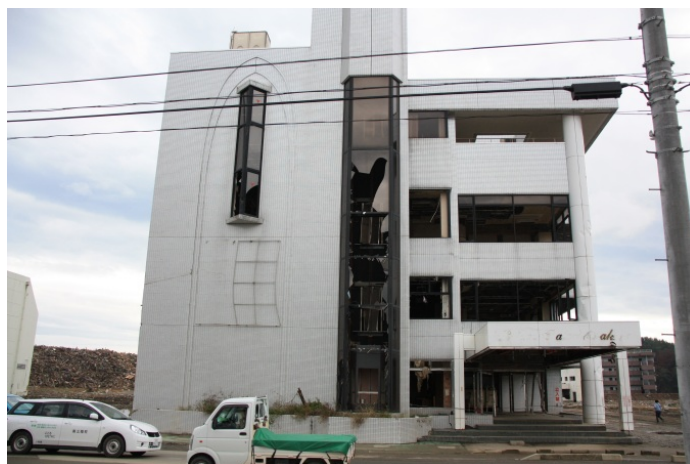
Figure 56 The Takano Kaikan building 160 m inland of the Matsubara apartment block. Little damage aside from glazing was observed here, despite heavy damage and collapse of RC buildings immediately seaward.

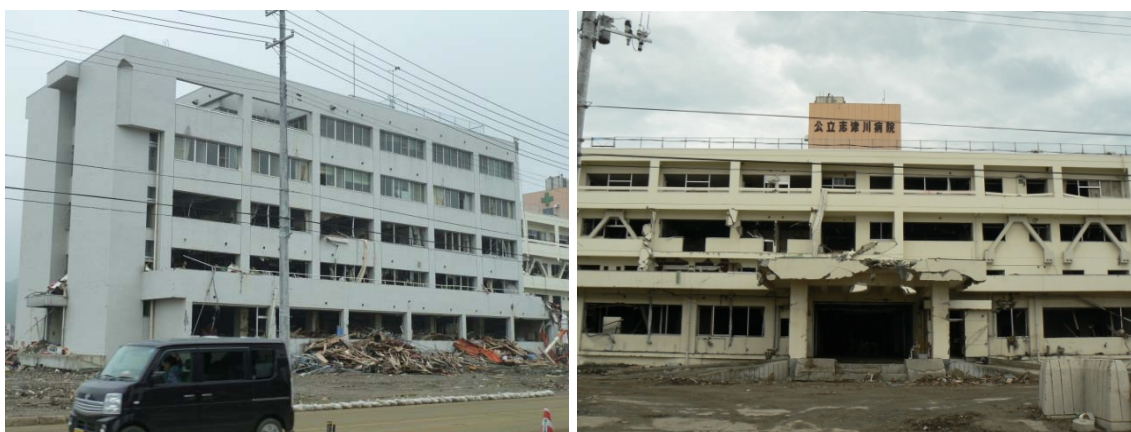
Figure 57 Shizugawa Hospital (west building) – the taller of the 2 hospital buildings at 5-storeys, this section suffered less debris damage than the east building.

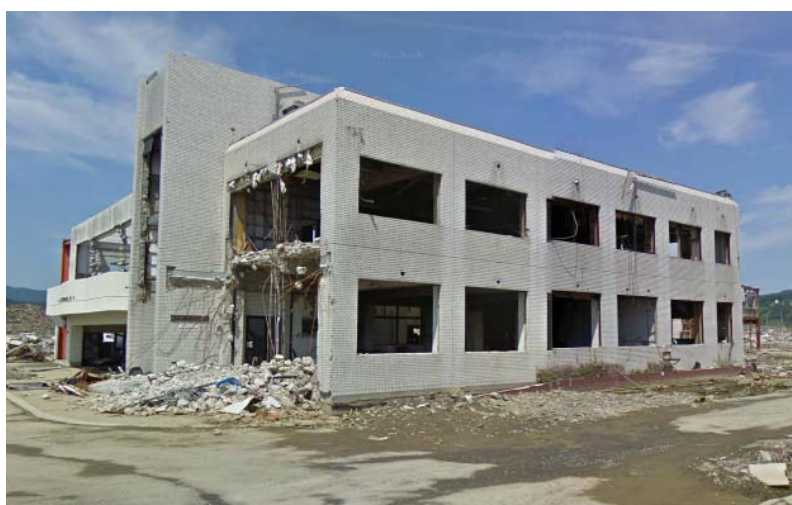
Figure 59 Minami-Sanriku fisheries co-operative building which was overtopped on March 11<sup>th</sup>. Image credit: Google Streetview, August 2011.

- Despite being only 2-storeys in height, the fishing co-operative building (Figure 59) was designated for vertical evacuation use through its ownership by a public organisation looking to protect its workers. The building was unused on March 11<sup>th</sup>.

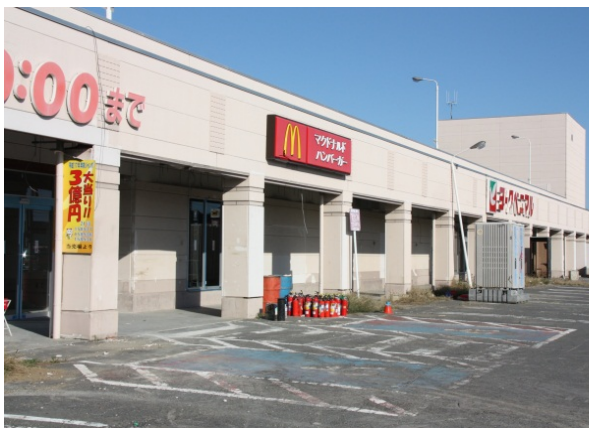
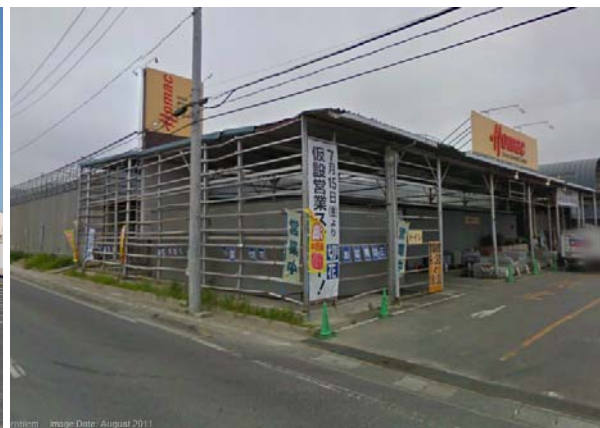
Figure 60 York Benimaru shopping centre, Minato-machi, Ishinomaki City. The rooftop car parking area is accessible by vehicle ramp and was successfully used for vertical evacuation on March 11<sup>th</sup>.

Figure 61 The Homac hardware store is a single storey building with car parking on the roof, which is accessible by vehicle ramp. Image credit: Google Streetview, August 2011

There was widespread use of buildings for informal (unplanned) vertical evacuation in Ishinomaki on March 11<sup>th</sup>, 2011. Following production of the 2005 government guidelines on vertical evacuation, Ishinomaki City office reached agreement with three private companies in the Minato-machi district of the city to use their facilities for evacuation. On March 11<sup>th</sup>, a total of around 500 people sought refuge at these three buildings: York Benimaru shopping centre (Figure 60), Homac hardware centre (Figure 61), and Hotaru funeral facility (Figure 62). Although these buildings are only 2-storeys in height, they were deemed appropriate for the city's level of tsunami risk and were sufficient for the tsunami inundation which occurred. Two of the buildings (Homac and Hotaru) have external vehicle ramps leading to rooftop car parking areas; the funeral facility appeared not to have external access to the 2<sup>nd</sup> storey, and it is unclear whether 24 hour access is available.

In addition to these three designated buildings, almost any building that is higher than a 2-storey residential structure was used for vertical evacuation in this event. About 260 official and unofficial evacuation places were used in total, providing refuge to around 50,000 people. These included schools, temples, shopping centres and housing. In addition to this, there were another 50,000 people trapped in the upper storeys of houses. Due to the effects of this tsunami, it is recognised that more evacuation structures are required west of the Kitakami River. Relocation of evacuees was required in some locations, for example at Kadonowaki Elementary School (Figure 63), which was inundated at the first floor and was subsequently affected by fire within 1 hour of the earthquake. Those people that had evacuated to the school were able to leave the school prior to the fires, moving further inland and uphill to another school.

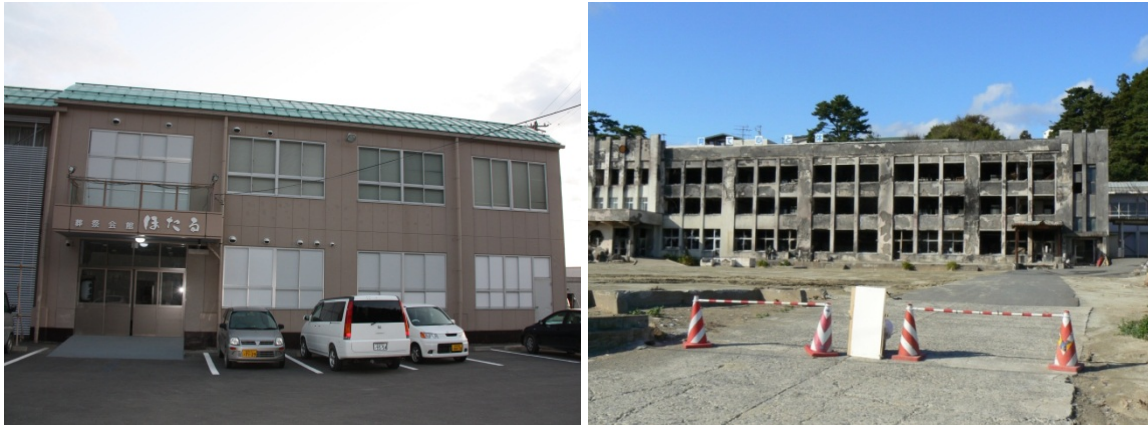
Figure 62 The Hotaru funeral facility. This is an unlikely vertical evacuation facility given the lack of obvious roof space or external access, but successfully provided refuge on March 11<sup>th</sup>.

Figure 63 Kadonowaki Elementary School was damaged by fire while inundated during the tsunami. People who had sought refuge here were able to leave the building and evacuate further uphill at the rear of the school. This building is a typical school structure in Japan; these buildings are commonly used as evacuation or emergency welfare centres.
