Fraser, S.; Leonard, G.S.; Matsuo, I. and Murakami, H. 2012. Tsunami evacuation: Lessons from the Great East Japan earthquake and tsunami of March 11<sup>th</sup> 2011, *GNS Science Report* 2012/17. 89 p.

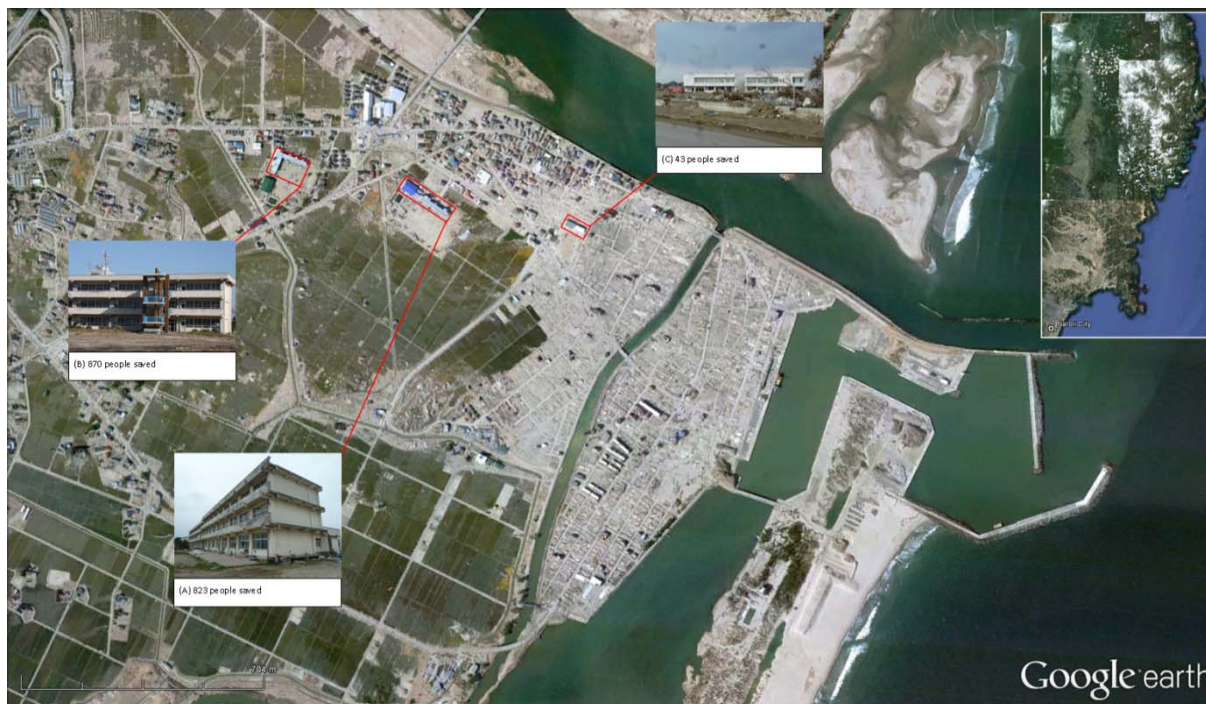
Figure 64 Locations of designated evacuation buildings in Yuriage, Natori City: (A) Yuriage Junior High School; (B) Yuriage Elementary School; (C) Yuriage Community Centre. Sendai International airport is to the south of the area shown here.

Four tsunami buildings in Natori City had been specified by the municipality government as evacuation places: Yuriage Community Centre (Figure 65), Yuriage Junior High School (Figure 66), and Yuriage Elementary School (Figure 67). These buildings are situated outside of the previously estimated tsunami hazard zone, so it is believed that these buildings had been identified as regular evacuation centres, rather than specifically for vertical evacuation. Sendai International Airport in Kitakama was also an evacuation location, through an existing agreement with local residents that it would be used in the event of a tsunami. These buildings were the destination for many people evacuating Yuriage (Murakami and Kashiwabara, 2011) and a total of 3,285 people evacuated to these buildings (Unknown, 2011b), but other 1 to 2-storey buildings between Yuriage and the airport, such as a pump-house and a university boat club building were also successfully used for refuge. People also survived on a pedestrian footbridge close to the Yuriage Bridge. The designated schools in Yuriage are 3-storeys in height and the community centre is 2-storey. In this event a small amount of water reached the 2nd storey but people survived at that level.

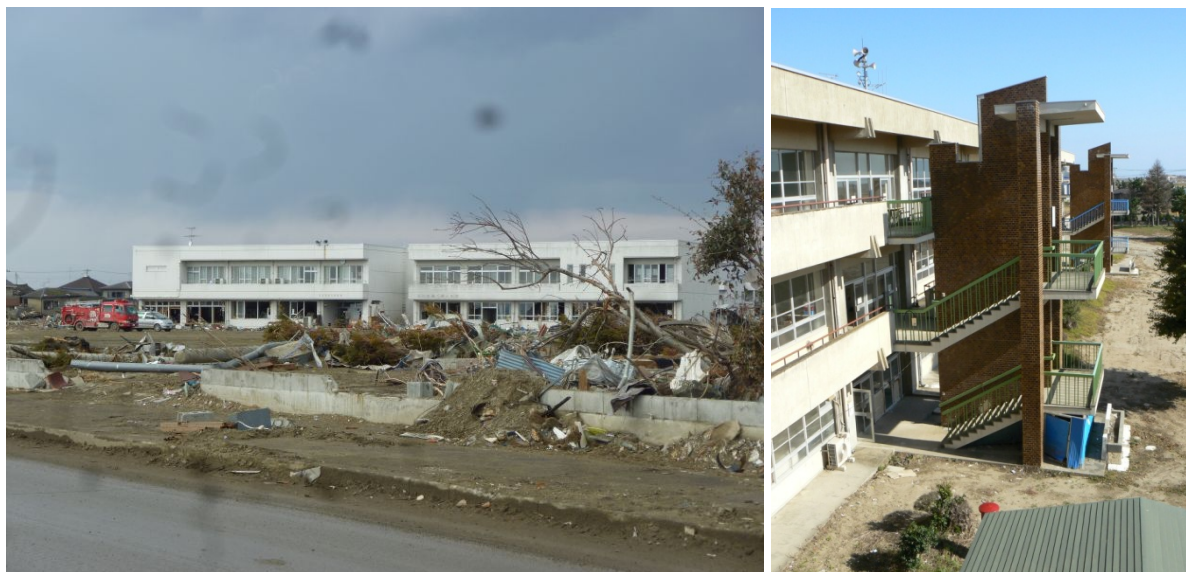
Figure 65 The Yuriage Community Centre was inundated to the 2<sup>nd</sup> storey but 43 people survived in the building.

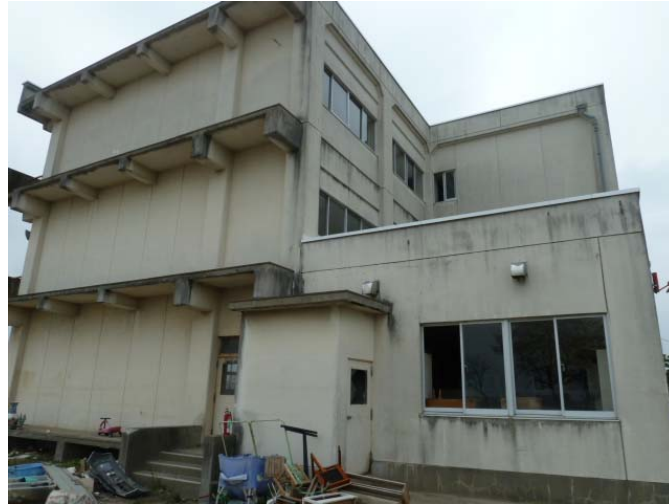
Figure 67 Yuriage Junior High School is constructed on ground which is raised 1.8 m above the surrounding fields. This helped to mitigate damage from the tsunami flow and only contents damage was observed (EEFIT, 2011). 823 people took refuge here.

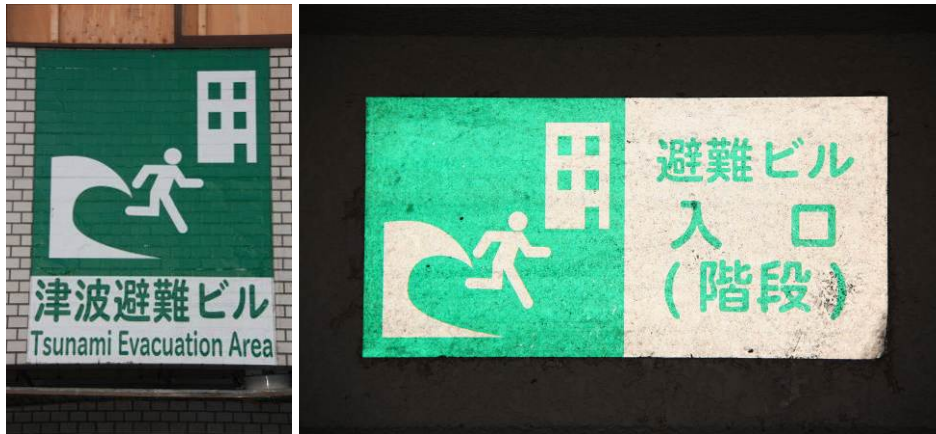
Consistent vertical evacuation signage for buildings was introduced in 2004 and in general only buildings constructed after 2004 have this signage in place on their exterior (e.g. Figures 68 and 69). The only observed buildings with official signage in place are the apartment block in Kamaishi; Hotel Horaikan in Unosumai; Matsubara apartment block in Minami-Sanriku; the Prefectural Office in Kesenuma City; and Yoyoi food factory in Kesenuma.

Figure 68 Official vertical evacuation signage, as photographed on the apartment block in Kamaishi.

Figure 69 Sign indicating the entrance to external stairways at the apartment block in Kamaishi (Translation: “Evacuation building entrance (stairways)”).
