LAKE HOROWHENUA ACCORD AND CLEAN-UP FUND

– PROGRESS REPORT

Horizons Regional Council Palmerston North

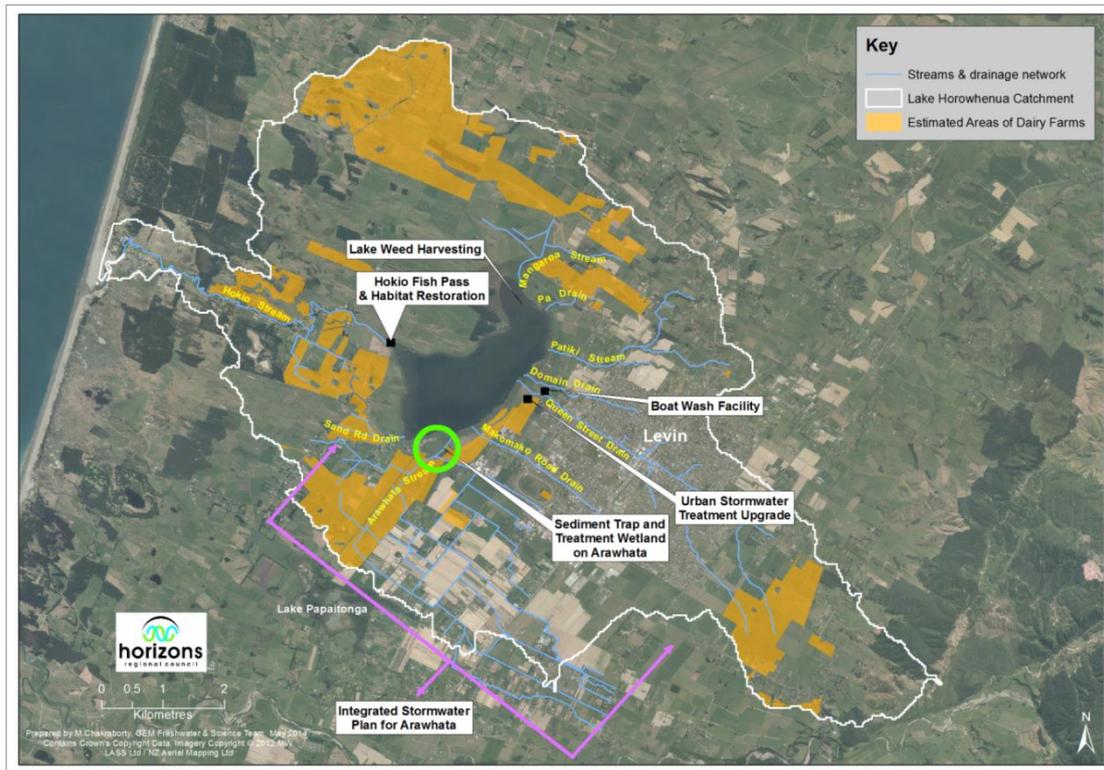
Figure 1: Map showing where each of the eight projects are going to take place around Lake Horowhenua.

Eight projects are currently being undertaken as part of the Clean-up Fund (Figure 1). These are:

1. Undertaking lake weed harvesting
2. Provision of a boat wash facility in Levin
3. Riparian fencing and planting
4. Treating stormwater entering the Lake through the Queen Street Drain.
5. Creating a sediment trap and treatment wetland on the Arawhata inflow to the Lake.
6. Creating integrated drainage and sediment control plans for cropping farms along the Arawhata sub-catchment.
7. Creating sustainable milk production plans for dairy farms.
8. Construction of a fish pass at the weir on the Hokio Stream.

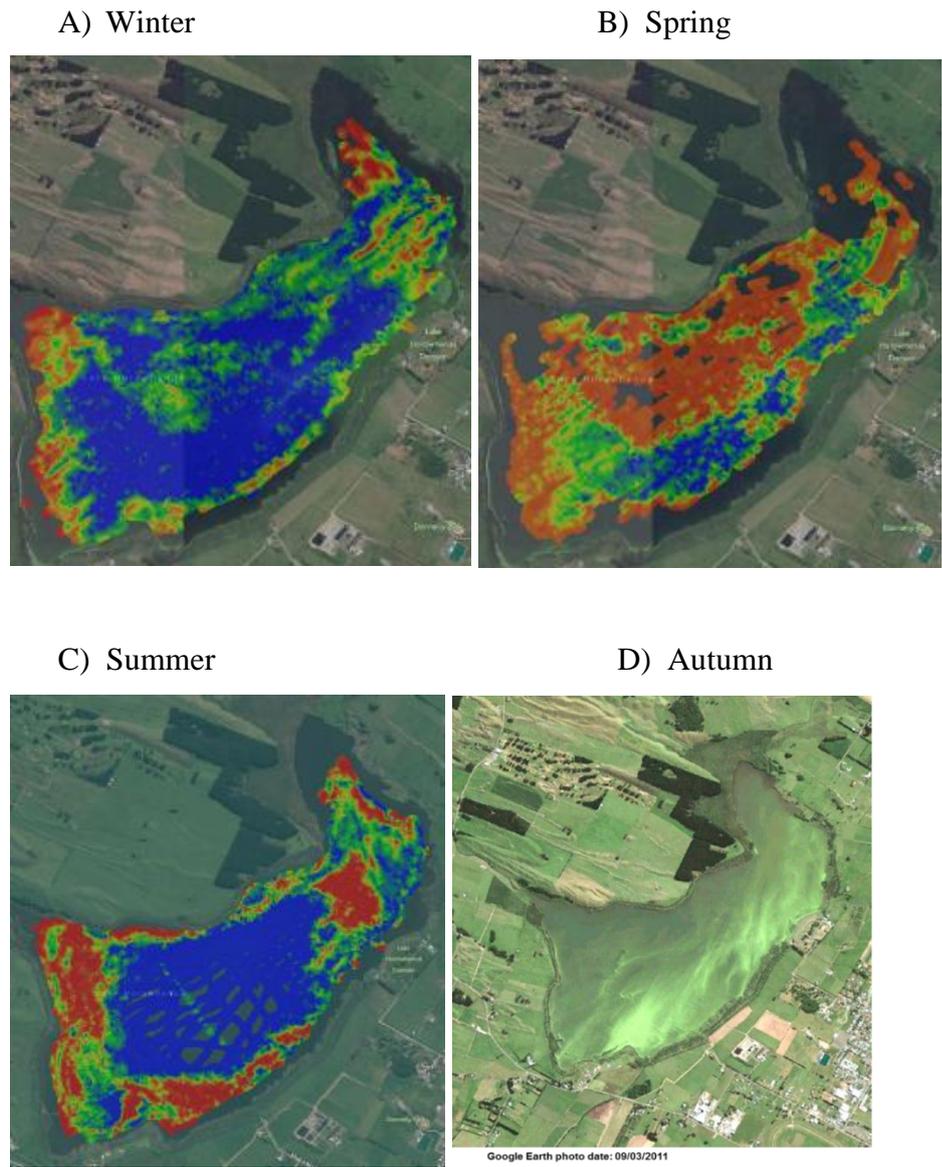
Figure 2: Maps showing Lake weed in different seasons. Red (dense weed), Green (Some weed), Blue (No weed). Note the Autumn map is a google image showing the cyanobacteria bloom in 2011.

Monitoring of the amount of lake weed present in different seasons was undertaken for Horizons Regional Council by NIWA (Figure 2, Table 1). The harvesting recommendations from NIWA was 9 days per month in Spring and 3 days per month in summer. This level of harvesting is expected to remove 1,350 tonnes of wet weight lake weed in spring and 600

tonnes in summer. This removal of lake weed is estimated to remove 5.2 tonnes of nitrogen and 0.8 tonnes of phosphorus from Lake Horowhenua annually. Work to refine the harvesting strategy and determine the end use of the weed is ongoing.

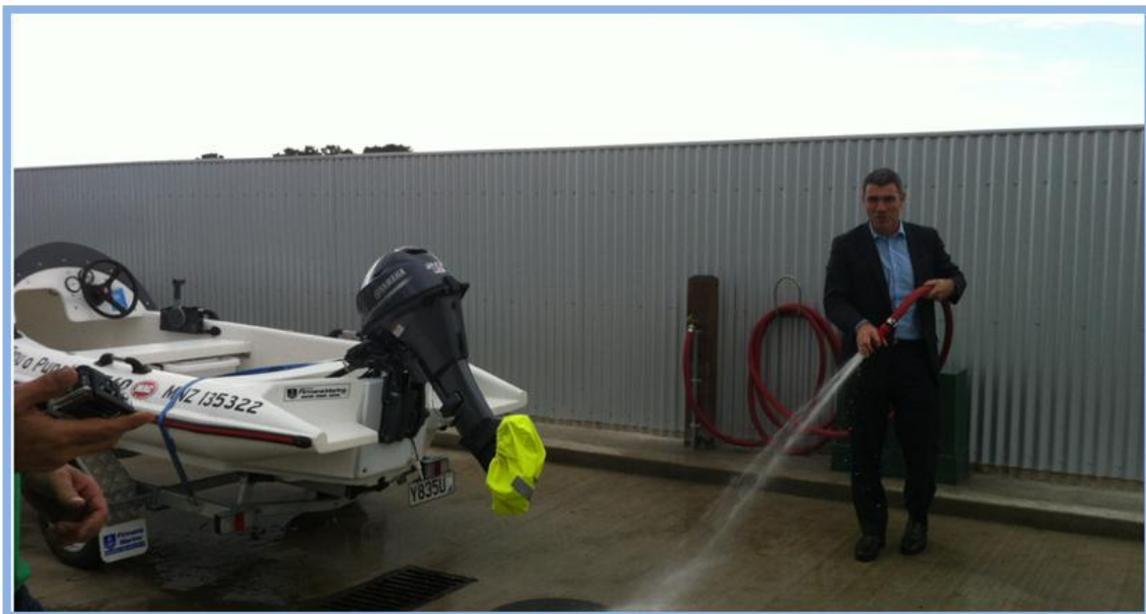
Photo 1: Minister Guy testing out the new boat wash facility built as part of the Lake Horowhenua Clean-up Fund.

Introduction of exotic lake weeds not currently found in Lake Horowhenua (e.g. *Egeria densa* or hornwort) are a risk to water quality in the lake. Lake weeds could irreversibly change the water quality and character of the lake. Many lake weeds can be spread by fragments broken off the main weed bed and fragments can survive considerable periods of time out of water. Lake weed can easily be transferred on boat trailers and leisure activity equipment. *Egeria* and hornwort are present in lakes within the Horizons Region but are not present in Lake Horowhenua. Provision of a boat wash facility is a preventative measure to guard against further weed introductions that could impact on lake ecology and water quality. The boat wash facility was installed in July 2014 as part of the Lake Horowhenua Clean-up Fund project and reduces the likelihood of aquatic weeds entering the lake on recreational equipment (Photo 1).

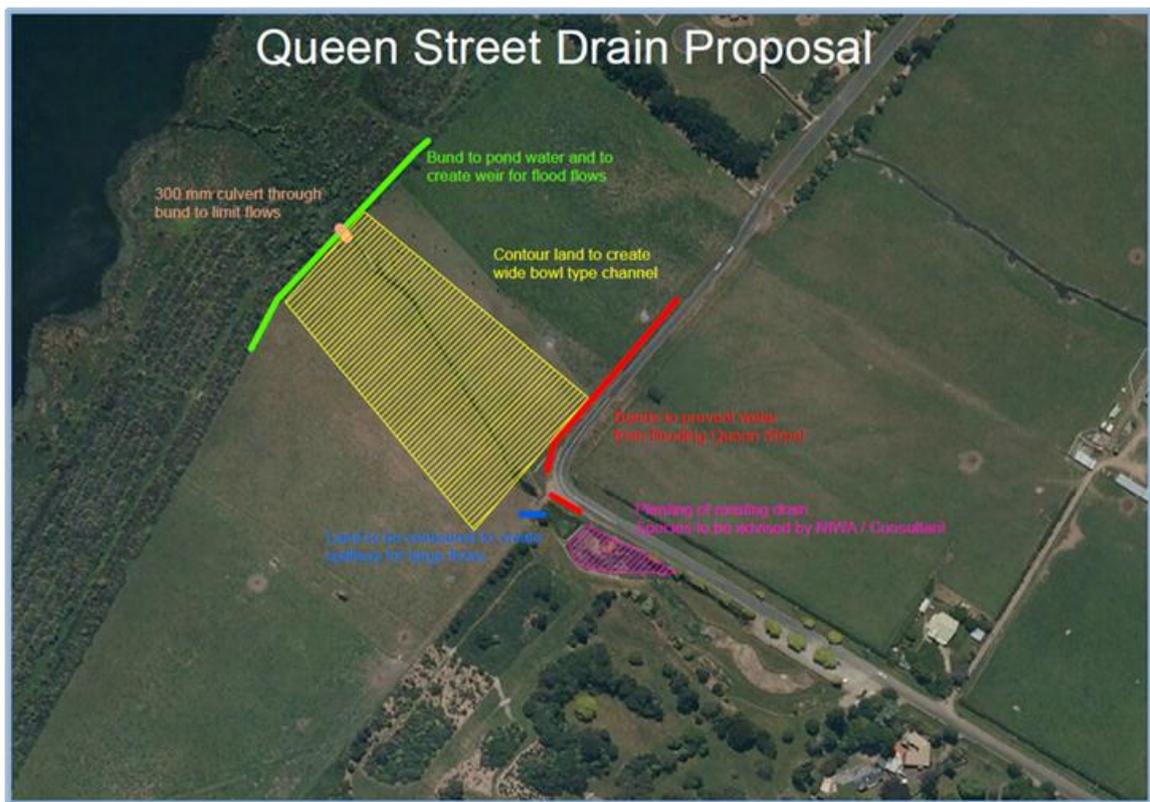
Figure 3: Draft design proposal to filter stormwater from the Queen street drain before it enters Lake Horowhenua.

Stormwater inflow from the Levin Township is a source of contamination for Lake Horowhenua. While many of the stormwater inflows do not flow permanently into the lake, when they do they can contribute significant loads of nutrient and sediment. Slowing stormwater down prior to entering the lake provides an opportunity for sediment in the stormwater (including some of its associated nutrient and other contaminant load) to settle out before reaching the lake (Figure 3). Further work to identify options for stormwater treatment within the network is underway by Horowhenua District Council.

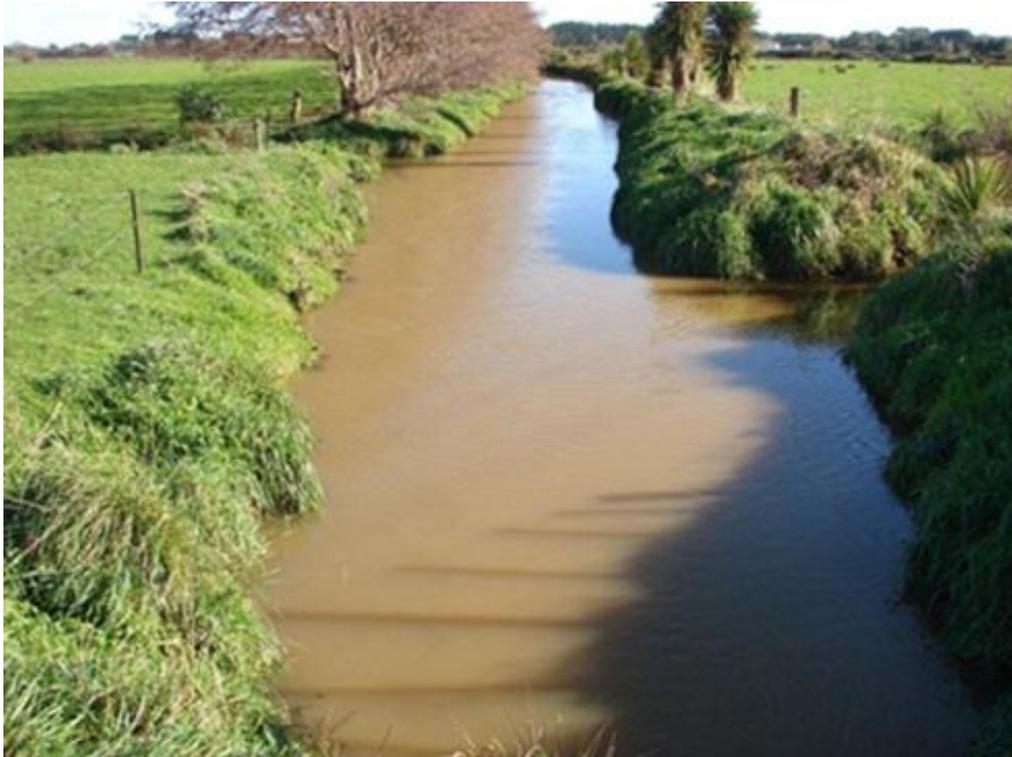
Photo 2: Sediment in the Arawhata Stream following rainfall.

The Arawhata Stream is a small intensively farmed catchment and has the largest surface inflow. The Arawhata is the most consistent contributor of sediment and is the largest single source of nitrogen to the lake (Photo 2). Recent data suggests that the Arawhata Stream may become anoxic at night and enhance oxygen depletion in the lake. The sediment trap and treatment wetland will reduce the speed of water flow, allowing sediment and associated nutrients to settle out before entering the Lake.

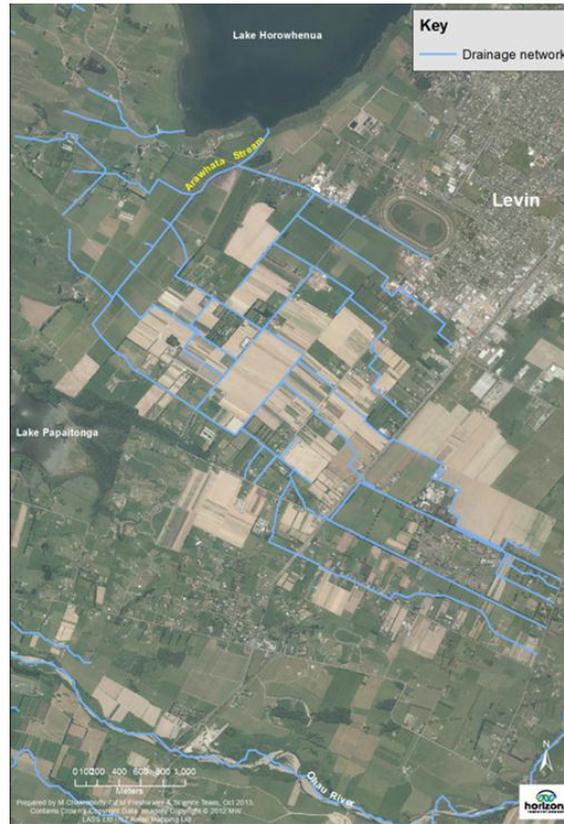
Figure 4: Map of the Arawhata sub-catchment showing the intensively farmed areas and the drainage network.

A high proportion of the sediments and nutrients entering the Arawhata stream is from flood waters and overland drainage from cropped land. Horizons Regional Council has engaged Dan Bloomer from LandWise to work with growers to identify problem areas on their farms (Figure 4). These are often areas where flood waters from ineffective drainage networks are causing blow outs and large amounts of sediment are being lost to the Arawhata Stream. Dan Bloomer is also working with growers to reduce on farm ponding and improve on farm drainage. The integrated catchment drainage and sediment control plans for growers has the potential to increase farm profitability while decreasing the loss of sediment and nutrients to Lake Horowhenua.

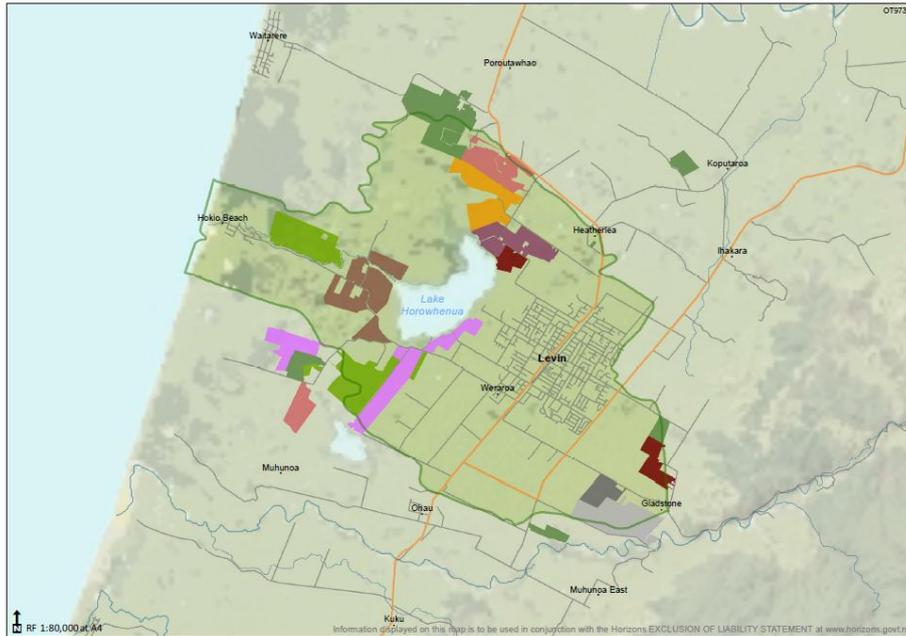
Figure 5: Map showing the ten dairy farms identified in the Lake Horowhenua Catchment. Each colour on the map represents a different farm owner.

There are ten dairy farms within the Lake Horowhenua catchment. Dairying accounts for approximately 1430ha of the catchment with about 1020ha being milking platform (Figure 5). Horizons Regional Council One Plan has established regulatory requirements for these farmers to manage their sediment and nutrient inputs to Lake Horowhenua. Horizons Regional Council and Dairy NZ are working with farmers within the catchment to produce sustainable milk production plans for each farm. These plans include completing detailed soil mapping, completing nutrient budgets and assessing effluent management to identify opportunities to reduce sediment and nutrient run-off and reduce nutrient leaching.

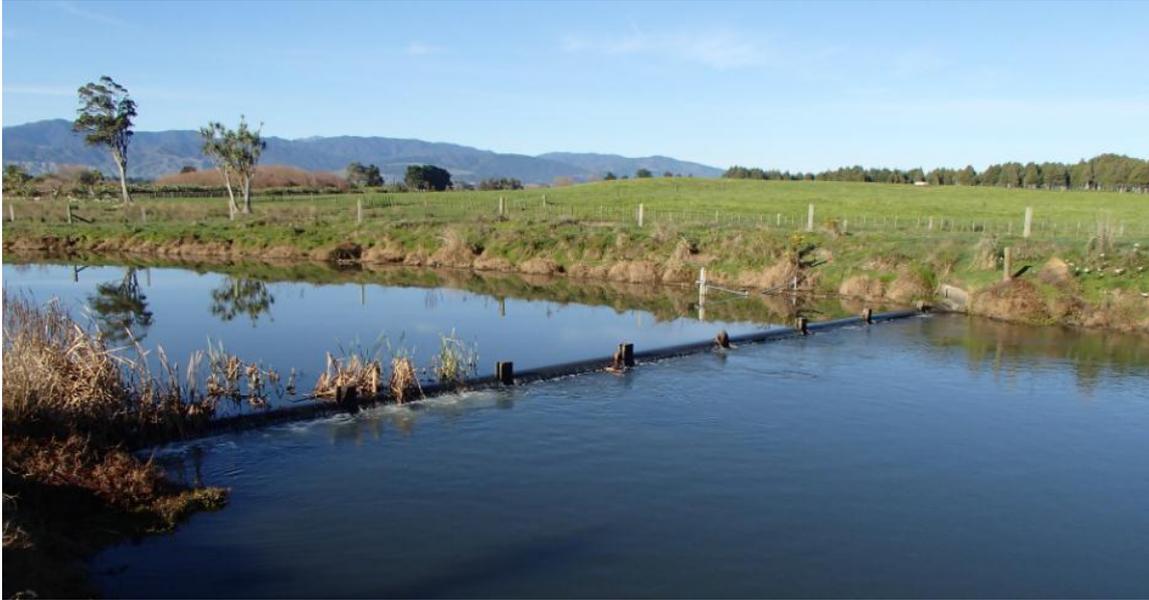
Photo 3: Weir along the Hokio Stream which impedes fish migration from the ocean to Lake Horowhenua.

A weir historically installed on the Hoki stream restricts upstream migration of species such as grey mullet and flounder (Photo 3). This weir is the most likely reason for the reduced number of some types of native fish species and it has been recommended that this be addressed by installing a fish pass. The weir is a key piece of infrastructure for the lake enabling water levels to be managed to achieve legislated requirements. The fish survey undertaken in 2013 also found a high abundance of tuna (eel) in Lake Horowhenua. However, tuna greater than 1 kg in size were nearly absent and tuna average weight was only 191.4g, well below the minimum commercial size limit of 220g set by the Ministry for Primary Industries. These findings may be consistent with tuna populations that have been overfished, although there could be other reasons for these findings and more research is needed.
