Auckland Engineering Lifelines Group Project AELG-19

Review of Impacts of Volcanic Ash on Electricity Distribution Systems, Broadcasting and Communication Networks

Auckland Regional Council
Technical Report No.051 April 2009
ISSN 1179-0504 (Print)
ISSN 1179-0512 (Online)
ISBN 978-1-877528-60-6

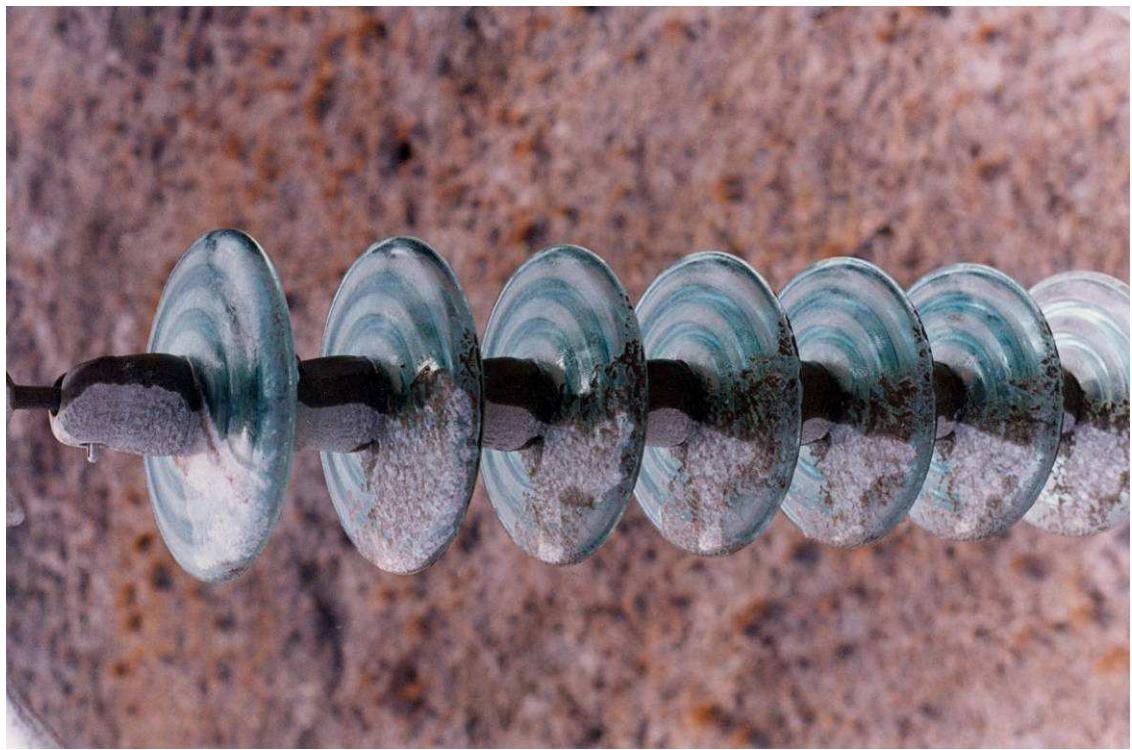
FIGURE A4: Flashover damage from falls of volcanic ash and mud on 25 September 1995 caused on high-voltage electrical power lines at the base of the volcano (from Powermark 1995, unpublished, "Report on volcanic ash contamination").

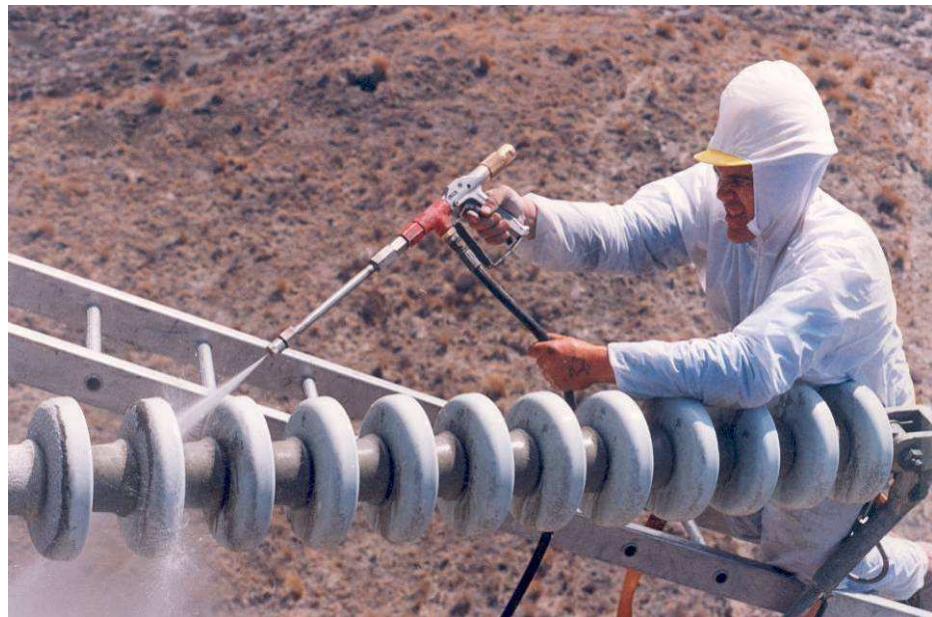
FIGURE A5: Cleaning the power lines/pylons

Electricity supply companies were required to hand clean insulators and towers following every ash fall event (Johnston et al 2000) and towers required repainting afterwards to reduce the acid-induced accelerated corrosion (Figure A5). In addition, the auto recloser system used by the main lines company, Transpower, which breaks electrical supply to a circuit when there is an earth or fault, had to be operated manually during the 1995–1996 eruptions of Mount Ruapehu (A. Joosten, pers. comm 2006). A major concern at the time was that ash fall could cause one circuit to trip out of service, leading to a cascade tripping of remaining circuits transmitting electricity to the upper North Island (Bebbington et al. 2008). Cleaning of 18 towers (and insulators) was undertaken on 27 September 1995 by four crews of four men (Powermark 1995). The ash was found to be dry and easy to remove. Strain towers were the most affected due to their insulator configurations (i.e. horizontally strung). It was found that subsequent rains (on 26 September 1995) had washed the northern side of towers and insulators. It was concluded that normal rainfall would clean ash from structures, conductors and insulators except the undersides of strain strings. Three strings of insulators were found to have widespread flashover damage but with no electrical problems.

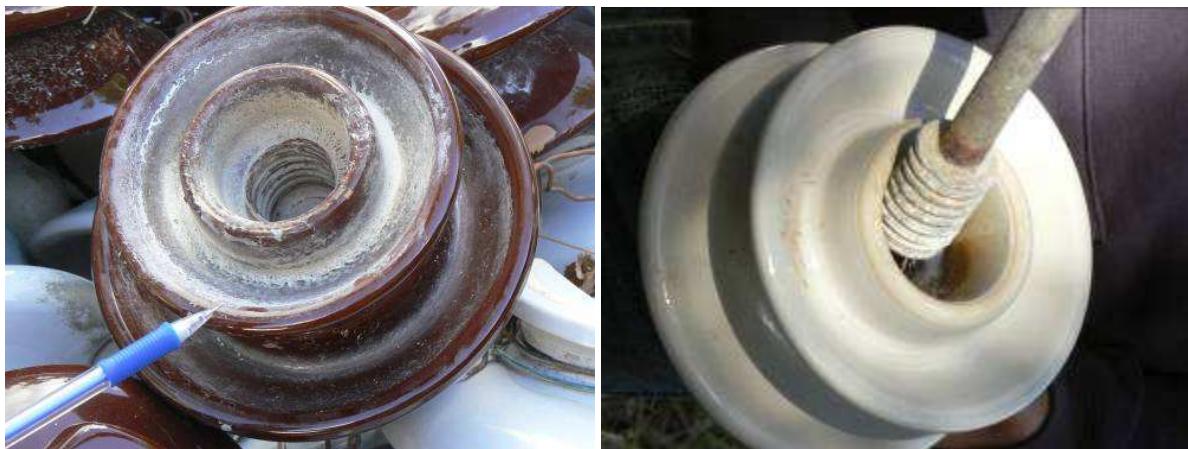
Figure A6: Insulators used on 33 kV line, with ash contamination (left) and flashover damage (right)

A 68 km stretch of 33 kV line to Futaleufu (75 km from volcano) was affected by fine grained rhyolitic ashfalls between 20 mm to over 300 mm in some areas. Local linesmen reported that 10-20% of insulators (porcelain) suffered flashovers from fine volcanic ash accumulation following light misty rain between 6-9 May 2008. The ash covered lines and insulators had operated without problem until the light rainfall. Subsequent heavy rain had reportedly washed much of the ash off, but significant volumes of ash remained underneath insulators where flash-over strikes had occurred (Figure A6). Following initial inspections, the lines company decided to totally replace all insulators on the line, as it was too laborious to clean or assess damage to each insulator. Many of the insulators which had suffered flashover were cracked and exhibited burn marks at the base where it screwed onto the supporting metal pin (Figure A6). Only vertical insulators suffered flashover. Horizontal string insulators did not suffer problems. Isolators and transformers on the line were also reported to have suffered flashover damage. It took 20 days to repair the line.
